Las Vegas Wash Vegetation Monitoring Report, 2017

January 2019

SOUTHERN NEVADA
WATER AUTHORITY

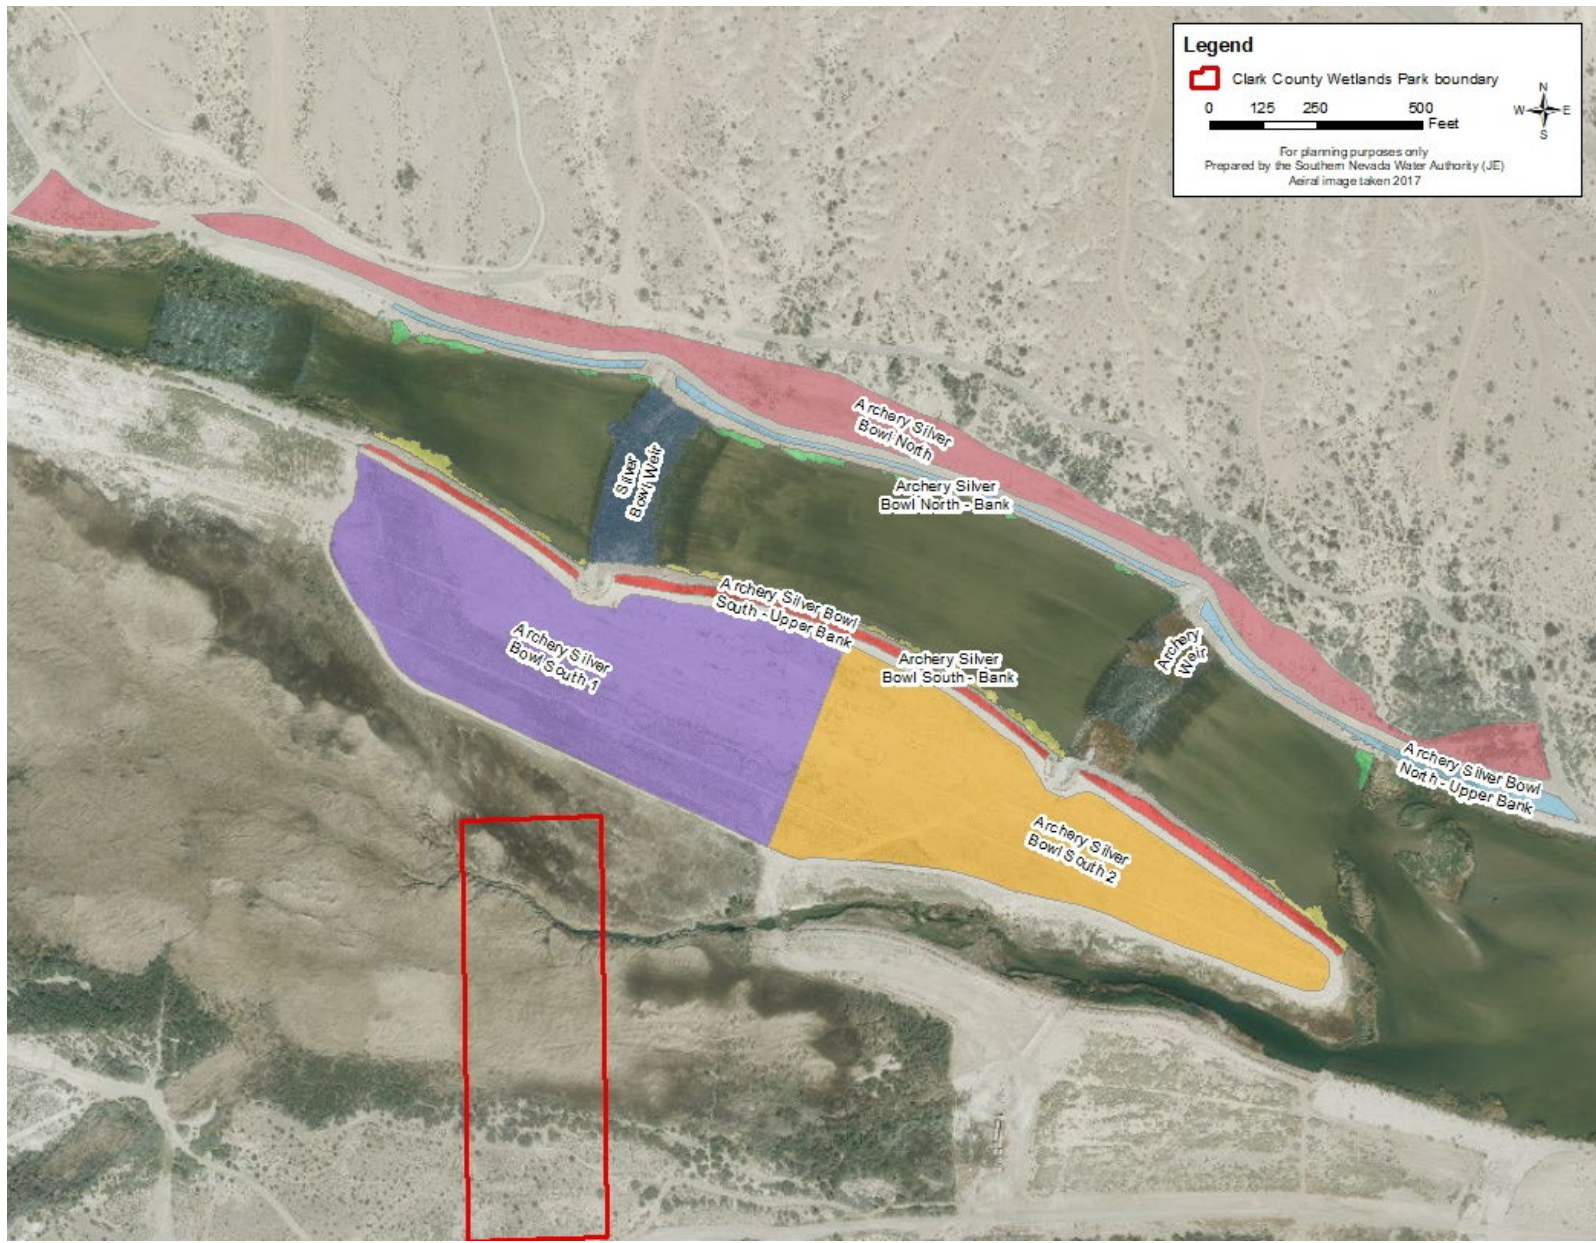
Figure 3. Aerial photograph of 2017 delineated Archery and Silver Bowl Weirs revegetation sites.

The Archery and Silver Bowl Weirs were constructed simultaneously, and their project boundaries are adjacent to each other (Figure 3). Therefore, the revegetation that took place after the weirs were completed does not use the boundaries of the individual weirs but rather the combined footprint of both structures. Planting began on six sites in 2015 and one site in 2016 (Table 3). These include two Green-Up sites; Archery Silver Bowl South 1 (ASBS1) in October 2015 and Archery Silver Bowl South 2 (ASBS2) in April 2016. This monitoring year added two new sites

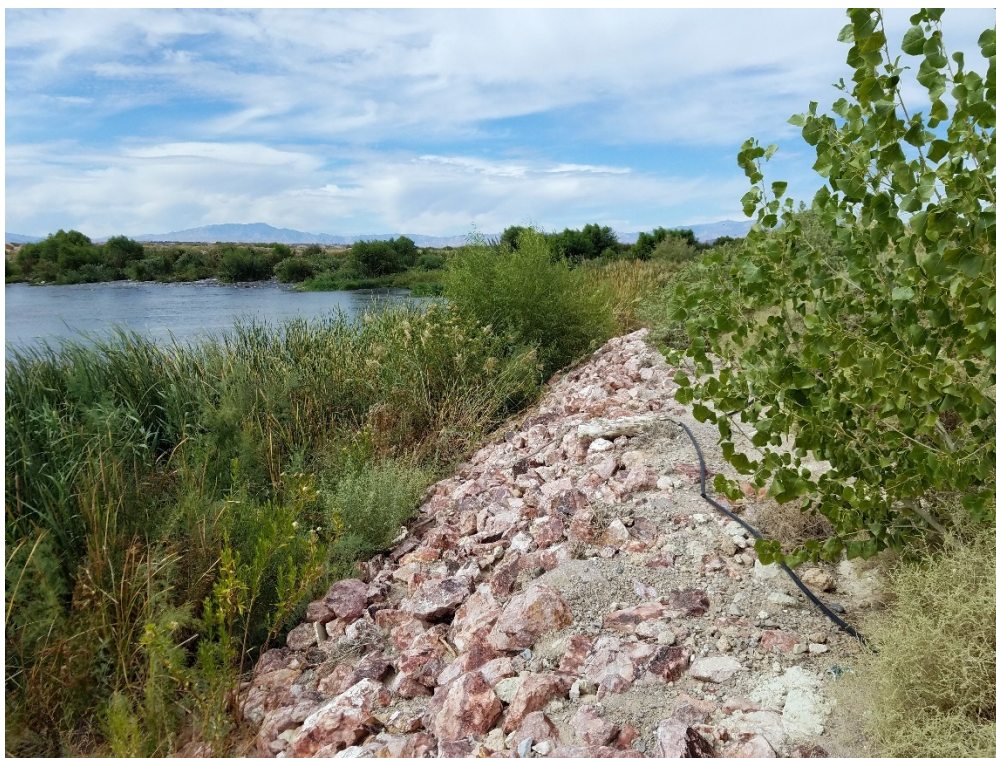
Figure 4. Wetland and riparian vegetation line the banks of the Wash at Archery Silver Bowl North Bank (along water-photo left) and Archery Silver Bowl North Upper Bank (above rock-photo right).

that were passively established wetlands that formed on the weirs themselves; Archery Weir (AW) and Silver Bowl Weir (SBW). The five remaining sites were planted by SNWA’s contractor beginning in 2015 and continuing into 2016 including all wetland sites (Figure 4).

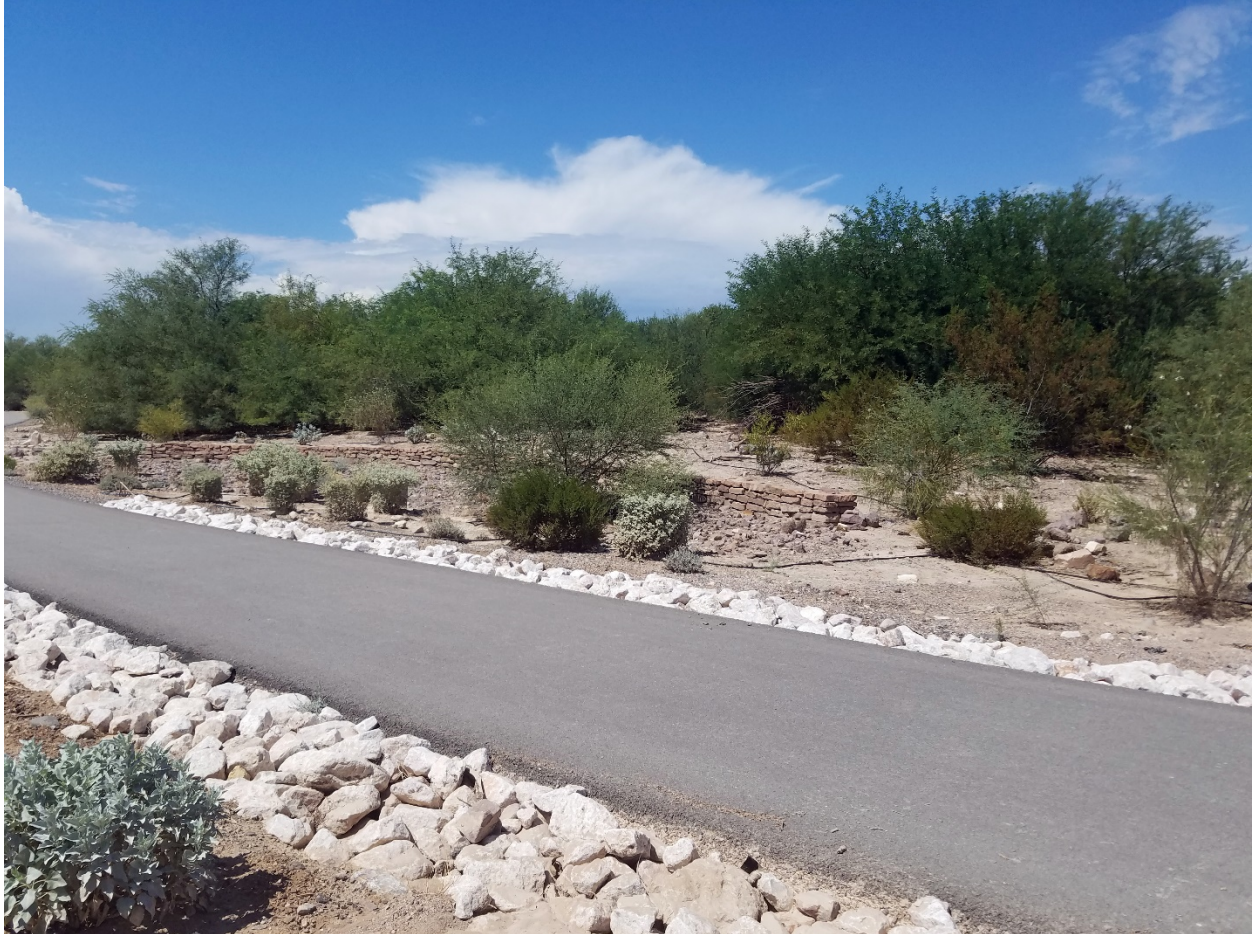
Figure 6. Vegetation at Bostick South Tamarisk lines the Clark County Wetlands Park bike trail.

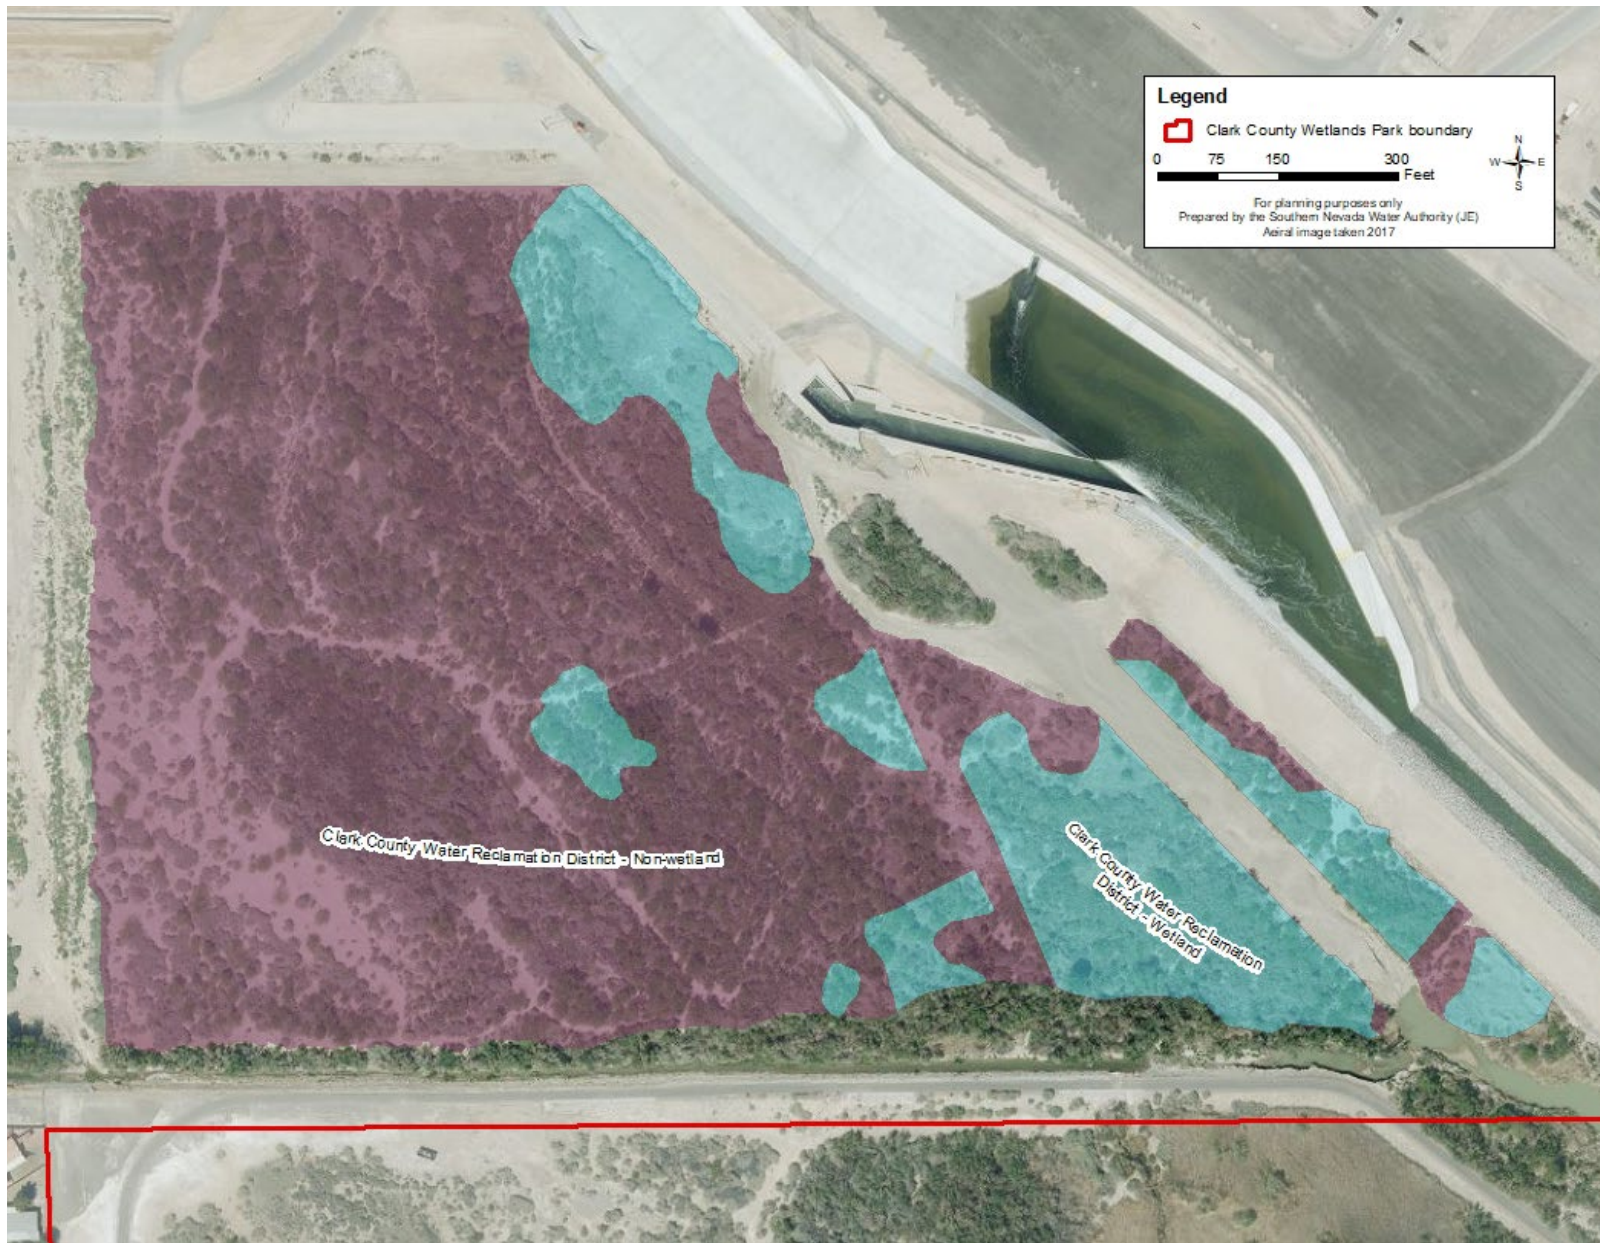
Figure 8. Aerial photograph of 2017 delineated Clark County Water Reclamation District revegetation sites.

Due to ongoing construction occurring at the property, the revegetation site was not accessible during the monitoring season. Shortly after the monitoring year concluded, construction was also completed. Therefore, field monitoring will reconvene in 2018. Aerial imagery and ArcGIS data document that there have been physical changes, as expected, by the construction. Specifically, the southeast corner of the site had access routes created through it. It is unknown how the channelization will impact the groundwater, which was very high prior to the work. ArcGIS measurements of the cover of each of the 29 monitoring areas came up with similar total cover values each of the past two seasons with 84.6% in 2016 and 87.5% in 2017. In 2017, each of the 29 areas had the maximum cover value of 75-100% cover, with most having the 100% cover.

The site located at the CCWRD were monitored using ArcGIS in 2017. Although there are both wetland and non-wetland components to the site (Figure 8; Table 6), the site was planted as one contiguous site and is considered a single site. There is little distinction between the plant species or soils in these two areas. Wetland areas were determined during the Jurisdictional Determination with the Corps by the CCWRD. Therefore, monitoring after the site was planted kept the wetland areas in order to report changes to the Corps for permitting needs. Twenty-nine monitoring areas were created for monitoring but do not distinguish between wetland and non-wetland areas.

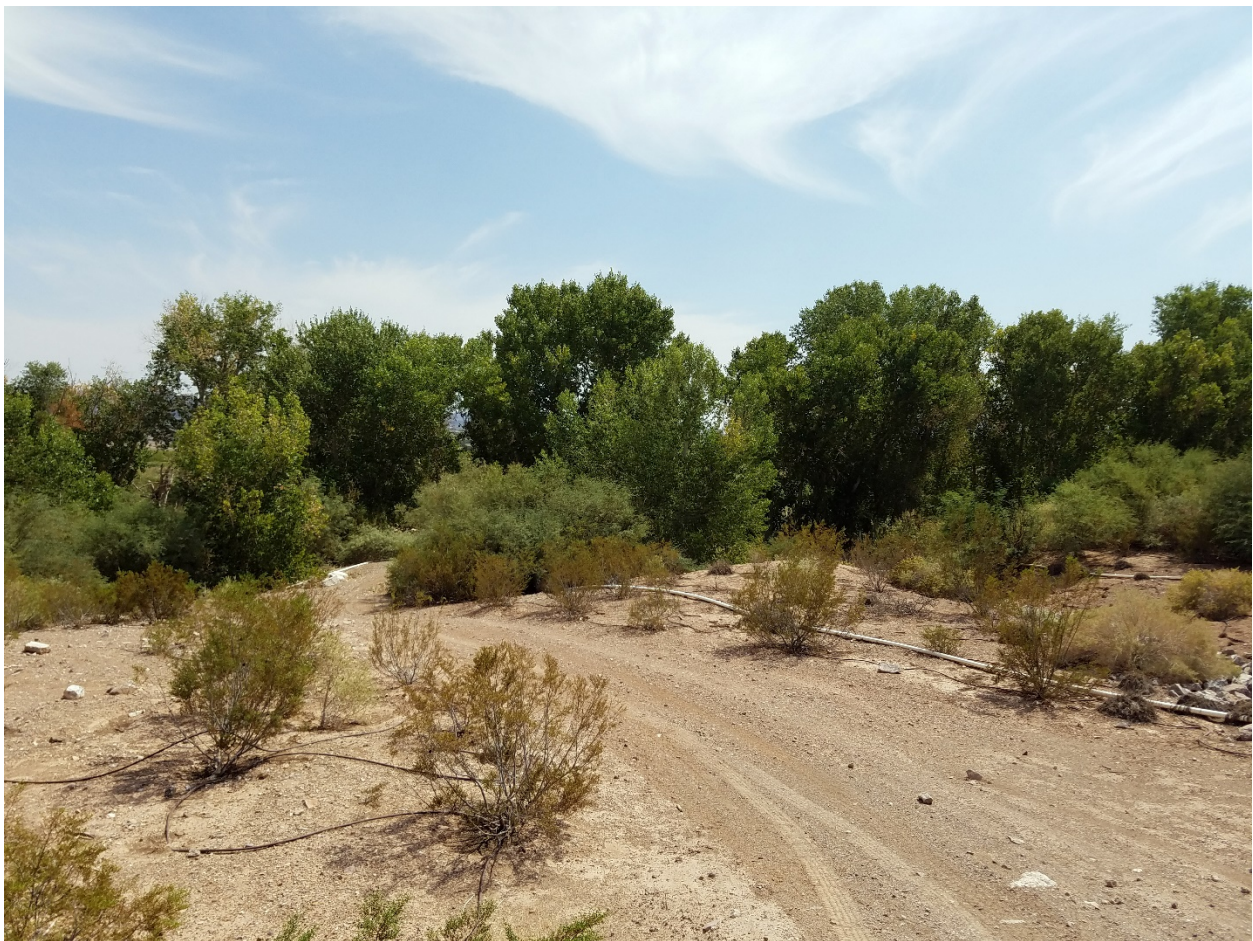
Figure 9. The cottonwoods in Cottonwood Cell 1 and Cottonwood Cell 2 are between 35 and 50 feet tall.

It is expected that the construction of the Historical Lateral Weir expansion will impact all of the sites at the Cottonwood Cells. There will be substantial impact to Cottonwood Cell 3 (CC3) due to the removal of vegetation on the easternmost edge of the site (Figure 10). Parts of Cottonwood Cell North and Cottonwood Cell North Stockpiles were also removed. In addition to physical removal of areas, there is likely to be hydrological impacts to CC1, Cottonwood Cell 2, CC3, and Cottonwood Cell Bank (CCB) due to a large increase in the backwater behind the Historic Lateral Weir. This should allow for greater infiltration of groundwater to both original cottonwood cells as well as other nearby sites. It should also increase the ability for riparian and wetland plants to be established along the bank itself upstream of the Historic Lateral Weir, expanding CCB and providing a substrate for new plantings as well.

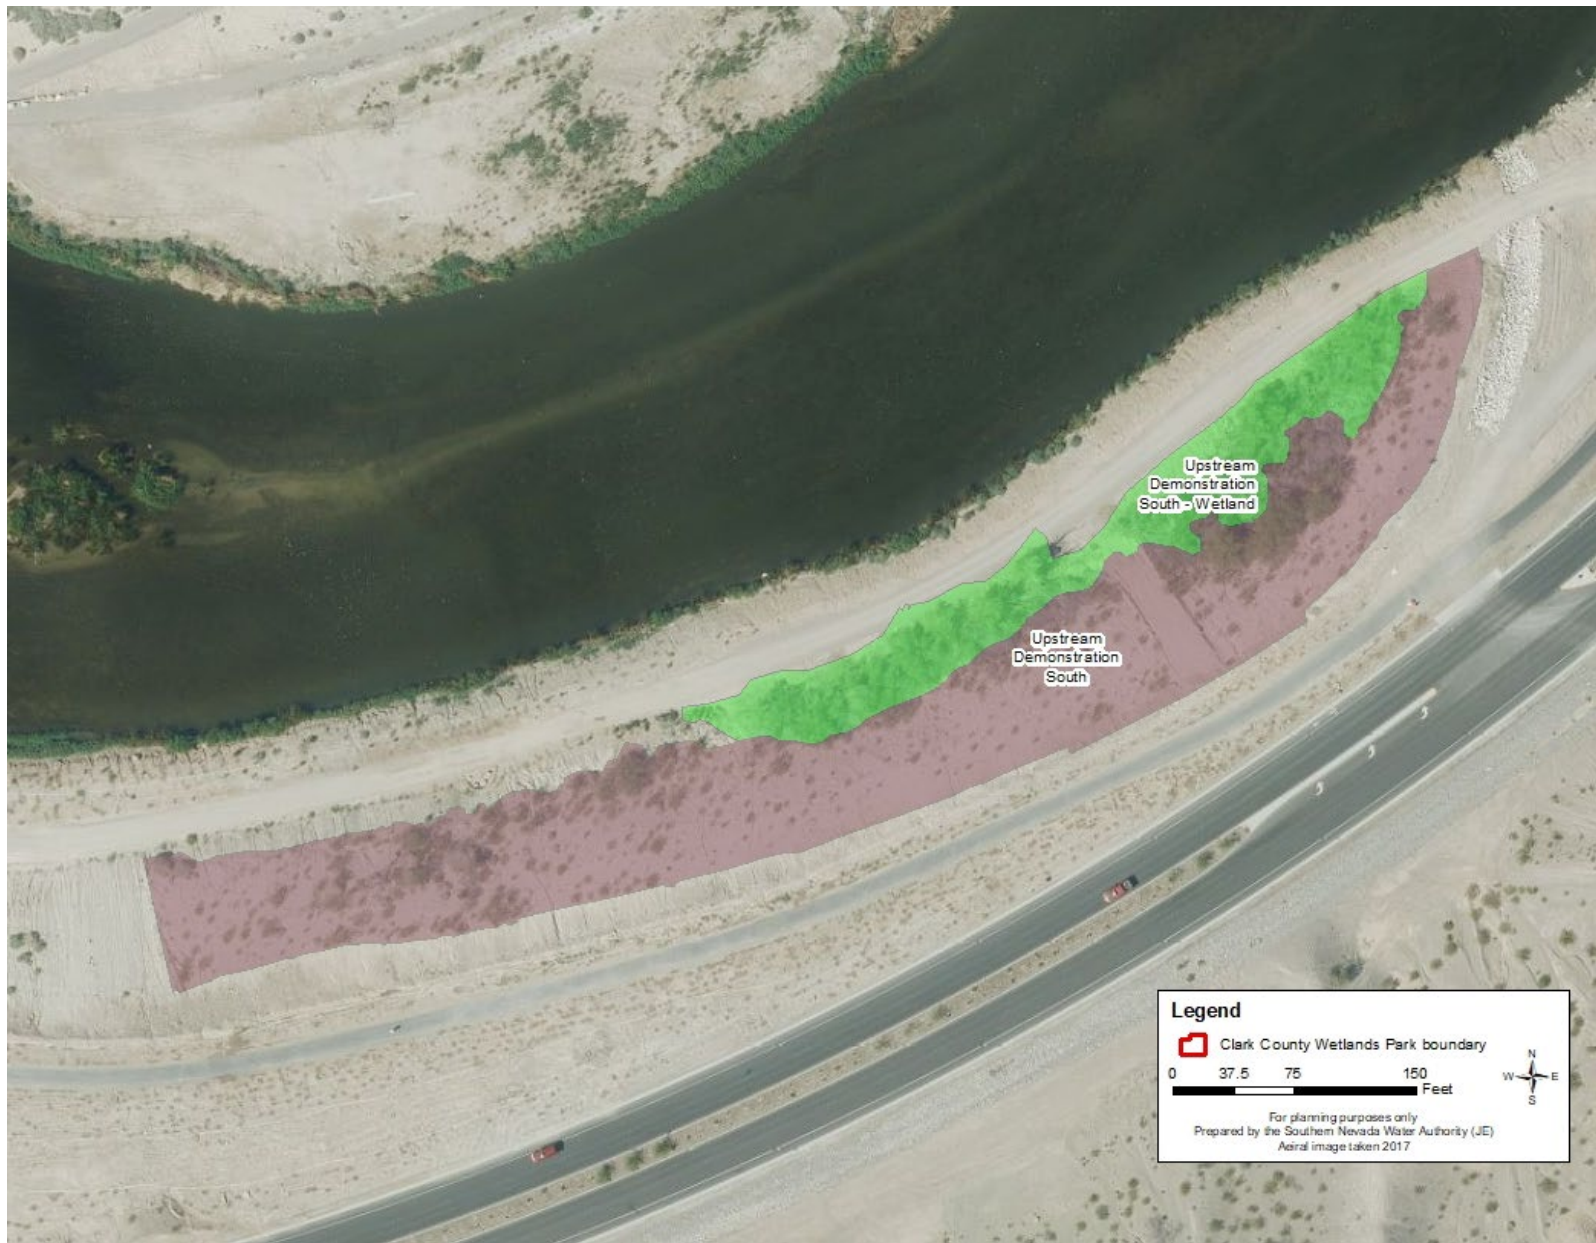
Figure 11. Aerial photograph of 2017 delineated Demonstration Weir revegetation sites.

The two sites at the Demonstration Weir have not changed much in terms of species richness and total cover over the past year (Table 8; Figure 11). In 2017, both sites were monitored for total cover using ArcGIS. Upstream Demonstration South – Non-Wetlands (UDS-N) has had the same total cover for the past three growing seasons; 25-50%. This is a pretty dry site on a steep bank. It should be expected that, although there was higher total cover from 2012-2014 (50-75%), the highest cover the site will sustain in the long-term will be around 50%. This is consistent with surrounding areas with similar plants. Upstream Demonstration South – Wetland went up to 75-100% again in 2017 after dipping to 50-75% in 2016. Last year’s dip was the only time since 2006 that the site didn’t have the maximum cover. This is likely due to impacts from the construction of the Three Kids Weir downstream of the sites which created a new barrier of a road and bank protection between the site and the Wash. But as water was able to slowly infiltrate through the soil, the remaining vegetation appears to have begun recovering.

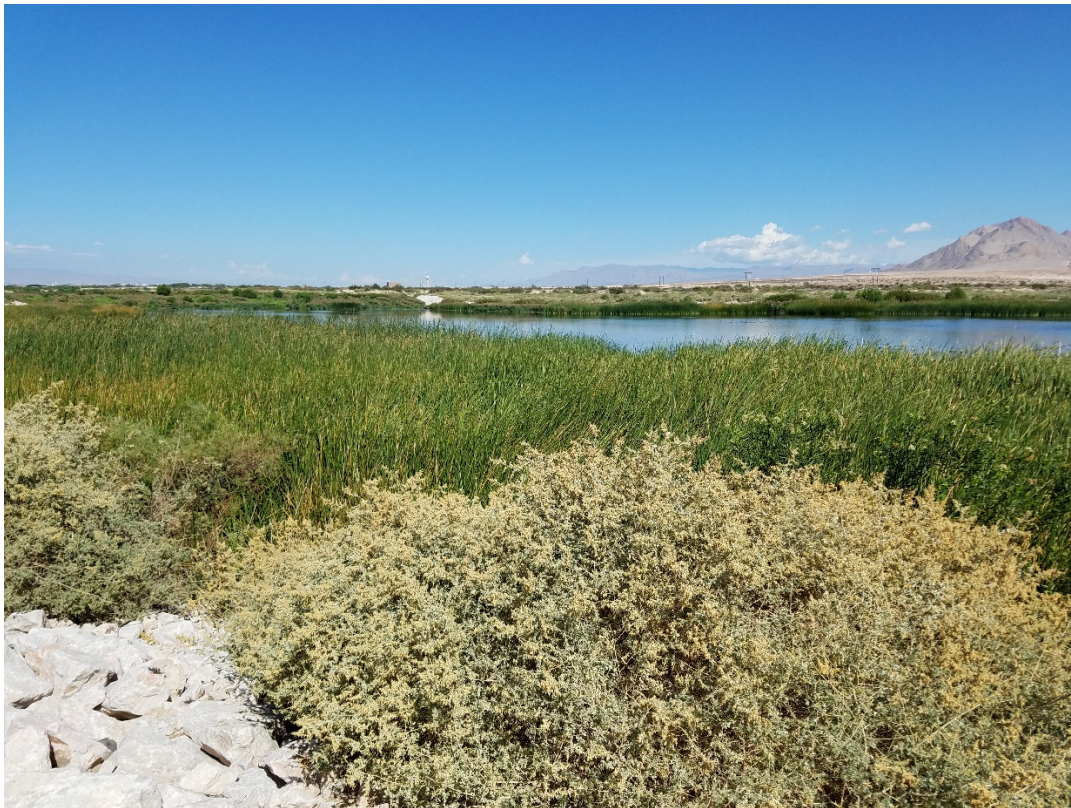
Figure 12. Dense stands of cattails line the banks of the Wash upstream of the Duck Creek Confluence Weir.

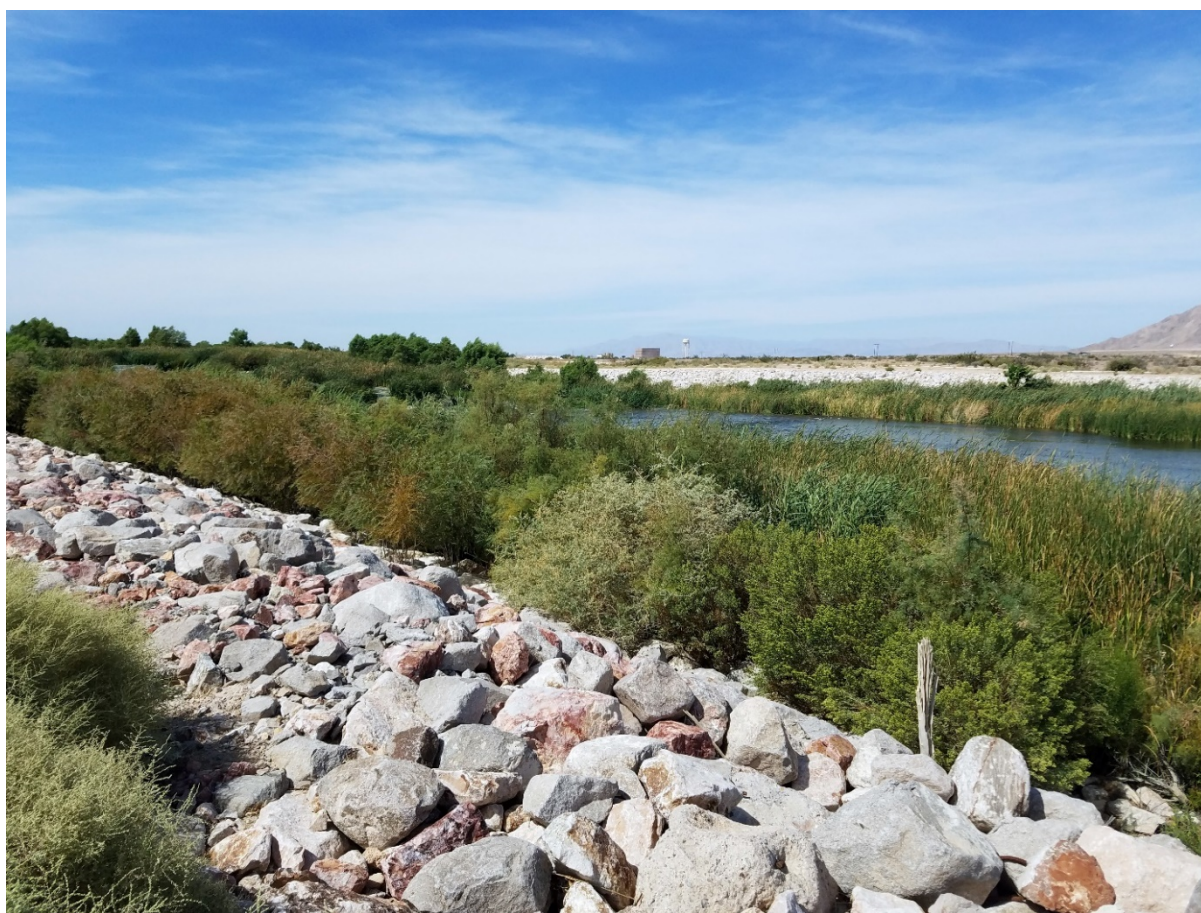
Figure 14. Thirty-three species were identified at the DU Wetlands No. 1 Emergent revegetation site.

All three revegetation sites associated with the DU Wetlands No. 1 Weir had 75-100% total vegetative cover in 2017 (Table 10). All three sites were established in 2013 and therefore have had five growing seasons. DU Wetlands No. 1 Emergent (Figure 14), an actively planted wetland site, and DU Wetlands No. 1 Weir, a passively created wetland site, have both had the maximum cover of 75-100% in each of their five growing seasons. The third site, DU Wetlands No. 1 South is a non-wetland site and was planted as a Green-Up in the spring of 2013 (Figure 15). This site has gone back and forth between 50-75% total cover and 75-100% total cover. It had the higher cover in its second growing season and again this year in its fifth. The second growing season can be attributed to the ongoing irrigation causing many new plants to establish on the site. The subsequent two years had a decline to 50-75% cover as a result of no longer irrigating the site. This most recent year's uptick in cover is likely due to continued growth of the planted plants. The site is much more even in terms of plant species coverage than most with six of the 13 species having 5-25% cover but none higher than that.

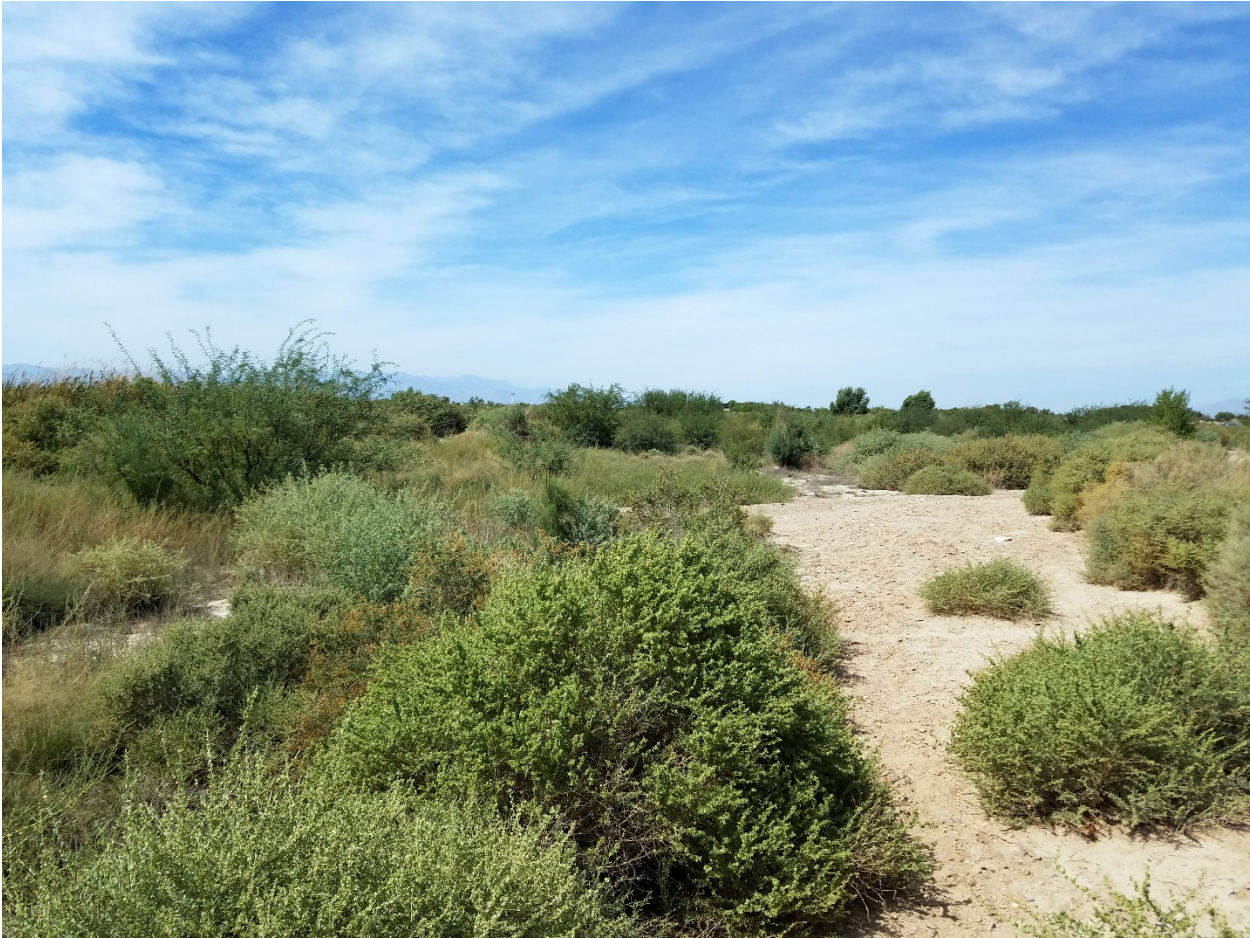
Figure 17. DU Wetlands No. 2 South had a diverse mix of vegetation types in 2017.

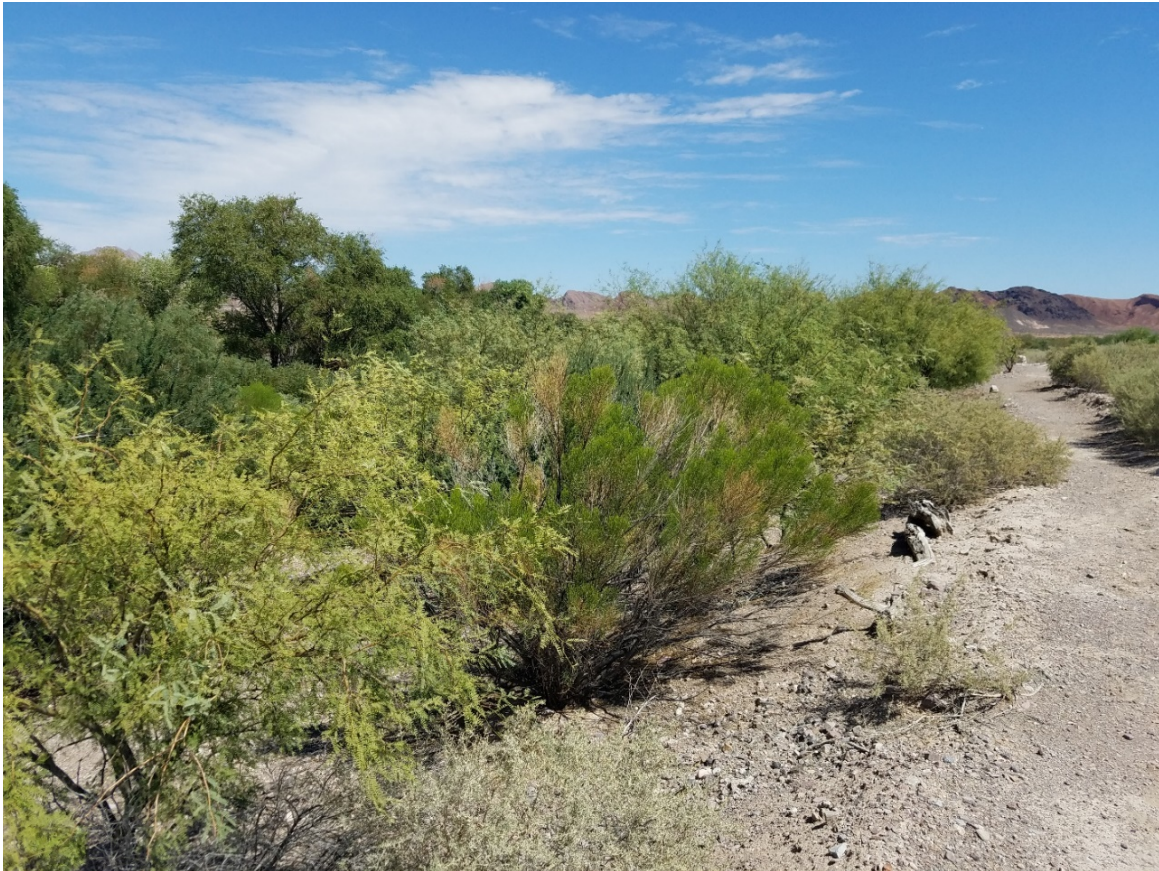
Figure 19. Upstream Historic Lateral South Bank non-wetland (center) and Upstream Historic Lateral South Bank wetland (left) will be impacted by the Historic Lateral Weir expansion project.

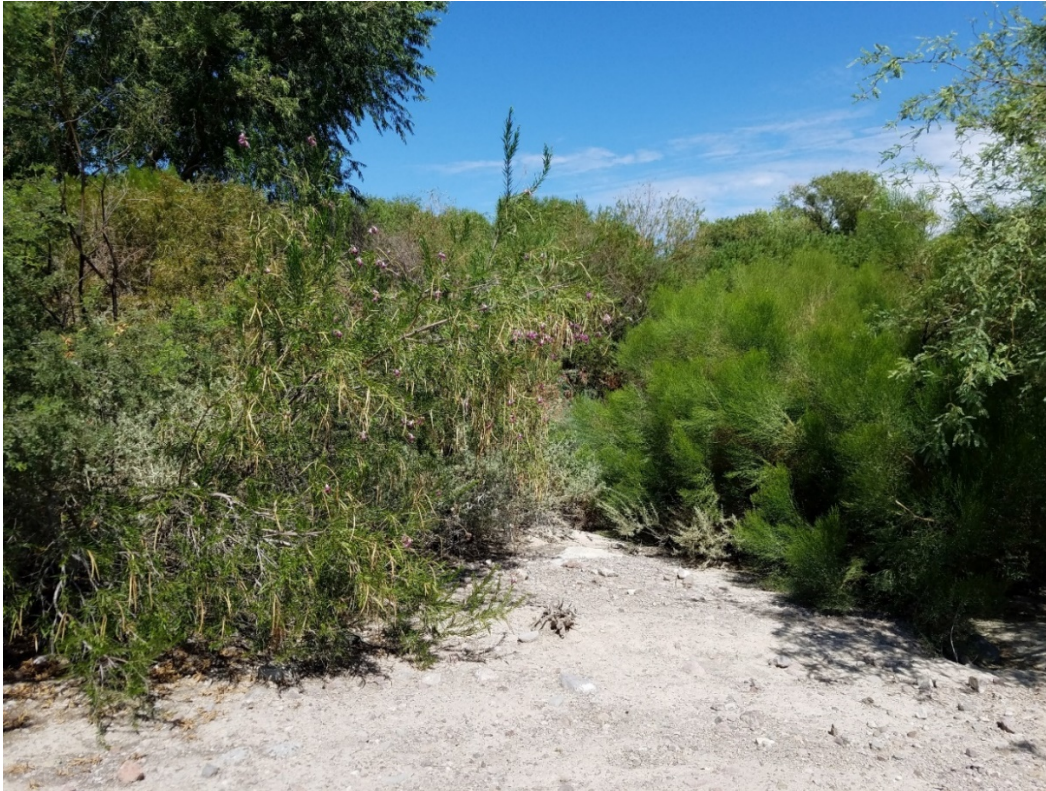
Figure 22. Mature vegetation covers the majority of the Pabco North non-wetland site.

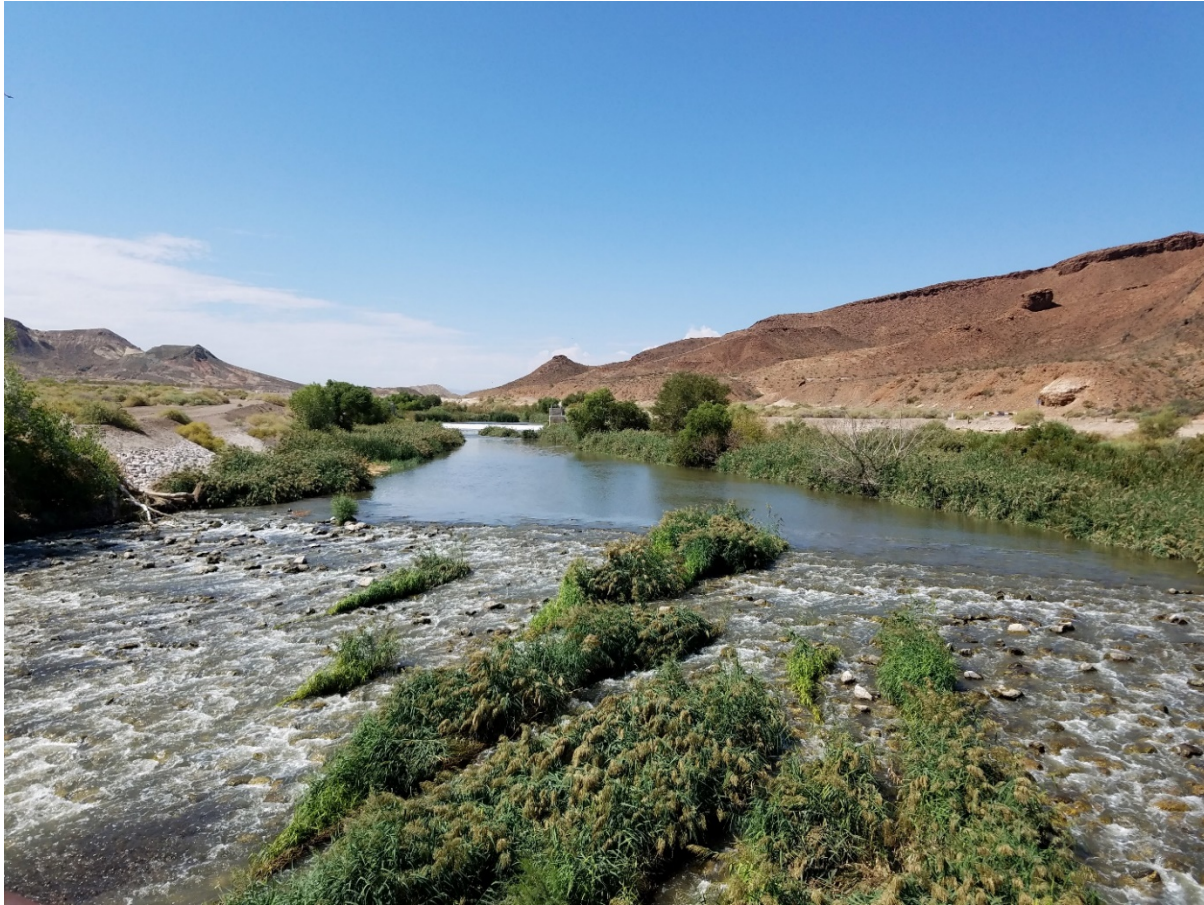
Figure 25. New vegetation established on the Powerline Crossing Weir in 2017 after being cleared in 2016.

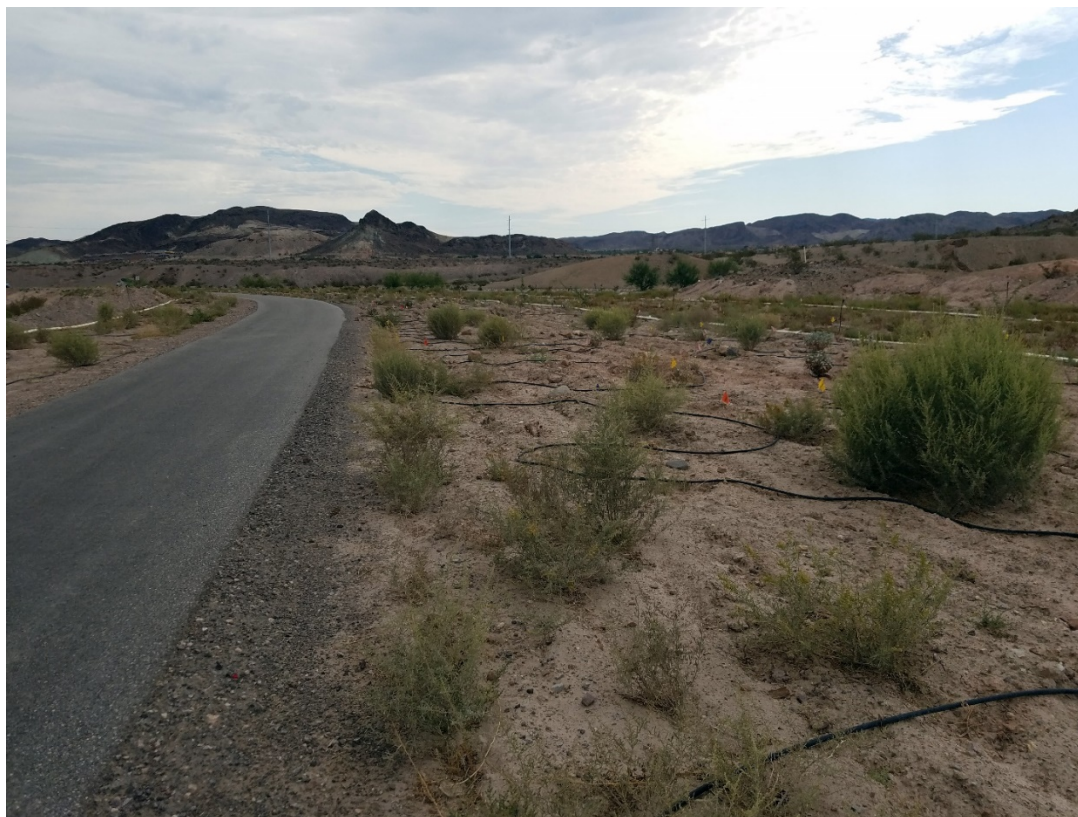
Figure 30. The Upstream Three Kids South revegetation site borders the Clark County Wetlands Park bike trail.

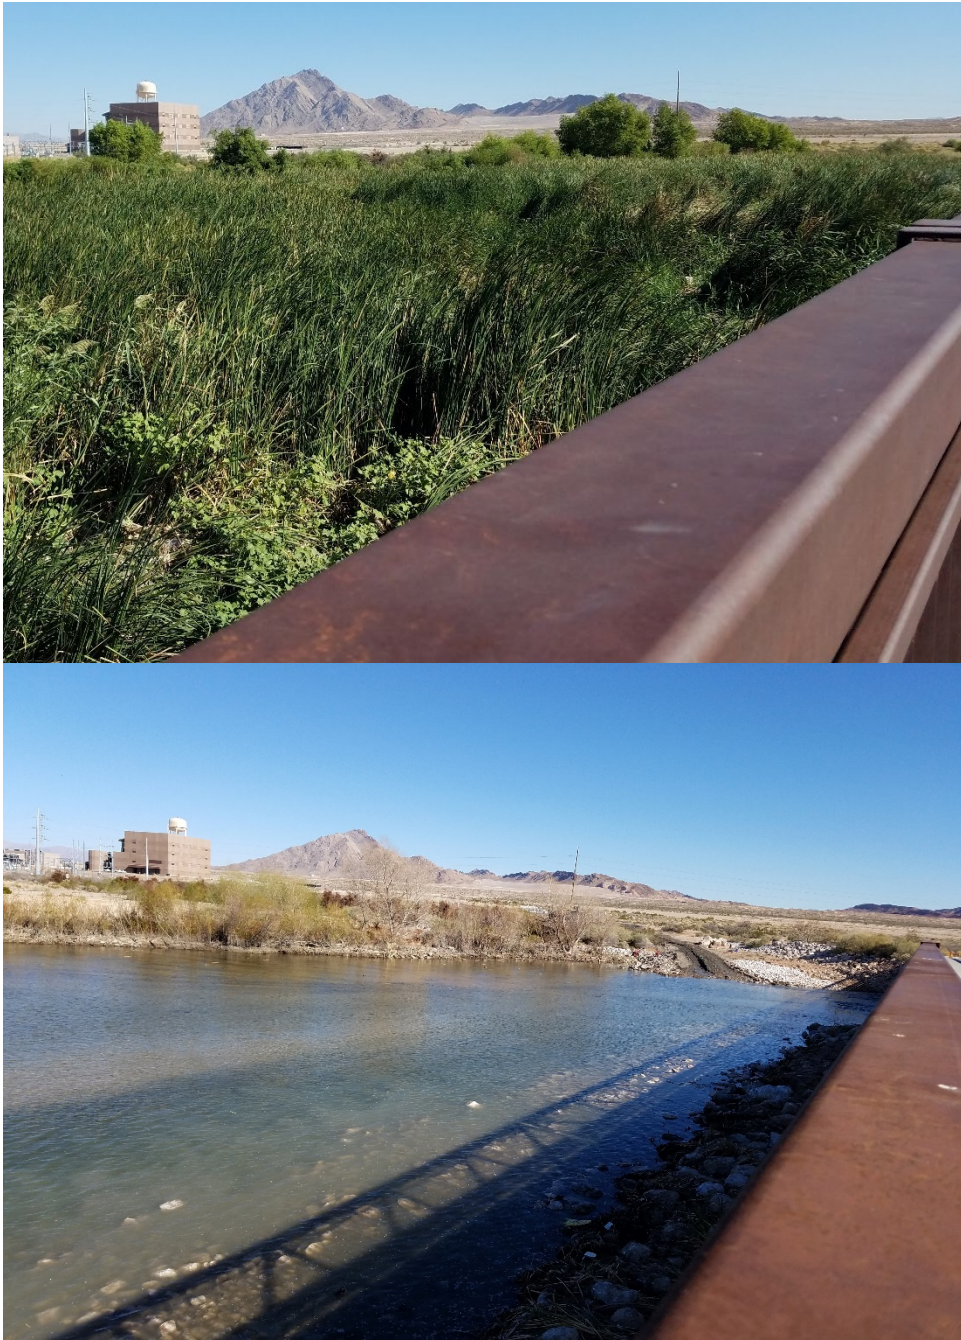
Figure 32. Before (top) and after (bottom) photographs of clearing of vegetation upstream of the Upper Diversion Weir and bridge.

In January of 2017, the majority of the vegetation in the backwater behind the Upper Diversion Weir, known as Upstream Upper Diversion Emergent (UUDE) was removed (Figure 32). The vegetation had collected a substantial amount of sediment and as a result collected trash during storm events and began to alter the flow path of the Wash. The revegetation site was reduced from 3.65 to 1.04 acres with the remaining area consisting of the vegetation along the outer edge of the backwater pond.
