# Las Vegas Wash Vegetation Monitoring Report, 2018

November 2019

Las Vegas Wash  
Coordination  
Committee

**Jason R. Eckberg, CERP, PWS, ESA Certified Ecologist  
Southern Nevada Water Authority  
100 City Parkway, Suite 700  
Las Vegas, Nevada 89106**

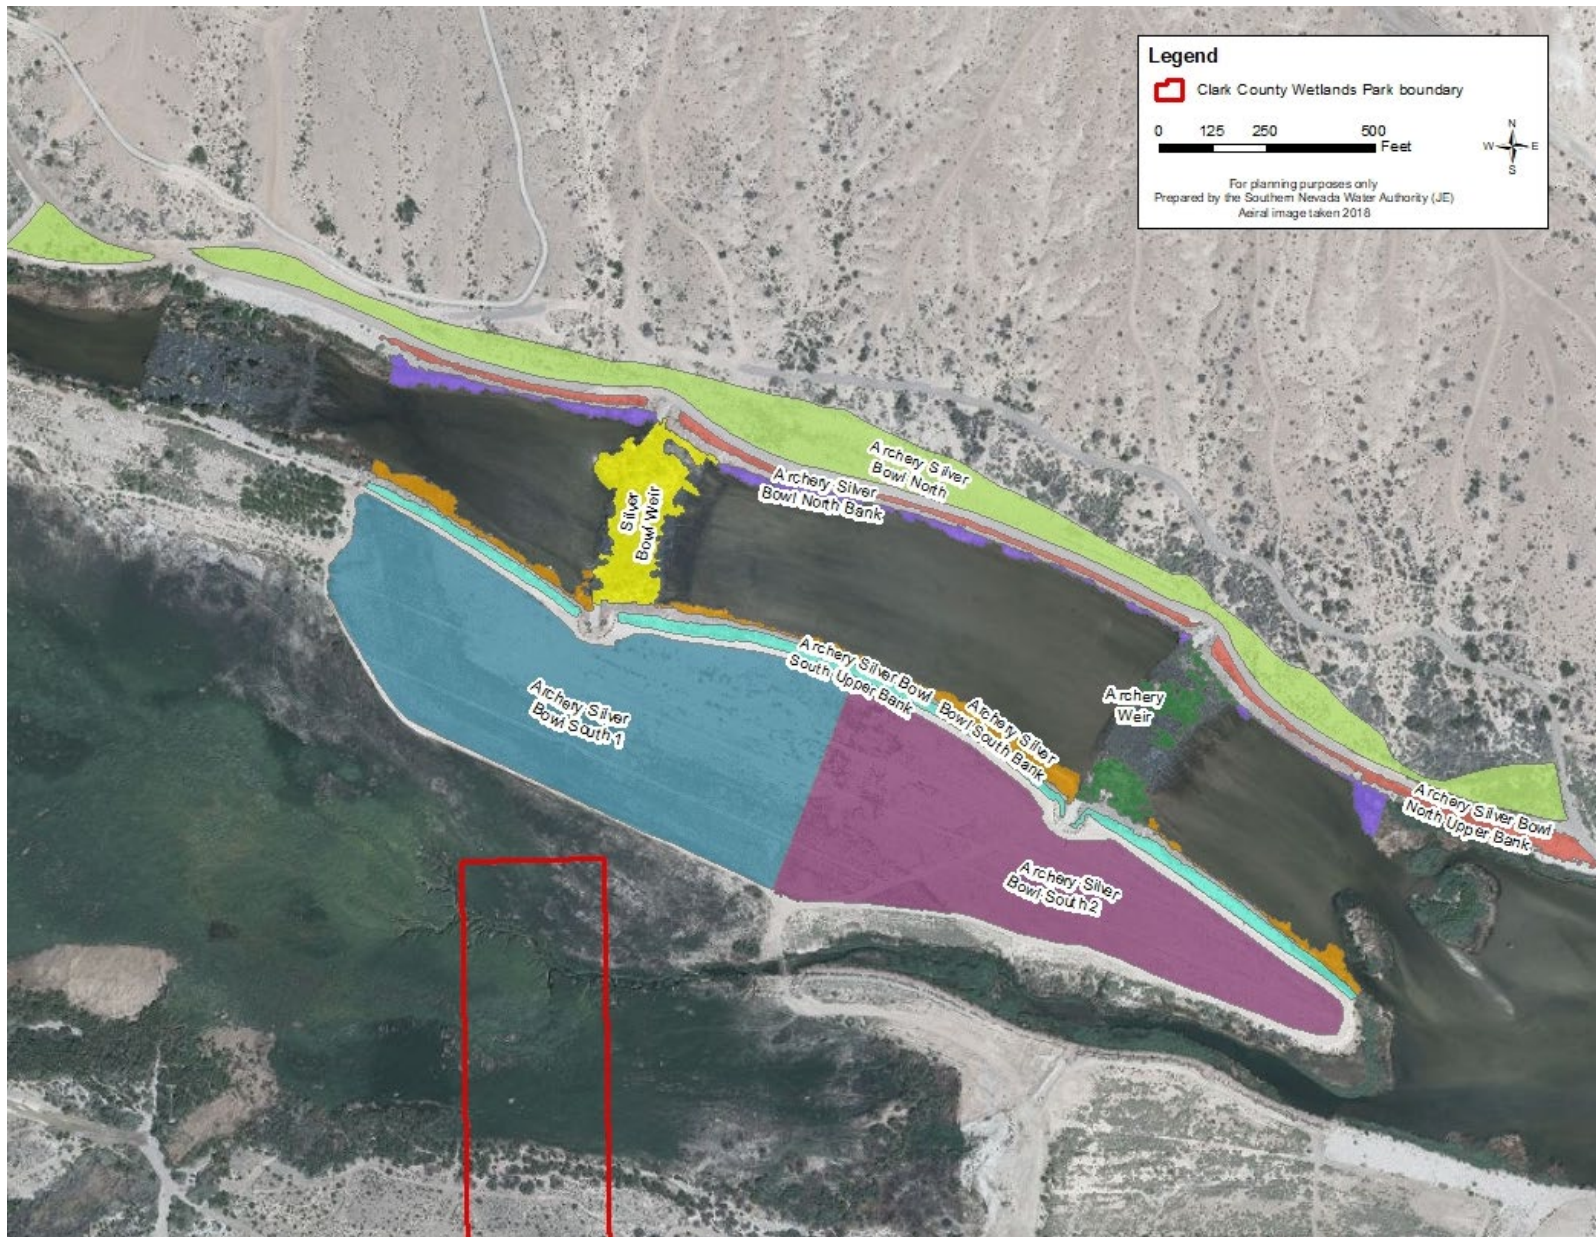
Figure 3. Aerial photograph of 2018 delineated Archery and Silver Bowl Weirs revegetation sites.

The two wetland sites that were actively planted, Archery Silver Bowl North Bank (ASBNB) and Archery Silver Bowl South Bank (ASBSB), have both had the maximum cover value of 75-100% for the past two growing seasons. Combined, these two sites increased in size by 0.97 acres since 2017. ASBNB had 26 species in 2018 which was one less than in 2017. The dominant species was southern cattail (*Typha domingensis*) which passively established on the site and had a cover value of 25-50%. The second most dominant plant was sandbar willow (*Salix exigua*) which was planted as pole plantings on the site and had a cover of 5-25%. The species richness at ASBSB increased from 18 to 21. The codominant species were southern cattail and common reed both passively established and both with 25-50% cover.

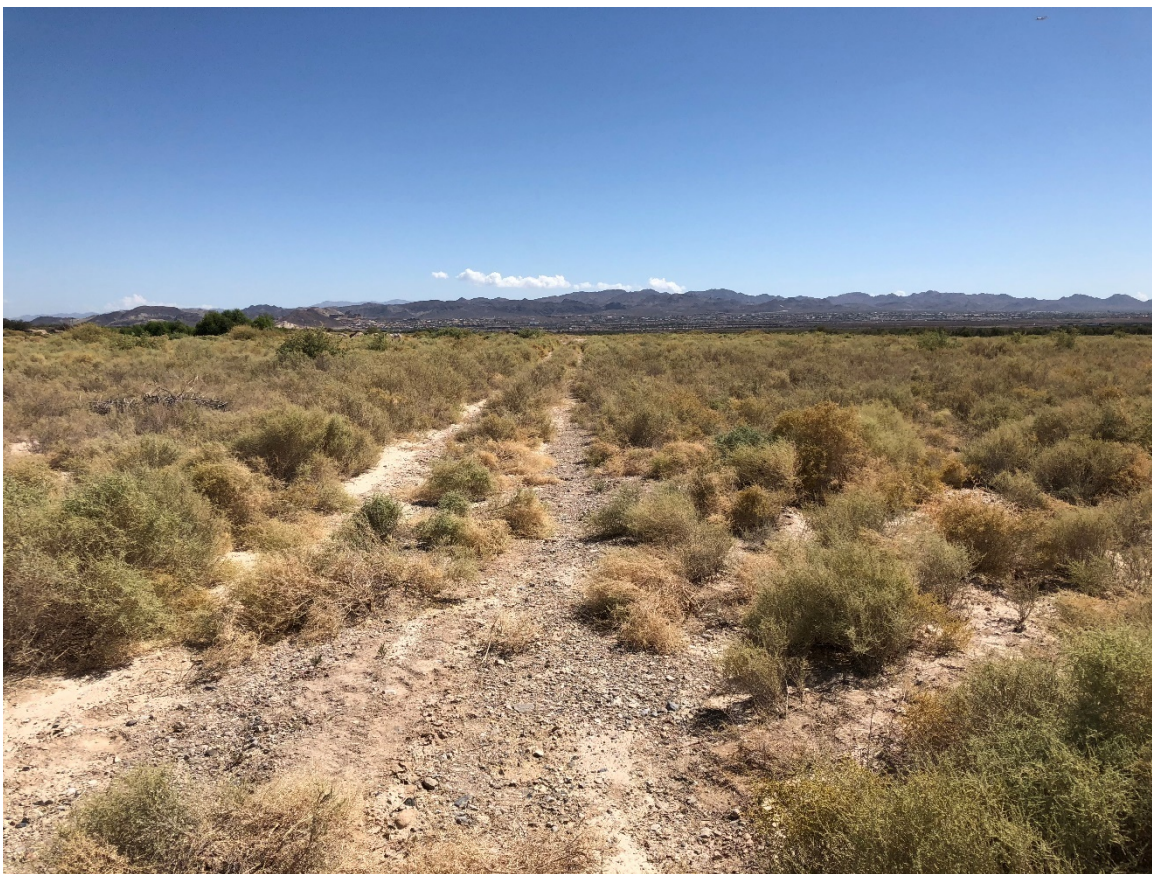
**Figure 4. Desert saltbush is the dominant plant on both non-wetland revegetation sites on the south side of Archery and Silver Bowl Weirs.**

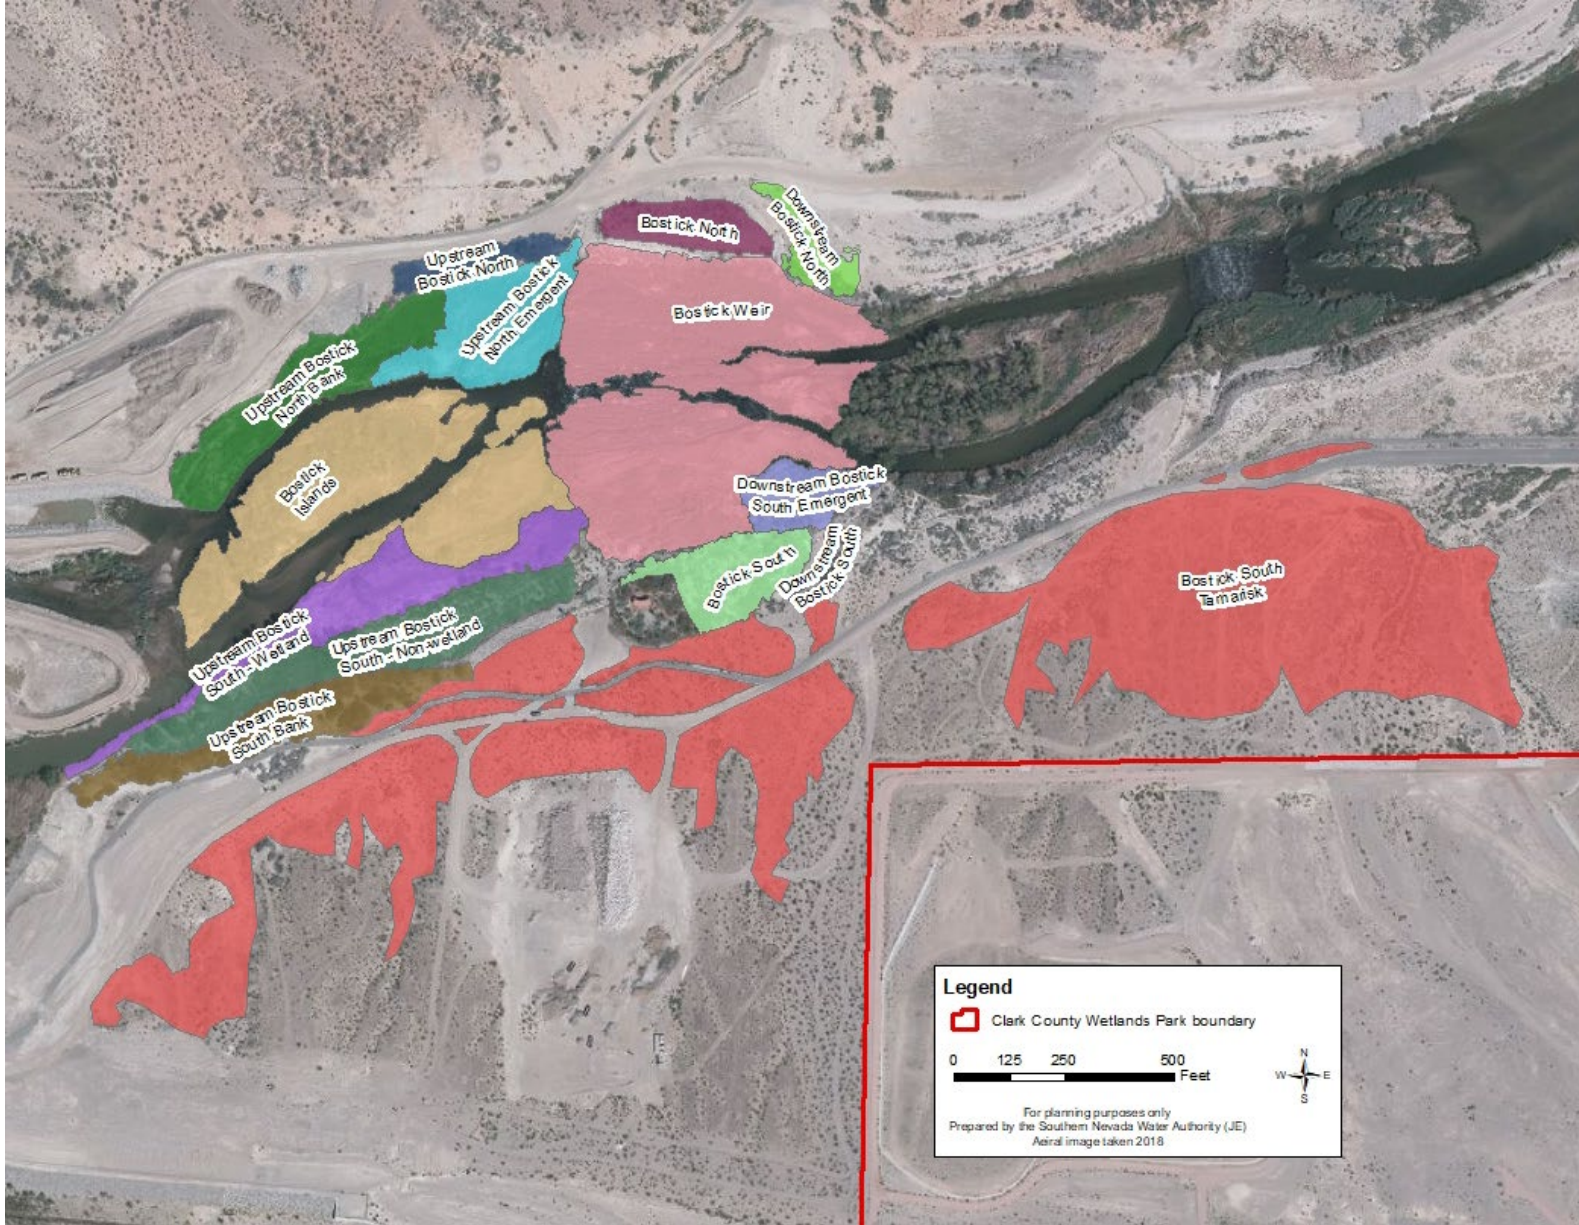
Figure 5. Aerial photograph of 2018 delineated Bostick Weir revegetation sites.

There are 14 revegetation sites near the Bostick Weir (Table 4; Figure 5). Many of the sites have mature vegetation in their 14<sup>th</sup> or 15<sup>th</sup> growing season. Bostick Islands (BI) was monitored in the field for the first time since 2013. Being in the center of the Wash channel, this site is difficult to access as well as time consuming when compared to other sites. An effort was made this year to get field data on BI rather than ArcGIS total cover data which had been collected the four previous years. In 2018, the total cover of BI was 75-100%, the same that has been measured every monitoring year since it was first monitored in 2008. There were six species identified on the site with the codominant species being Goodding’s willow (*Salix gooddingii*) and common reed both with 25-50% cover.

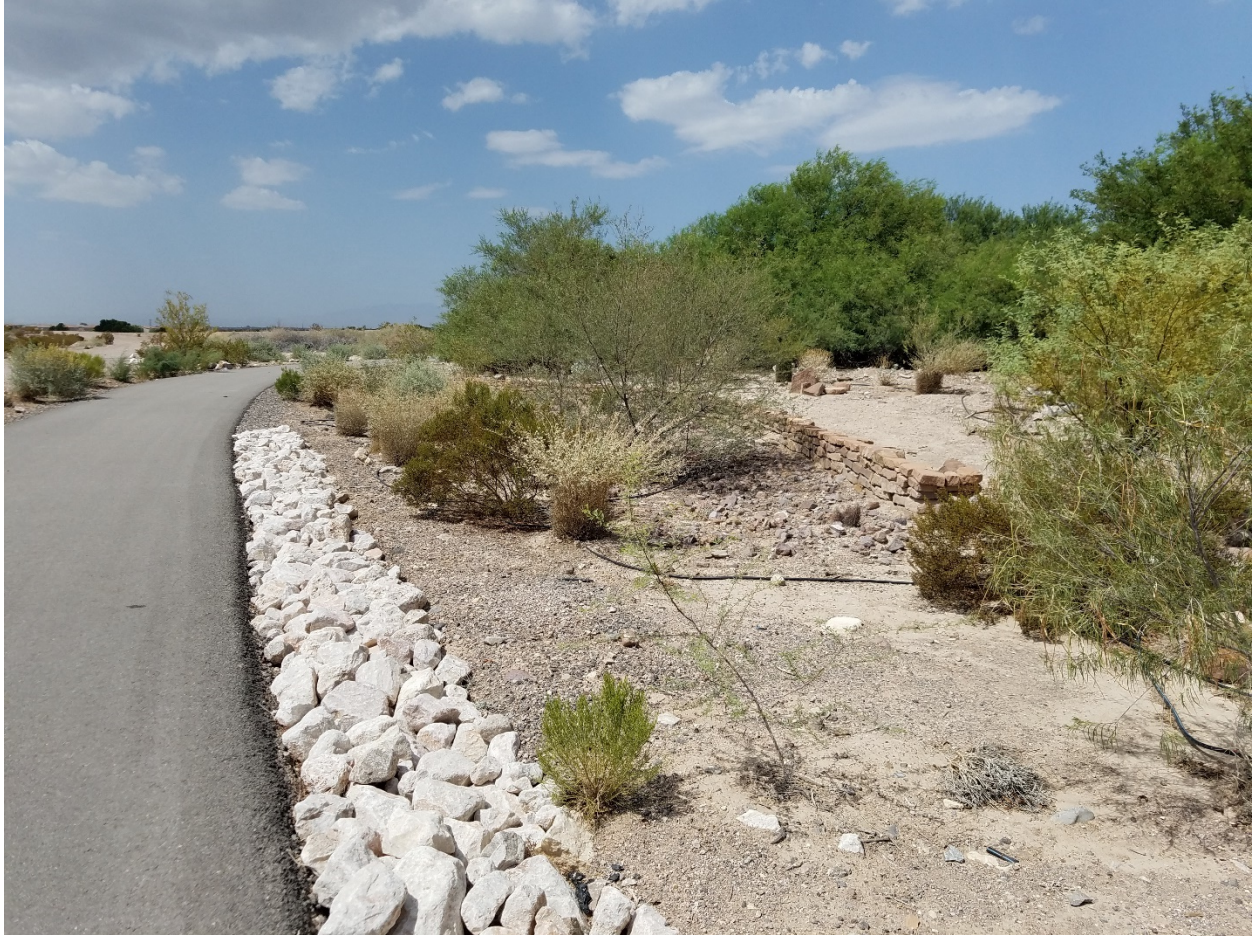
The youngest revegetation site at the Bostick Weir is Bostick South Tamarisk (BST) which was in its third growing season in 2018 (Figure 6). This site was primarily a monocultural stand of tamarisk prior to restoration and was not part of the original Bostick Weir construction footprint like the other sites. The total cover for BST in 2018 increased from 25-50% to 50-75% despite decreasing in species richness from 49 species in 2017 to 34 species in 2018. This is common and expected as irrigation frequency has decreased in 2018 causing many annual forbs and grasses to die off.

**Figure 6. Vegetation at Bostick South Tamarisk lines the Clark County Wetlands Park bike trail.**

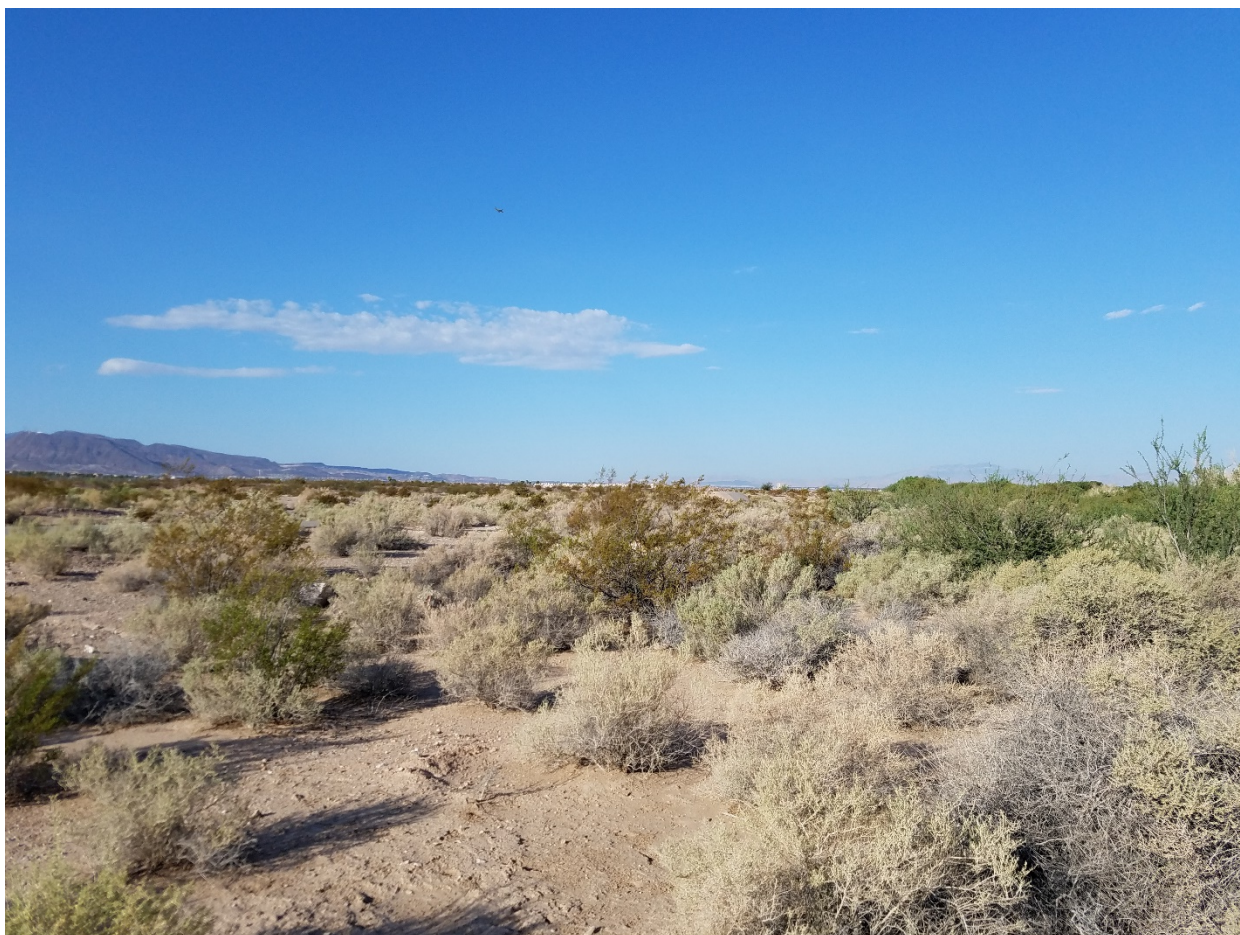
**Figure 8. Downstream Calico South – Non-wetland increased in total cover from 2017 to 2018.**

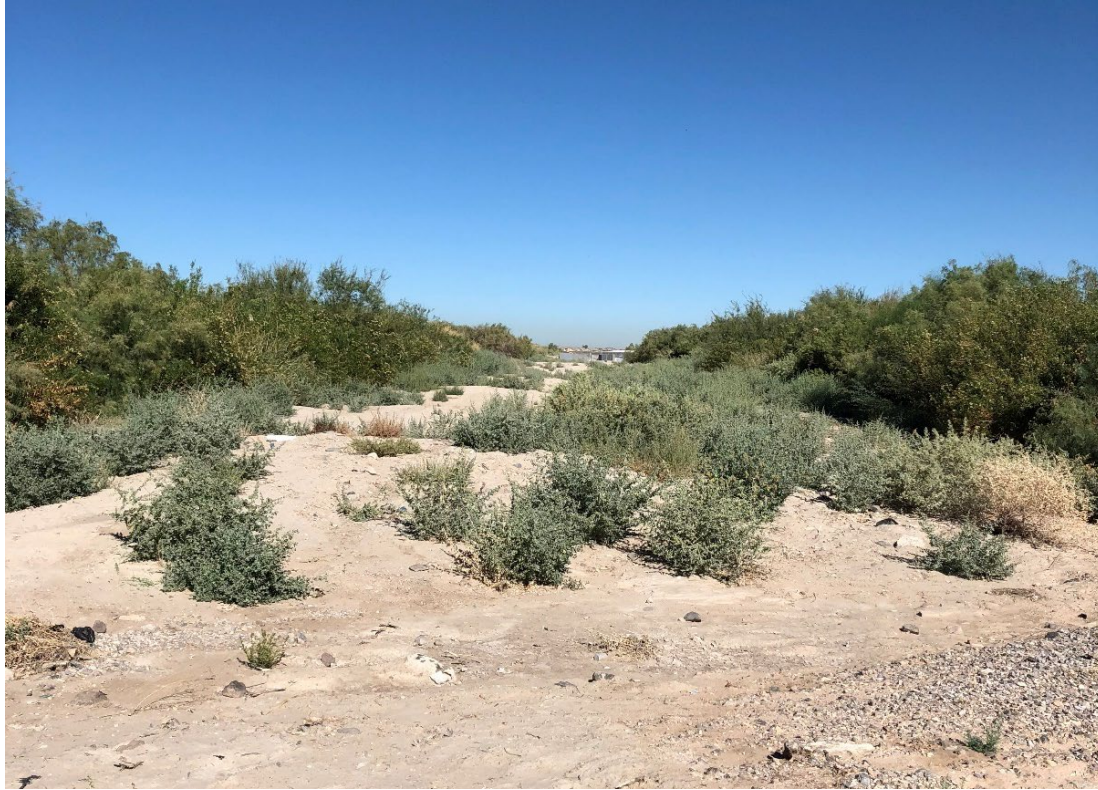
**Figure 10. The Clark County Water Reclamation District revegetation site continued to be dominated by honey mesquite and quailbush in 2018.**

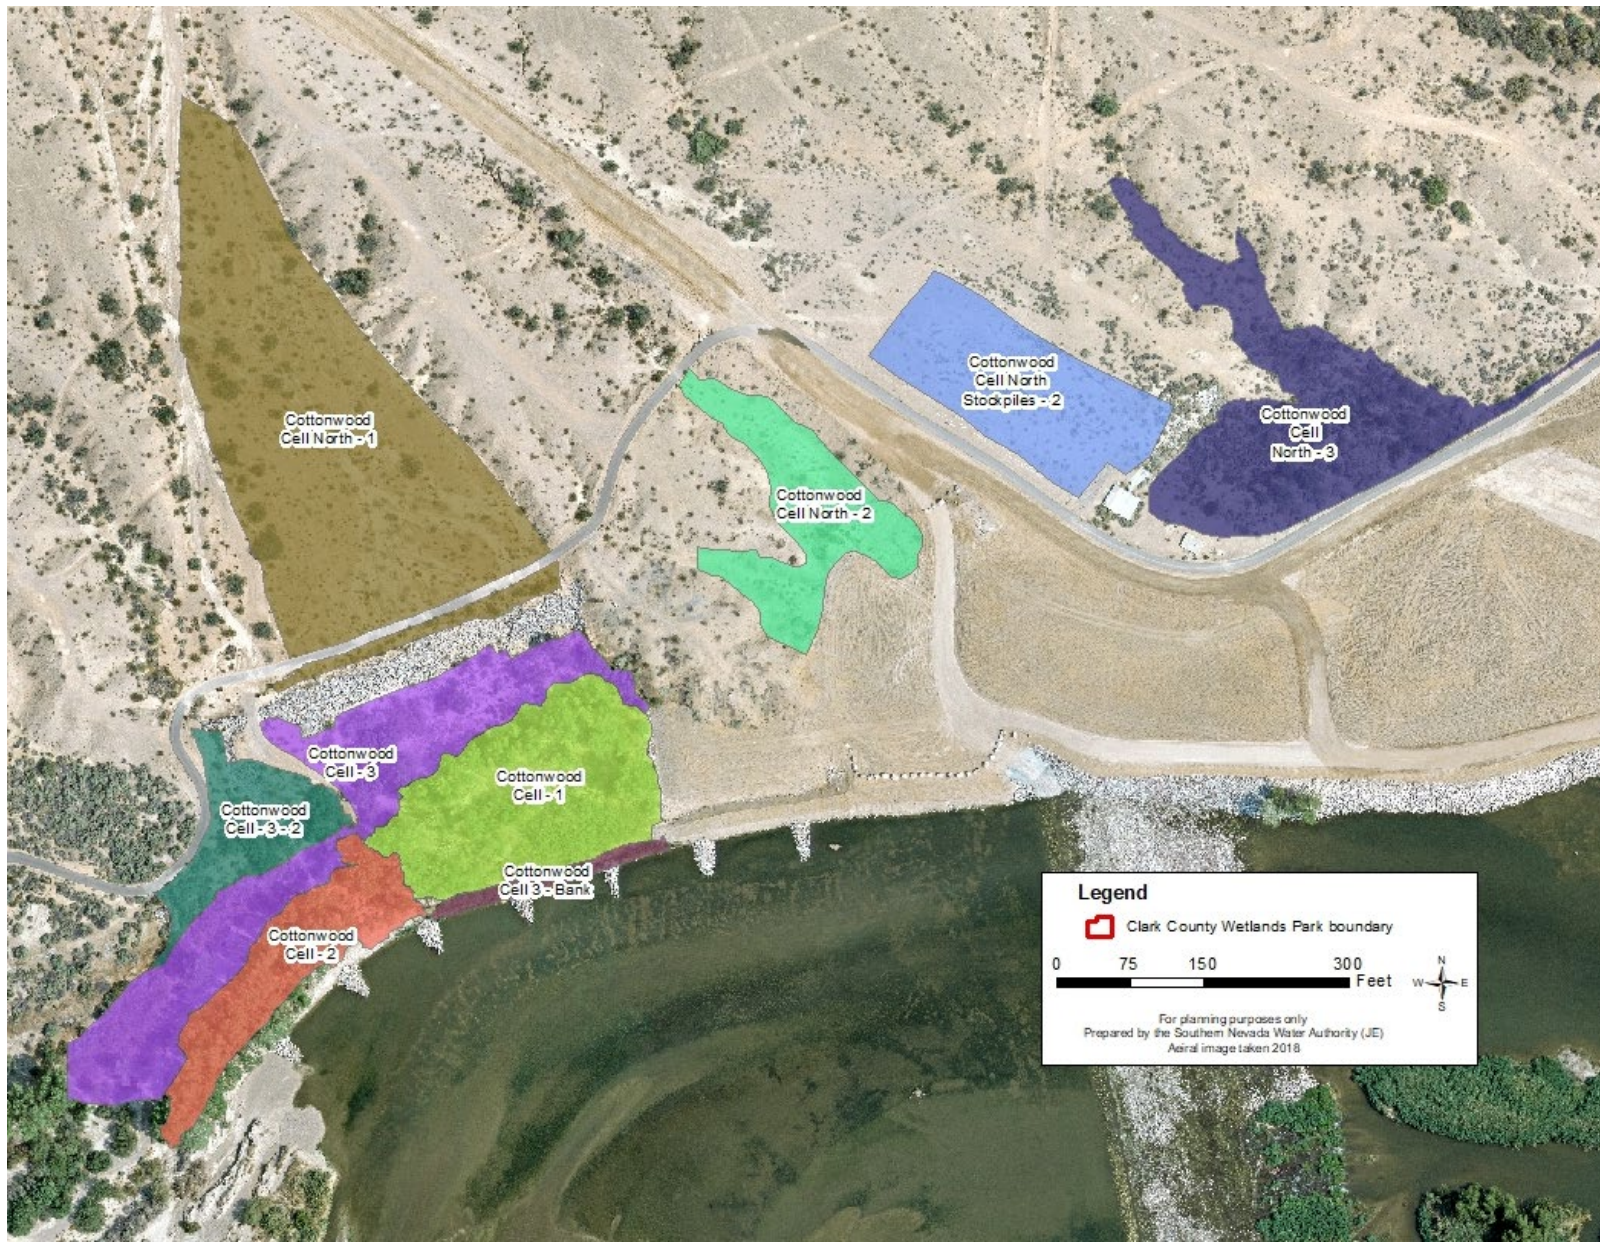
Figure 11. Aerial photograph of 2018 delineated Cottonwood Cell revegetation sites.

All seven of the revegetation sites at the Cottonwood Cells were monitored using ArcGIS for the 2018 monitoring year (Table 7, Figure 11). Therefore, only total cover and the changes in acreage are reflected in this year’s monitoring. The biggest change in the last year was the construction project expanding the Historic Lateral Weir. This weir is located downstream of most of the Cottonwood Cell sites (Figure 11). The expansion project required the removal of portions of four different revegetation sites; Cottonwood Cell North (CCN), Cottonwood Cell North Stockpiles

(CCNS), Cottonwood Cell Bank (CCB), and Cottonwood Cell 3 (CC3). CCN decreased from 4.83 to 4.23 acres, CCNS was reduced from 1.83 to 0.76 acres, CCB went from 0.21 to 0.09 acres, and CC3 decreased from 1.63 to 1.15 acres. All of the areas removed will be replaced in upcoming years along with additional areas created by the construction project.

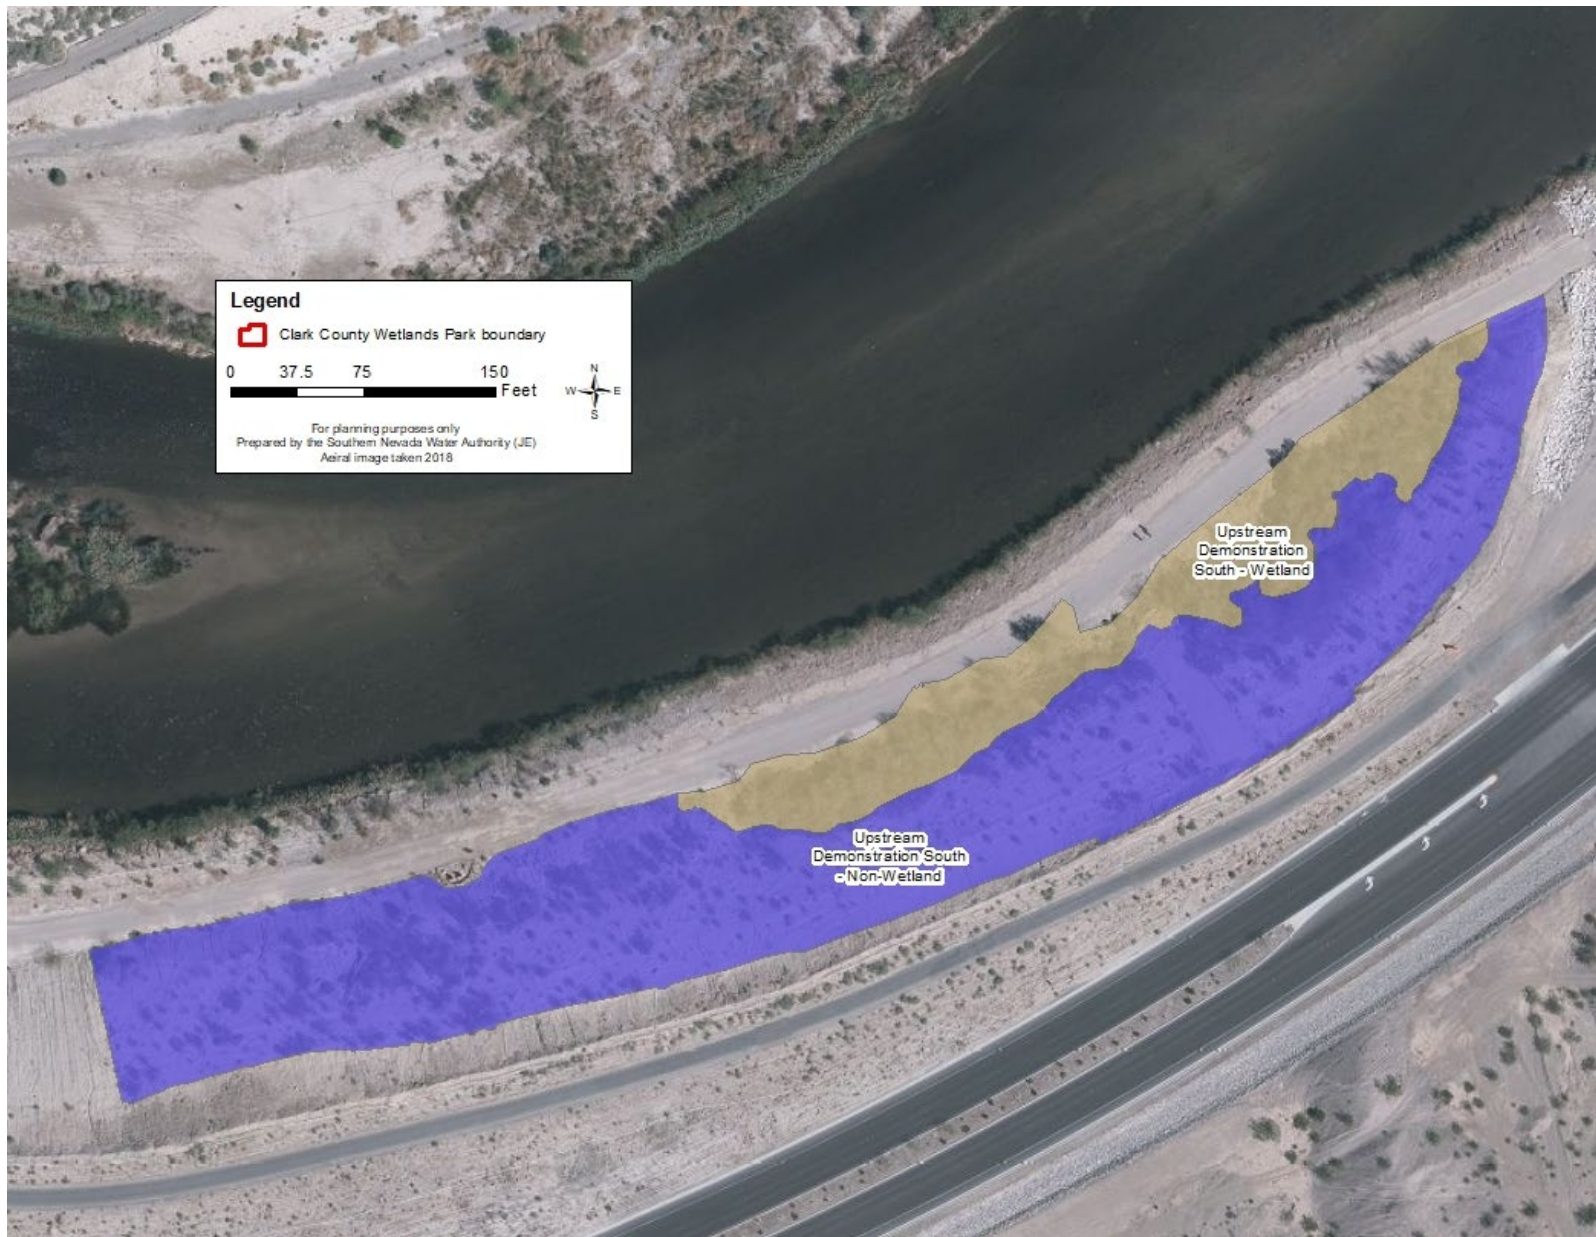
Figure 12. Aerial photograph of 2018 delineated Demonstration Weir revegetation sites.

The two sites at the Demonstration Weir were monitored in the field in 2018 after being monitored with ArcGIS in 2017 (Table 8, Figure 12). The Upstream Demonstration South – non-wetland (UDS-N) site had the same cover as the past four growing seasons of 25-50%. There was one new species identified on the site in 2018, bush seepweed (*Sueda nigra*). The total cover of Upstream Demonstration South – wetland (UDS-W) decreased from 75-100% to 50-75% since last growing season but was the same as the last field monitoring year in 2016. This is likely a result of the actual plant cover being near 75%. Either the field method or ArcGIS method could measure the cover slightly above or slightly below the actual cover resulting in changing cover classes. This site also increased in species richness to 10 species, up two from 2016. One new species on the site is bassia (*Bassia hyssopifolia*) which is a common weed. It only had a cover of 0.5% in 2018 but will be monitored to see if management actions are necessary.

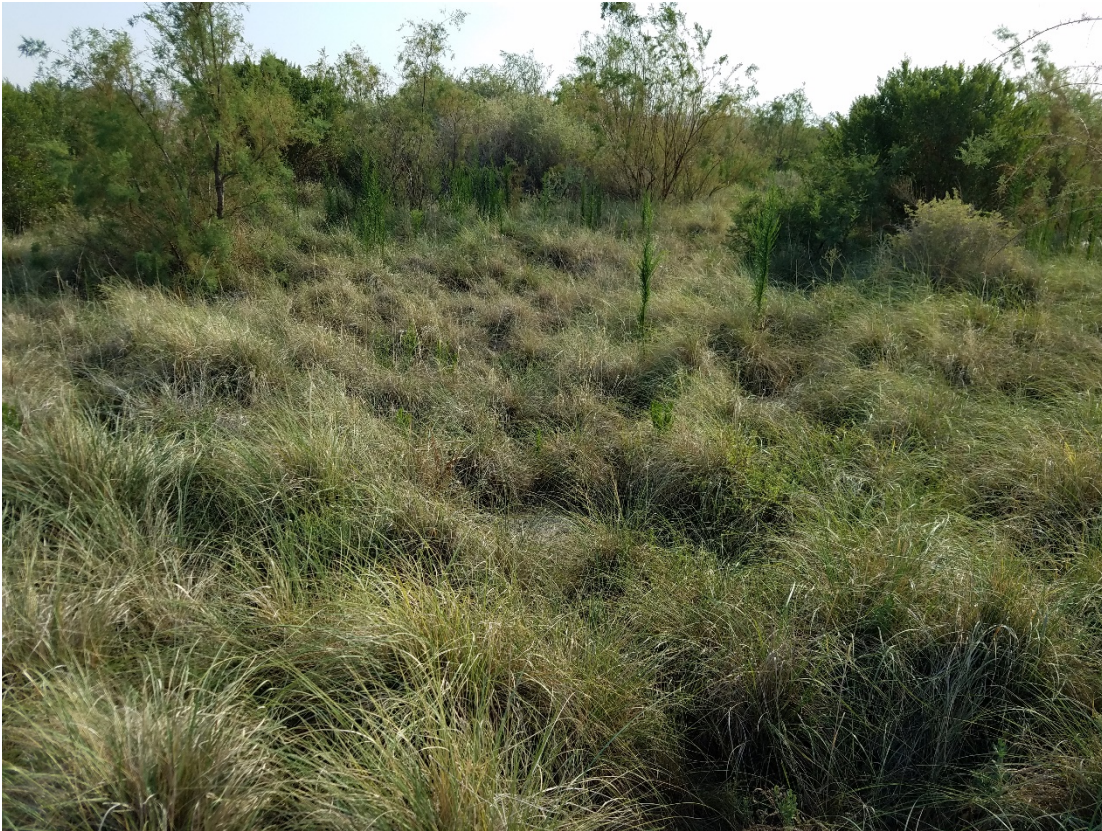
Three of the sites monitored in the field in 2018 increased in total cover while the remainder stayed the same as in 2017. Duck Creek Upper Narrows North (DCUNN) increased its cover from 50-75% to 75-100% despite decreasing in species richness from 31 to 17. Desert saltbush was the dominant species, which increased in cover from 25-50% to 75-100%. The other sites that increased in cover from 2017 to 2018 were Duck Creek Upper Narrows North Stockpile (DCUNNS) and Duck Creek Upper Narrows South 3 (DCUNS-3). Planted in the spring of 2015, DCUNS-3 has been dominated by desert saltbush with 50-75% cover in the past three years, but there are also zones of dense alkali sacaton (Figure 14).

**Figure 14. Areas of dense alkali sacaton were found in the Duck Creek Upper Narrows South 3 revegetation site in 2018.**

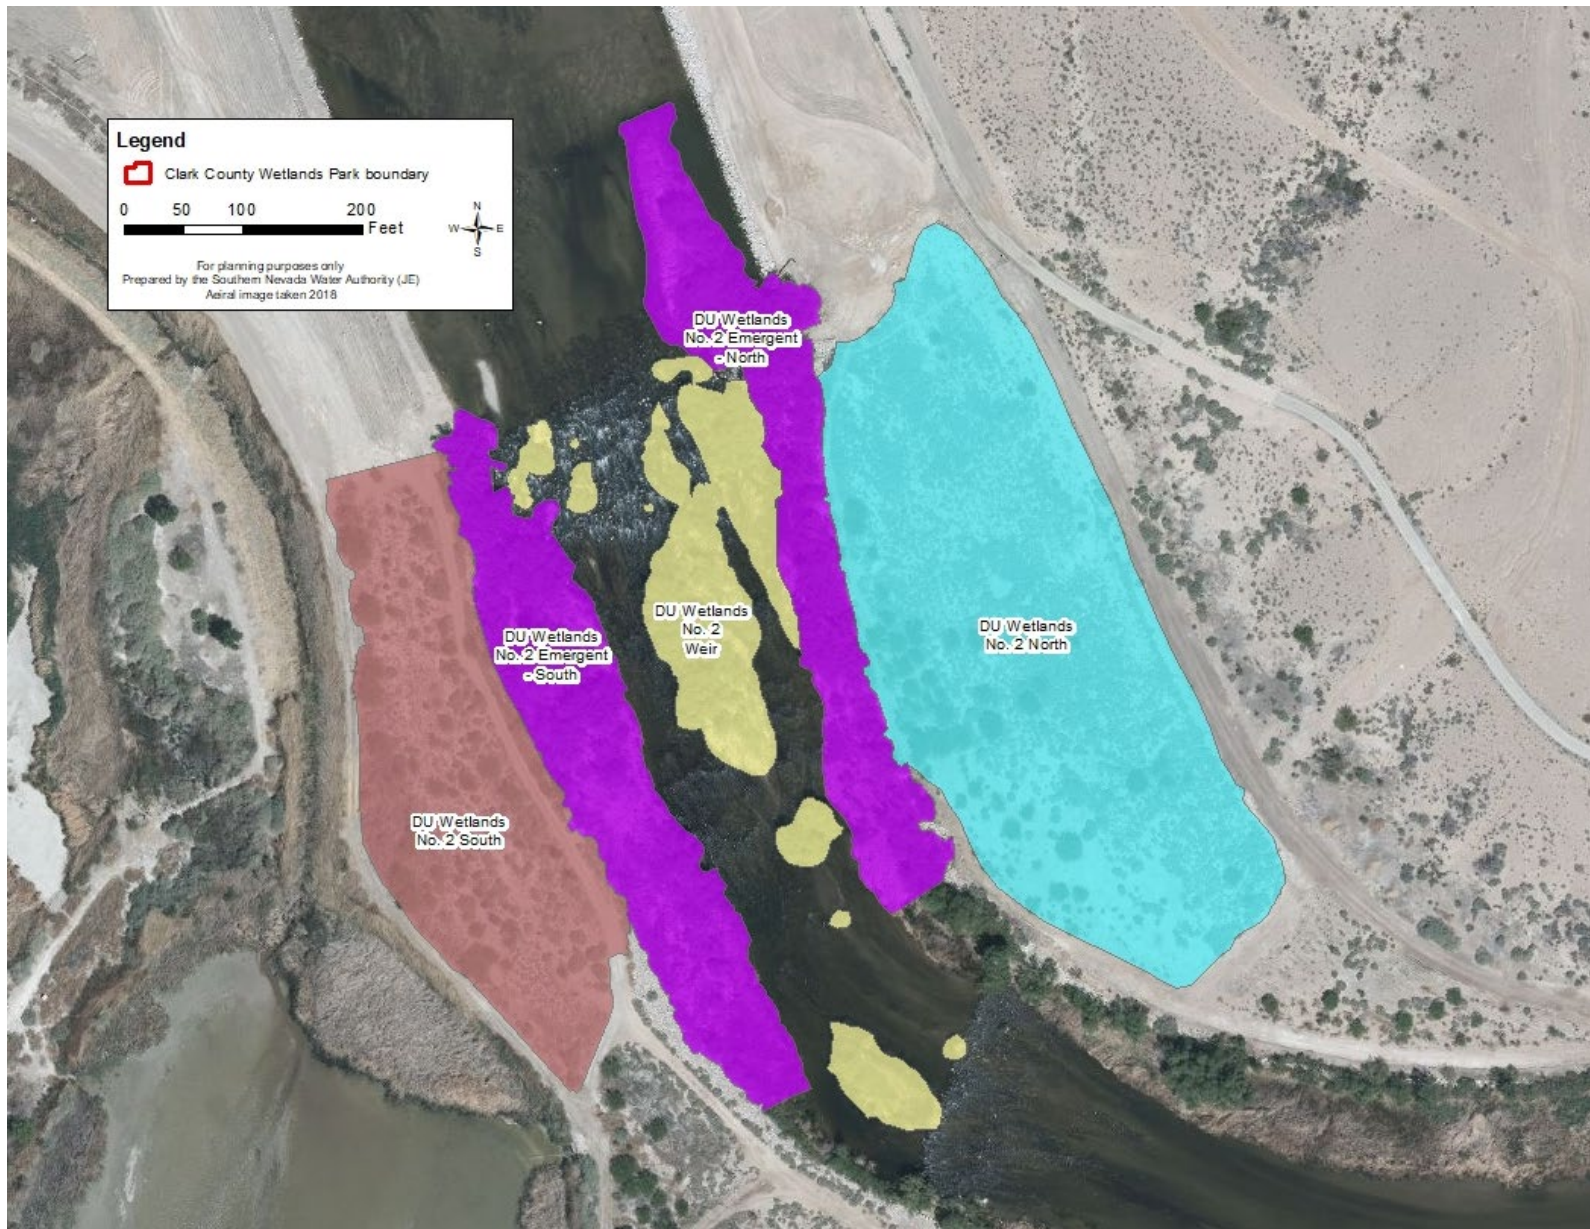
All four of the revegetation sites at the DU Wetlands No. 2 Weir had the maximum total cover for vegetation in 2018, 75-100% (Table 11, Figure 16). This data comes from two of the sites being monitored in the field with the other two being monitored using ArcGIS. The two sites monitored in the field were DU Wetlands No. 2 Emergent (DU2E) and DU Wetlands No. 2 South (DU2S). DU2E has had the maximum cover value since the first monitoring year in 2010. Now in its ninth growing season, there were 23 species found on the site; the dominant species was Goodding’s willow with a cover of 50.6% in 2018 (Figure 17). The total cover and species cover values are derived from a weighted average of monitoring areas on the north and south banks.

**Figure 16. Aerial photograph of 2018 delineated DU Wetlands No. 2 Weir revegetation sites.**

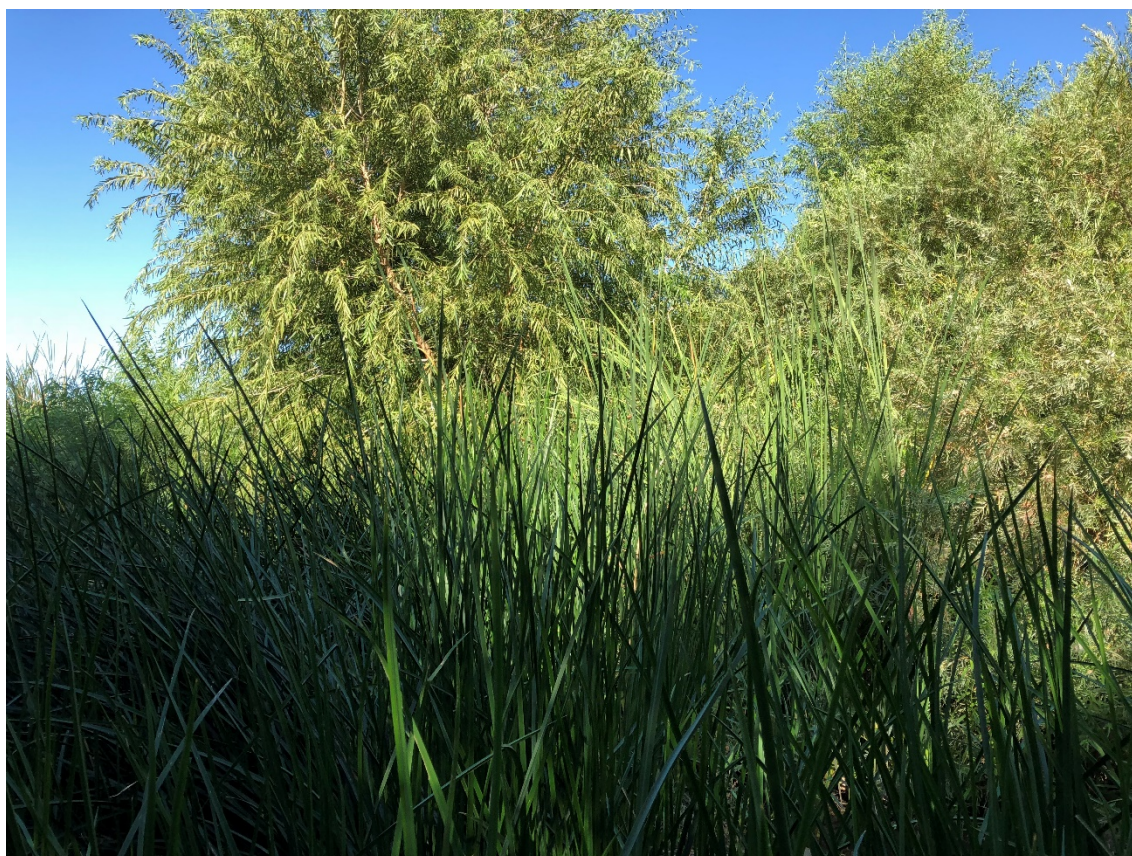
**Figure 17. Goodding’s willow (background) was the dominant plant on the DU Wetlands No. 2 Emergent revegetation site in 2018.**

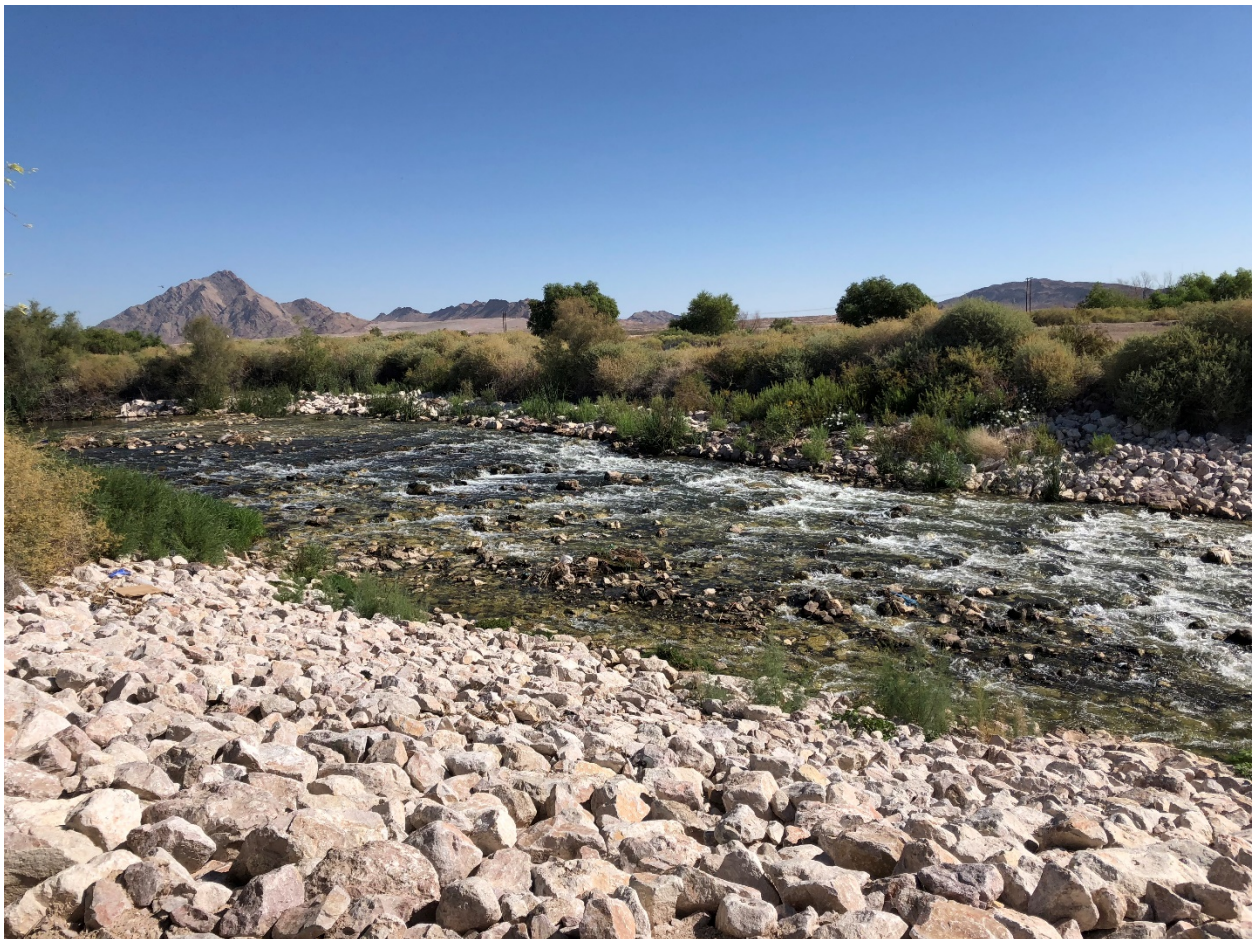
All four of the revegetation sites at the Monson and Visitor Center Weirs had the maximum 75-100% total cover in 2018 (Figure 20, Table 14) just as they did in 2017. Downstream Monson South - Non-wetland (DMS-N) and Downstream Monson South – Wetland (DMS-W) were both monitored in the field while the two north side sites were monitored for total cover using ArcGIS. All in their 16<sup>th</sup> growing season, there are typically only minor changes to the sites in terms of plant cover, species richness and species composition. There were larger than usual changes to the lower portions of both DMS-W and Downstream Monson North – Wetland (DMN-W) in 2018. In the early part of the year, the Visitor Center Weir was almost completely rebuilt (Figure 21). The length of the weir was expanded and some portions of the width as well. There was also new rock riprap installed. This project removed vegetation along the banks and in the channel; combined, the sites decreased by 0.3 acres. This new weir should provide a more stable backwater and will support new wetland areas in the future.

Figure 20. The Visitor Center Weir after reconstruction in 2018.

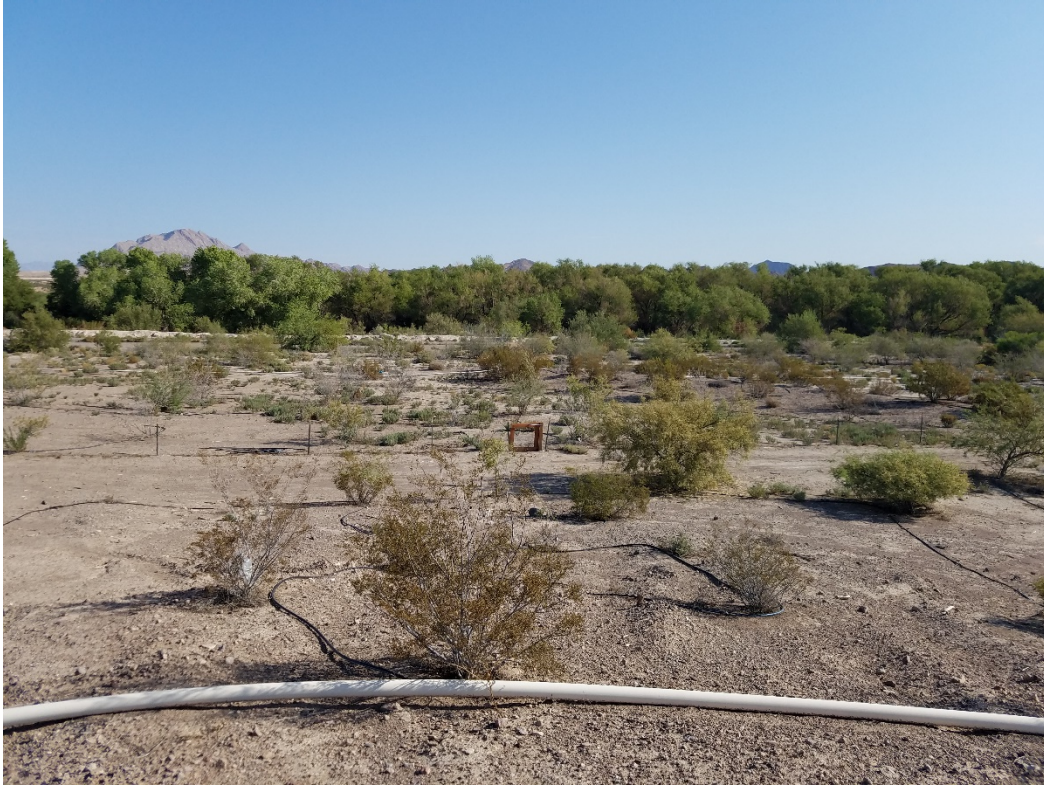
**Figure 23. Additional shrubs were planted at the Downstream Pabco South Upper Plateau revegetation site in 2017.**

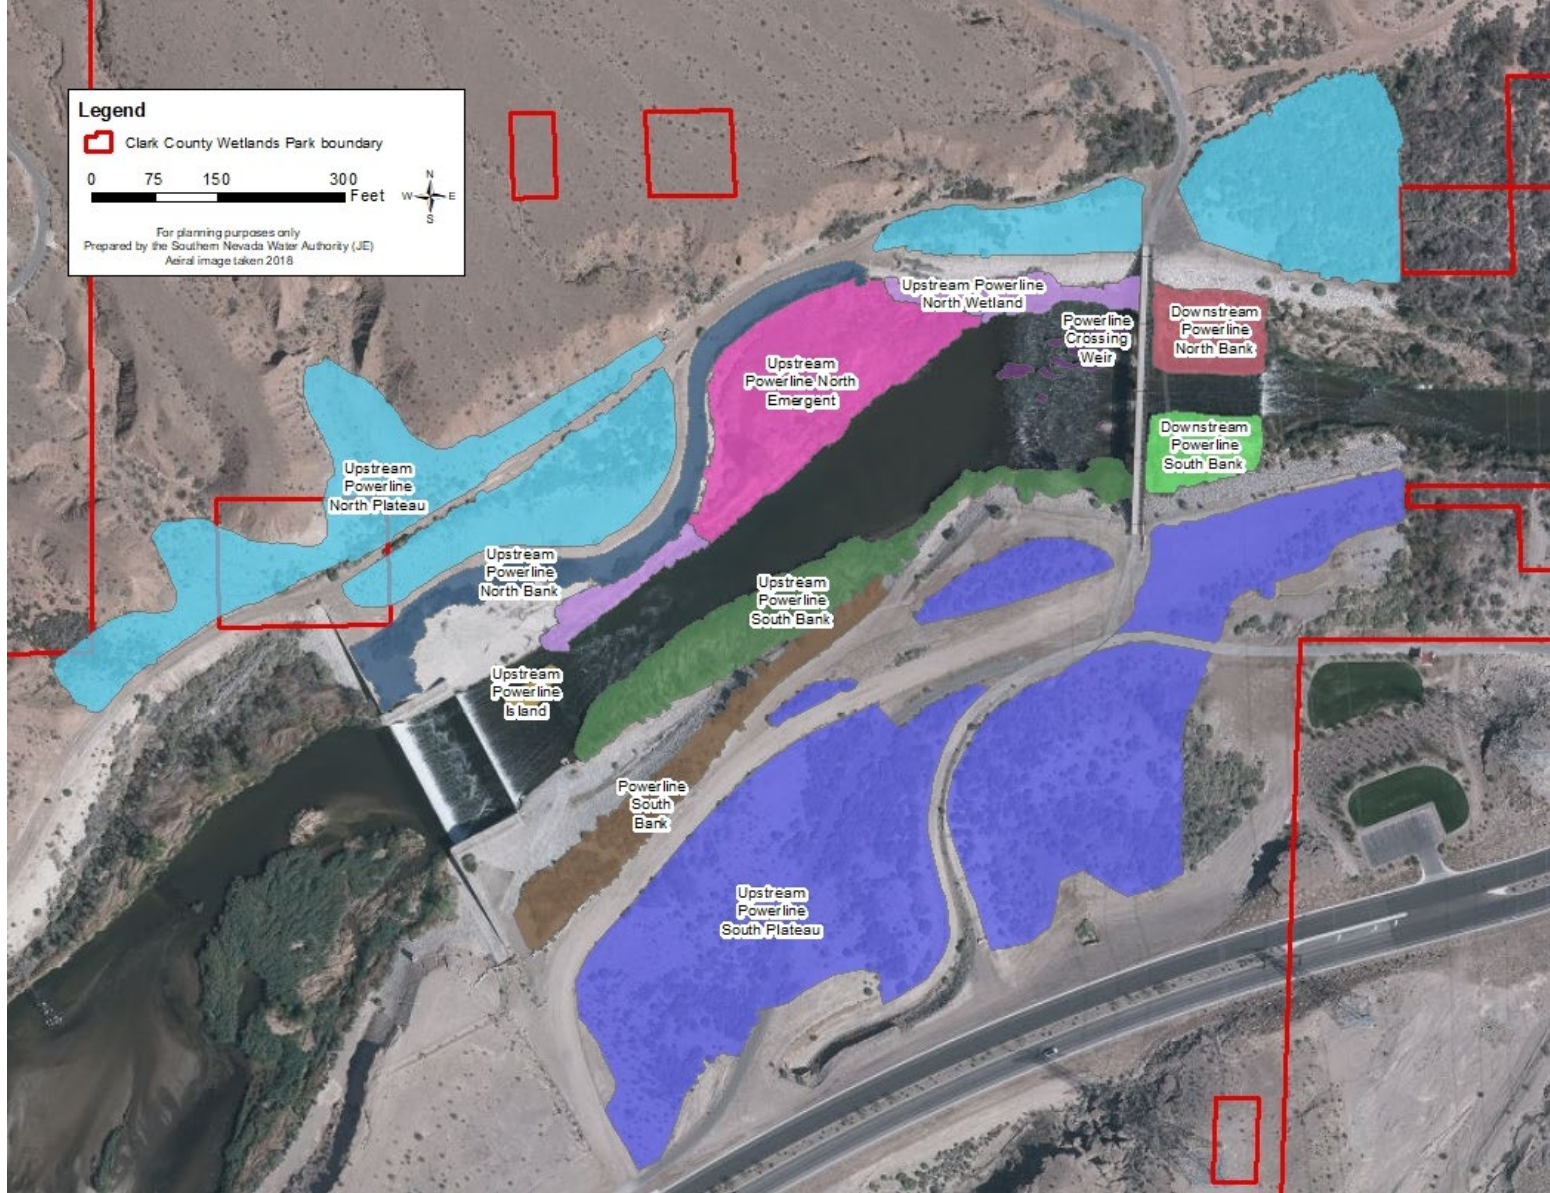
None of the 10 revegetation sites at the Powerline Crossing Weir were monitored in the field in 2018 (Table 16, Figure 24). Table 16 show the total cover of all of the sites as determined using ArcGIS. All of the sites were in their 12<sup>th</sup> growing season and have mature vegetation. Only three of the 10 sites have less than the maximum 75-100% total cover value. These are all non-wetland sites and are not expected to have the dense vegetation that the wetland sites typically achieve along the Wash. The four non-wetland sites are also the only sites to have changed in total cover since 2017. Non-wetland sites are more susceptible to have changes in vegetation because of weather than wetland sites.

**Figure 24. Aerial photograph of 2018 delineated Powerline Crossing Weir revegetation sites.**
