# Las Vegas Wash Vegetation Monitoring Report, 2018

November 2019

Las Vegas Wash  
Coordination  
Committee

**Jason R. Eckberg, CERP, PWS, ESA Certified Ecologist  
Southern Nevada Water Authority  
100 City Parkway, Suite 700  
Las Vegas, Nevada 89106**

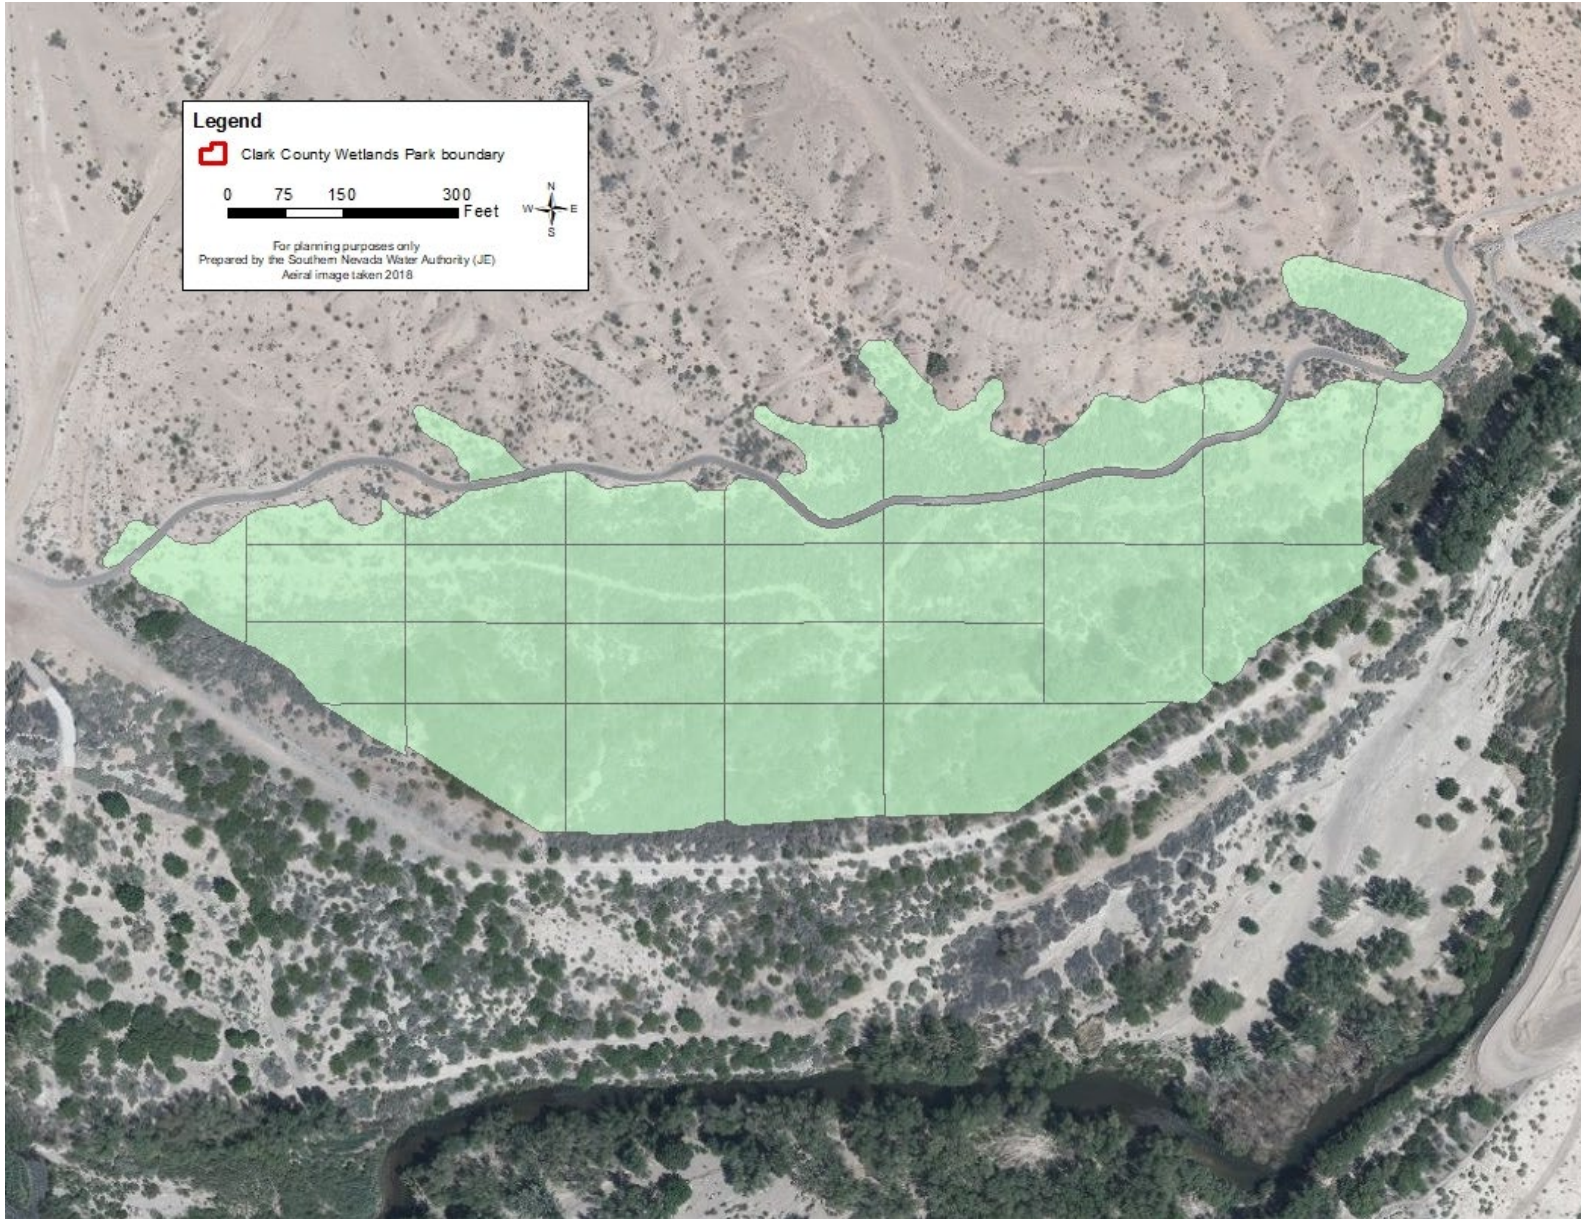
At just under 15 acres, Site 111 is one of the larger revegetation sites along the Wash (Table 19, Figure 27). Prior to the current year, this site was broken up into 26 monitoring areas and a weighted average was used for the total cover of the site. This year, however, the site was monitored as a single monitoring area. Random pedestrian transects were used through the entire site to capture species richness and cover. This was done due to substantial growth of shrubs such as quailbush, fourwing saltbush (*Atriplex canescens* var. *canescens*), and desert saltbush as well as honey and screwbean mesquites (*Prosopis pubescens*) which made it impossible to enter some of the monitoring areas. Instead, information was collected from the edges of vegetated areas, as well as observations from higher elevations to get plant cover. In alternating years, when ArcGIS is used for plant cover, the monitoring areas can be used again to both provide more detailed data as well as provide a comparison to field measurements.

The total cover for the site in 2018 was 75-100%. Since the site was considered a single monitoring area, the cover class ranges were used as opposed to previous years when a more specific percentage was calculated using a weighted average of the monitoring areas. Using the midpoint of the range, 87.5%, this was the highest total cover for the site in its 12 growing seasons. This is up from 2017 when the total cover was 82%. The second highest was 2012 when the total cover was 86.9%.

**Figure 27. Aerial photograph of the 2018 delineated Site 111 revegetation site.**

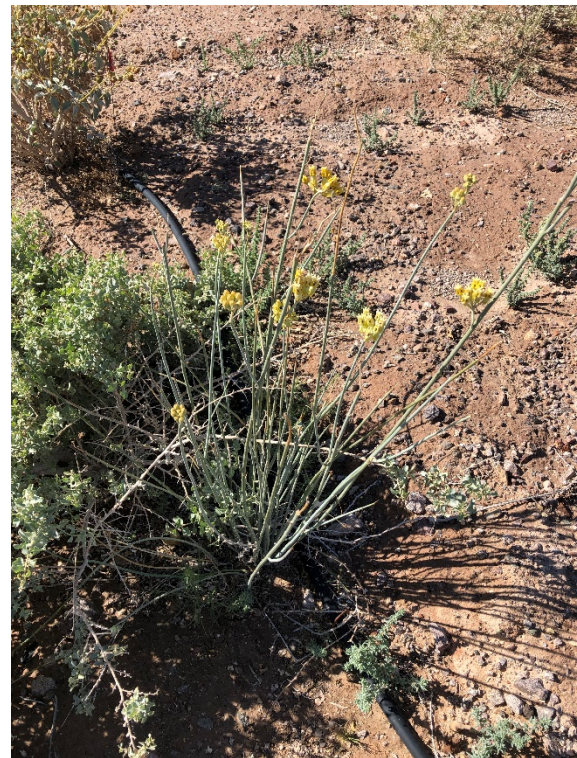
The lone Green-Up site at the Three Kids Weir is Upstream Three Kids South (U3KS). This site was planted on March 4, 2017, and was in its second growing season at the time of 2018 vegetation monitoring. There was a high success rate of planted plants with an 87% survivorship recorded in 2017. Survivorship was not recorded in 2018 due to difficulty knowing which plants were planted and which ones self-established. All of the planted species were still documented in 2018 despite a decline of five species from the previous year (Figure 29). Those species were mostly weed species that established on the site during heavy irrigation the first year. The dominant species on the site remained fourwing saltbush, which was hydroseeded on the site at the completion of the weir. The species with the second highest cover amount was the non-native weed bassia. After monitoring, extensive weed removal took place.

**Figure 29. Rush milkweed was one of the 20 species identified at the Upstream Three Kids South revegetation site in 2018.**

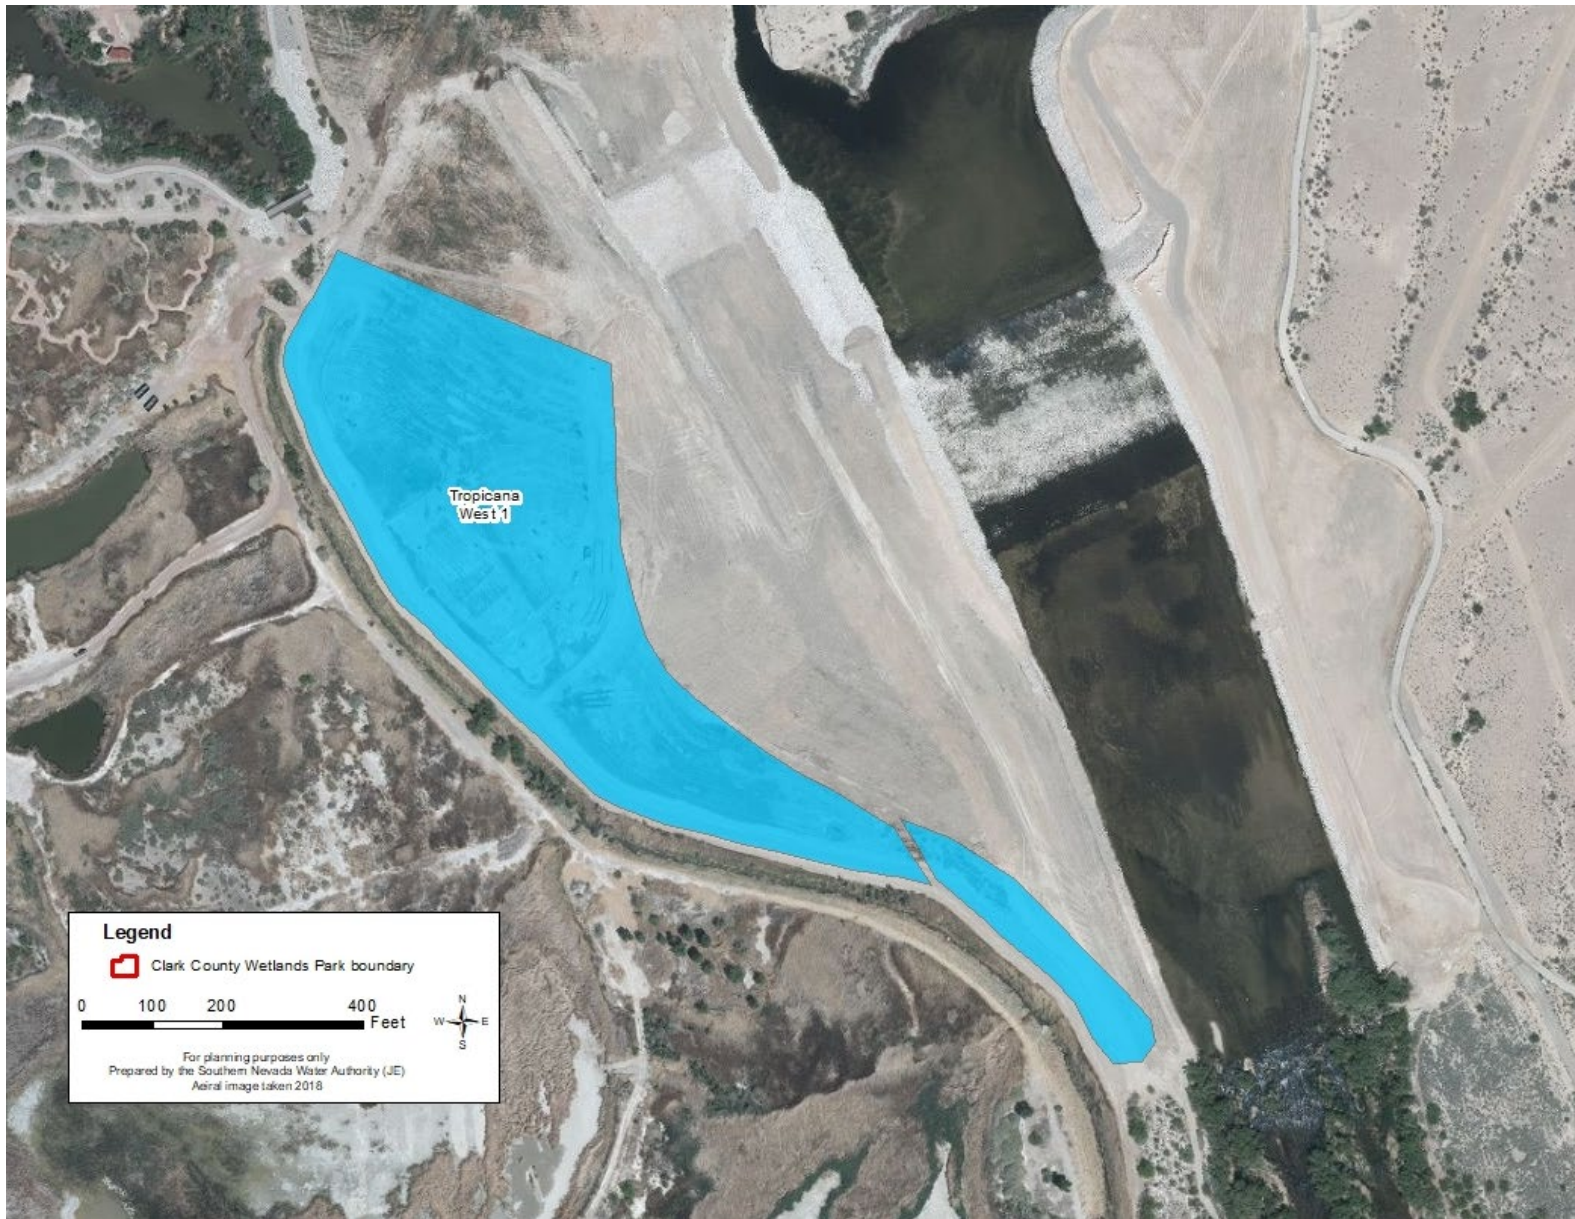
Figure 30. Aerial photograph of 2018 delineated Tropicana Weir revegetation site.

The newest revegetation site and the most recent Green-Up prior to 2018 vegetation monitoring was Tropicana West 1 (TW1) located at the Tropicana Weir (Table 21; Figure 30). The Tropicana Weir was completed later in 2018 and will have additional revegetation projects on the west and east sides of the channel. The area where TW1 is located was almost a monoculture of common reed and was cleared as an additional area for restoration along with the construction of the weir. Common reed is a very difficult weed to control and eliminate from an area. As such, an aggressive planting design was implemented on TW1 to try and outcompete the reed. This meant planting more individual plants than at typical sites and designing the planting area to allow for mowing of the reed (Figure 31).

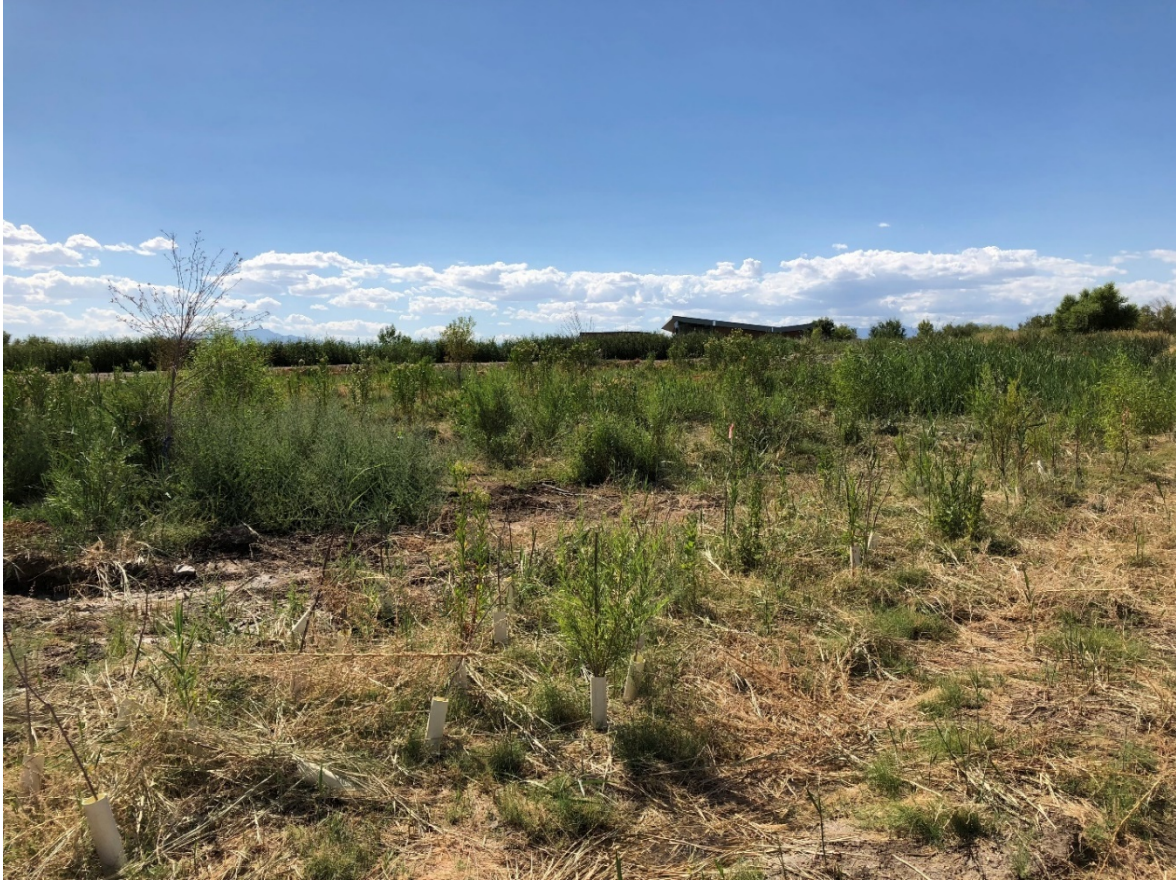
**Figure 31. Regular control of common reed allowed native plants to put on substantial growth in their first growing season at the Tropicana West 1 revegetation site.**

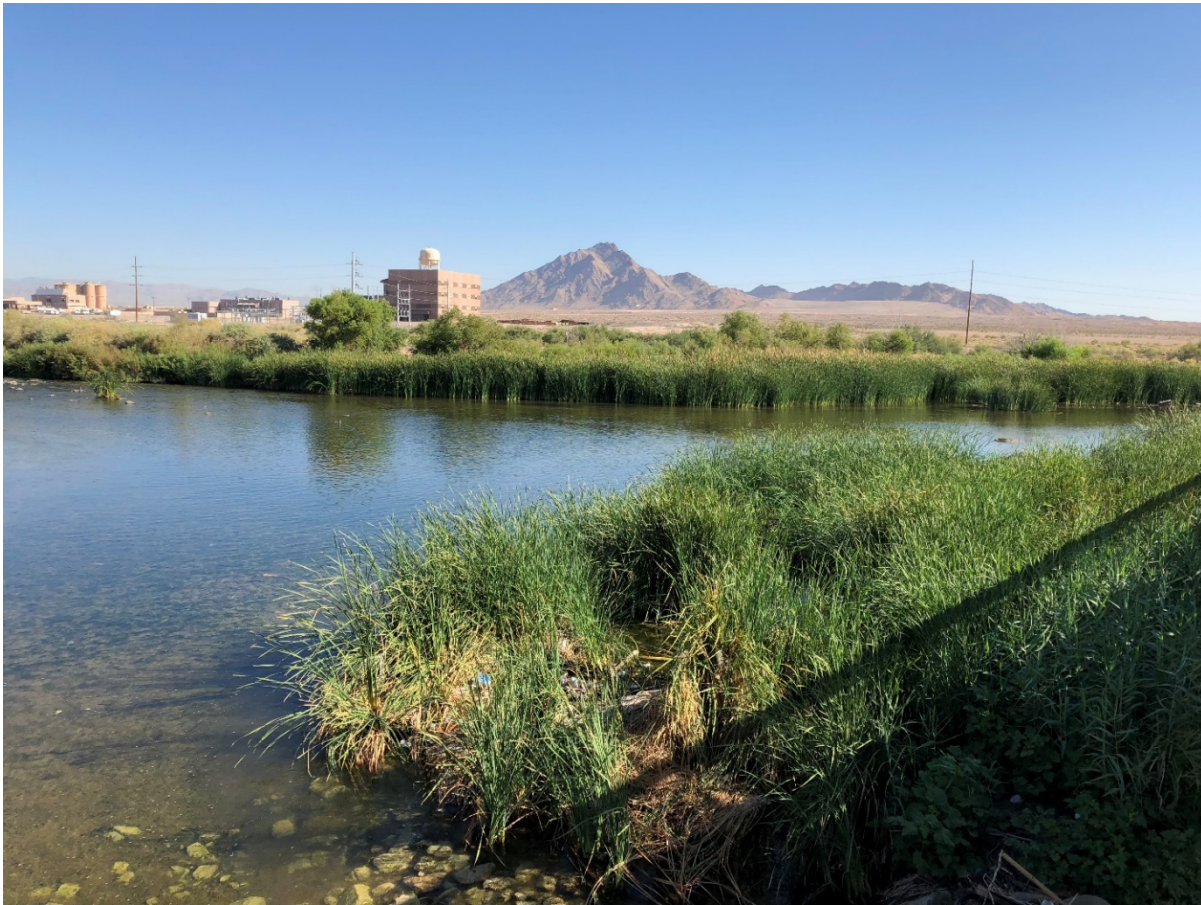
In January of 2017, the majority of the vegetation in the backwater behind the Upper Diversion Weir, known as Upstream Upper Diversion Emergent (UUDE) was removed (Figure 32). The vegetation had collected a substantial amount of sediment and trash and had begun to alter the flow path of the Wash. The revegetation site was reduced from 3.65 to 1.04 acres. By 2018, nearly three-quarters of an acre had reestablished in the backwater, and the site is now at 1.76 acres (Figure 33). Based on the species-specific data, it appears that the main contributor to the growth is southern cattail, which increased from 50-75% cover to 75-100%. The number of species also increased, from 12 in 2016 to 21 in 2018, which is the highest since 2011. Perhaps the disturbance from the sediment removal allowed for additional species to establish on the site. Another option is that many species were difficult to detect with the expansive growth of southern cattails in years past and the newly cleared area allowed for detection of species that were always present. This is

**Figure 33. A substantial amount of vegetation had regrown at the Upstream Upper Diversion Emergent revegetation site in 2018 after being removed in 2017.**

likely since only three of the 21 species were not detected at least once in the previous nine monitoring years. The new species were prostrate pigweed (*Amaranthus albus*), dodder (*Cuscuta denticulata*), and Spanish false fleabane (*Pulicaria paludosa*). Of these, only Spanish false fleabane is considered a riparian or wetland species. The others established on the banks where an access ramp was created for the 2017 vegetation removal.
