Las Vegas Wash Vegetation Monitoring Report, 2019

May 2020

**SOUTHERN NEVADA WATER AUTHORITY
Las Vegas Wash Project Coordination Team**

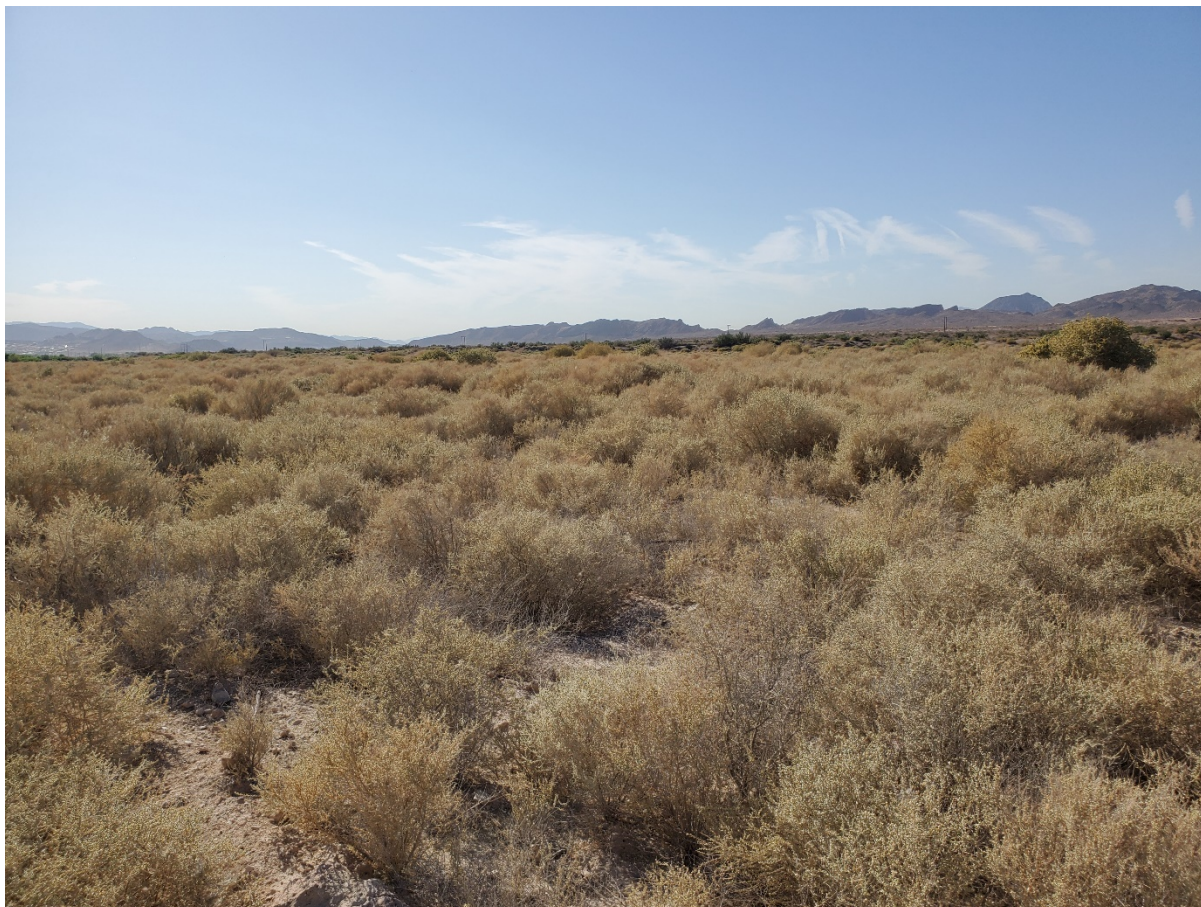
Figure 4. Both non-wetland revegetation sites on the south side of Archery and Silver Bowl Weirs were dominated by desert saltbush in 2019.

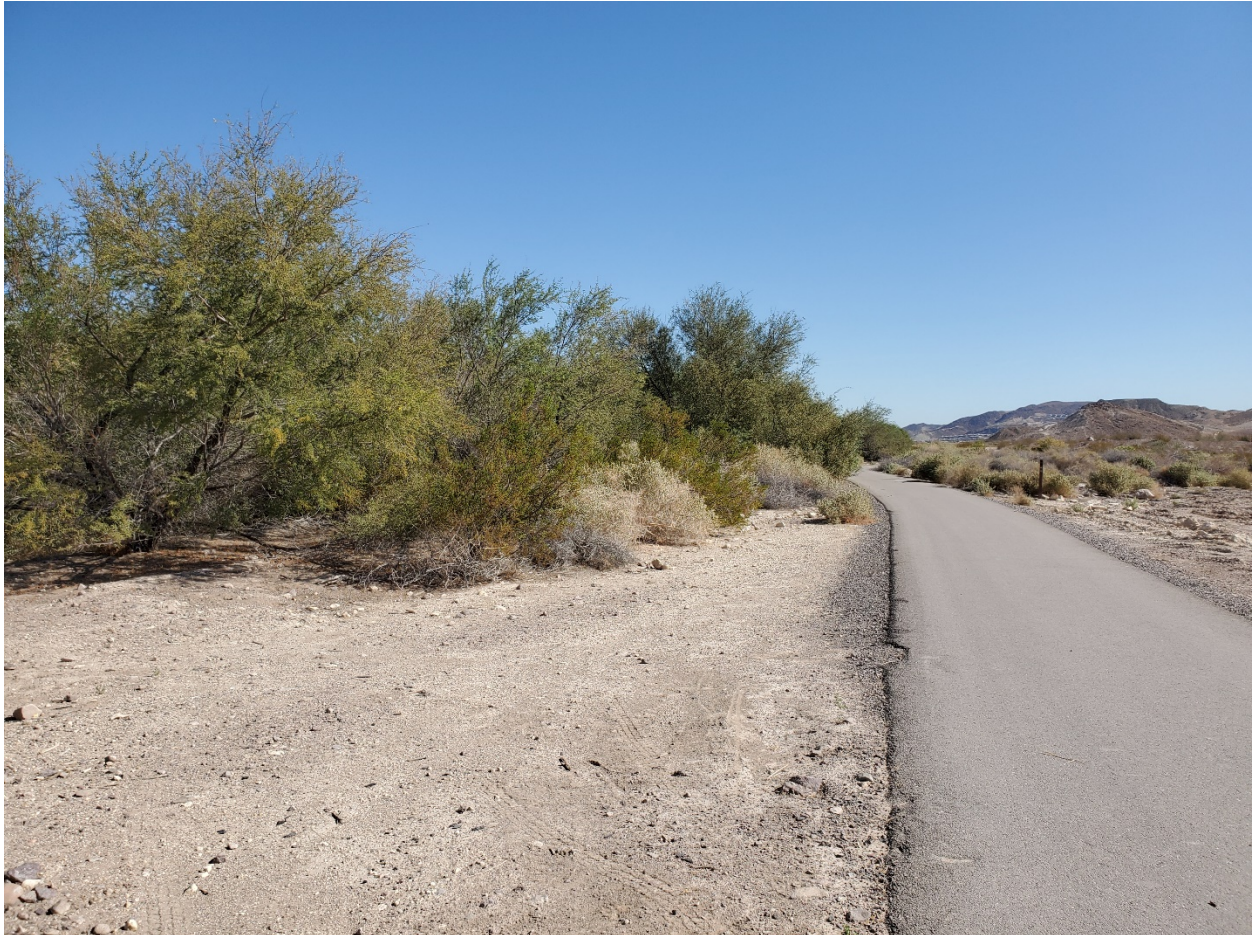
Upstream Bostick South Bank is one of the older sites at the Bostick Weir, which was in its 15th growing season in 2019. This mature site borders the Clark County Wetlands Park bike trail (Figure 6). This site has had the maximum 75-100% total cover every year since 2010 including

2019. The co-dominant plants on the site in 2019 were honey mesquite (*Prosopis glandulosa*) and screwbean mesquite. One or both of these species have been the dominant species on the site every monitoring year since 2006. There were no noxious species found on the site in 2019.

Figure 6. Vegetation at the Upstream Bostick South Bank is adjacent to the Clark County Wetlands Park bike trail.

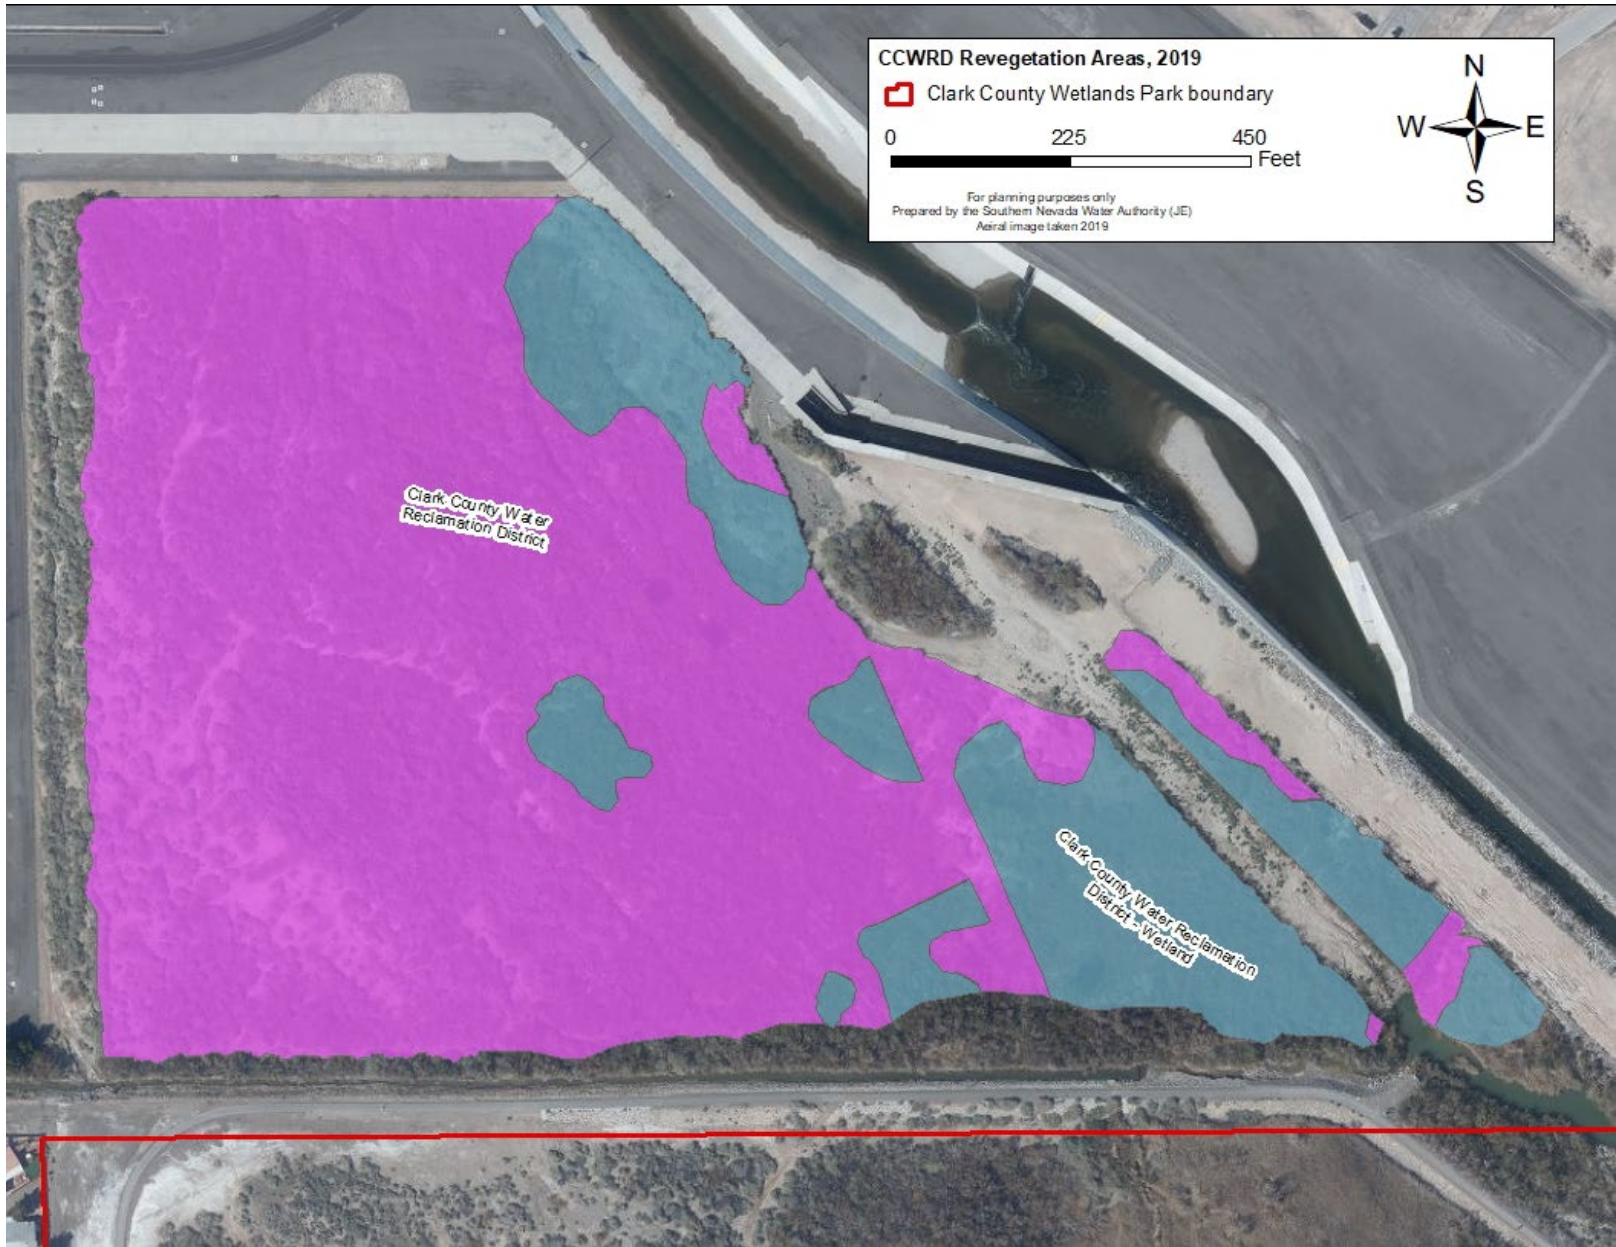
Figure 8. Aerial photograph of 2019 delineated Clark County Water Reclamation District revegetation sites.

The CCWRD revegetation site was not monitored in the field in 2019 after being field monitored in the previous year (Table 6, Figure 8). The total cover of the CCWRD site in 2019 was 75-100%, the same as it has been the previous two monitoring years. Starting in 2018 due to the density of the vegetation of the site, the monitoring protocol was changes to no longer separate the site into multiple monitoring areas. Individual areas within the site are difficult to access and therefore comparisons to previous year's data may not be valid. Although using ArcGIS would allow for continued usage of this method, it is desired to be able to compare this data to future years in which field monitoring of the site will resume.

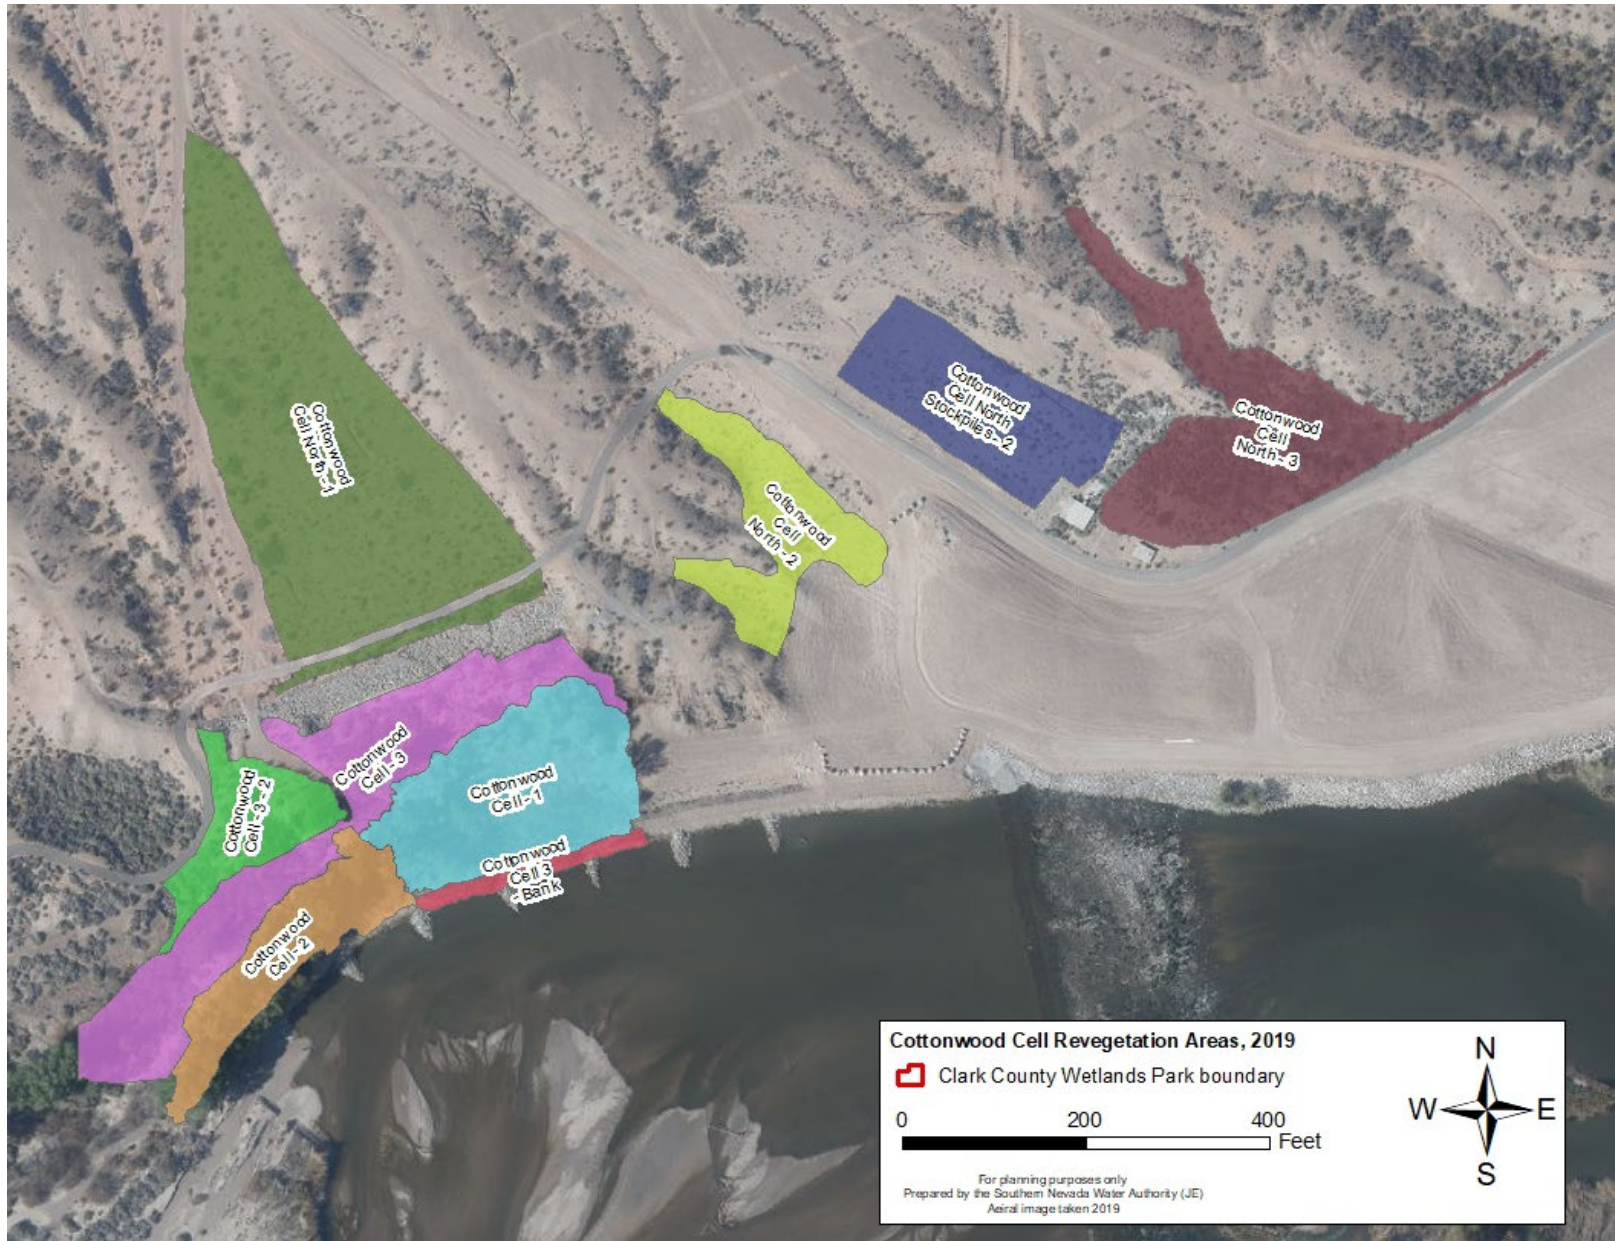
Figure 9. Aerial photograph of 2019 delineated Cottonwood Cell revegetation sites.

All seven of the revegetation sites at the Cottonwood Cells were monitored in the field in 2019 after using ArcGIS for the 2018 monitoring year (Table 7, Figure 9). The Historic Lateral Weir expansion was completed in December 2018. This year’s monitoring is the first full year of plant growth after a major change to the surrounding environment including earth moving, an increased backwater, as well as disturbance to previously existing vegetation. The expansion project required the removal of portions of four different revegetation sites; Cottonwood Cell North (CCN), Cottonwood Cell North Stockpiles (CCNS), Cottonwood Cell Bank (CCB), and Cottonwood Cell 3 (CC3). It is theorized that these changes will have impacts on the remaining vegetation. For example, the larger backwater behind the weir could allow for increased water infiltration to revegetation sites increasing growth of existing plants. A potential negative impact would come from the land disturbance which allows for weed encroachment into the area. This first year’s monitoring is not expected to have complete results of how these changes impacted the Cottonwood Cell sites but will be important first data point for evaluating the changes in the future.

The two sites expected to potentially benefit from an expanded backwater behind the Historic Lateral Weir are Cottonwood Cell 1 (CC1) and Cottonwood Cell 2 (CC2). CC1 and CC2 were planted exclusively with cottonwood (*Populus fremontii*) poles in 2002 and 2005 respectively. These sites are only a few feet away from the edge of the Wash. CC1 has declined in the cover of its namesake plant from 75-100% in 2010 to 25-50% in each field monitoring year since 2014 including the most recent year (Figure 10). This is believed to be a combination of disease and beaver herbivory. Cottonwoods were replaced by other species including state listed noxious weeds (johnsongrass, Malta starthistle, and tamarisk) as well as native species such as desert broom (*Baccharis sarothroides*). CC2 in contrast has had cottonwoods measure at 75-100% cover in every field monitoring season since 2007. The cottonwood poles that were planted at this

location remain at a much higher density than those at CC1. This is also potentially problematic in that the trees are not reaching their full growth potential and the Long-Term Management Plan specifically mentions this site as one that should be thinned to allow for greater growth as well as reduce the potential for disease.

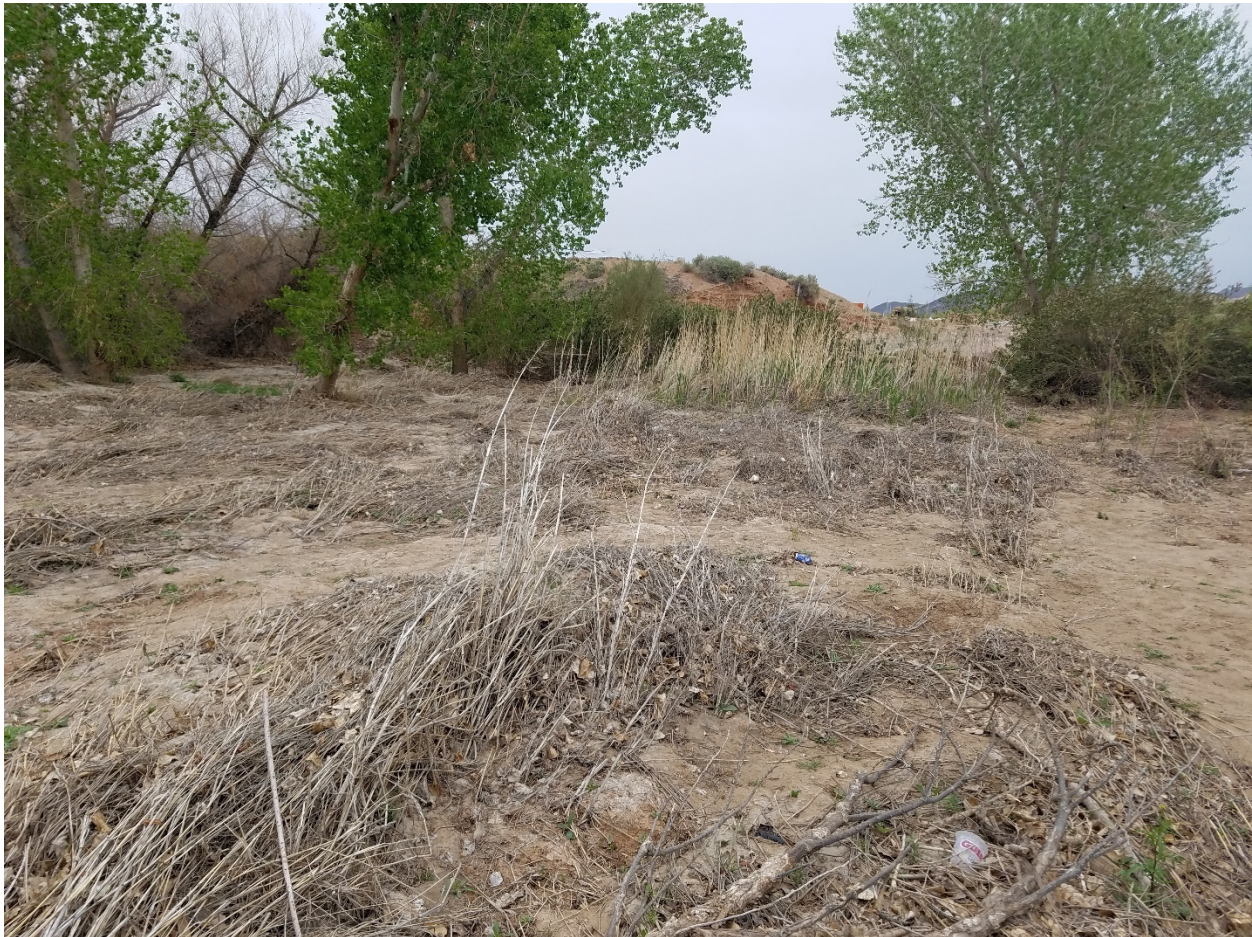
Figure 10. Sparse cottonwood trees at Cottonwood Cell 1 in 2019.

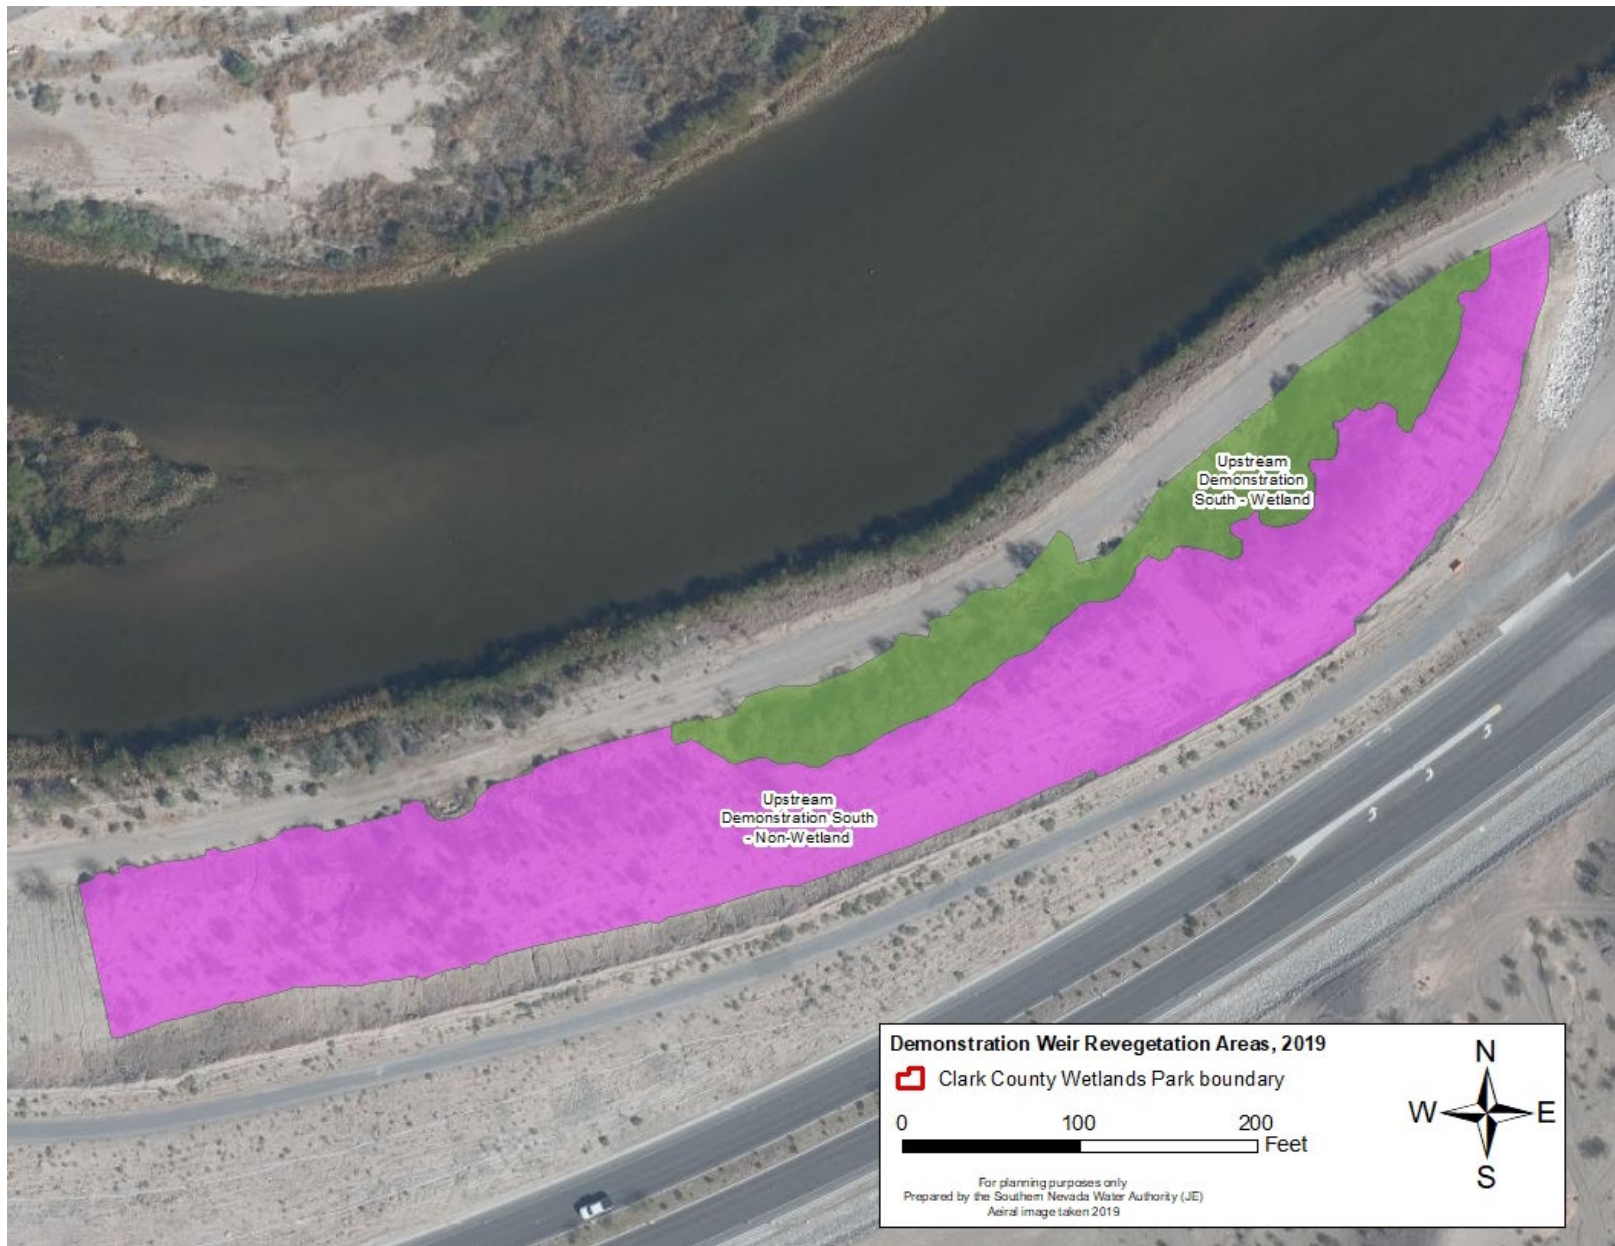
Figure 11. Aerial photograph of 2019 delineated Demonstration Weir revegetation sites.

The two sites at the Demonstration Weir were not monitored in the field in 2019 (Table 8, Figure 11). ArcGIS monitoring in 2019 showed that UDS-N had the same total cover as it has had since 2015, 25-50%. This site has not changed much in terms species composition or cover in many years except for a decline in the cover of the dominant species, creosote bush. In 2018, this species had a cover of 1-5% which was down from 25-50% two years earlier. Monitoring in 2020 will show if this is a long-term trend or a single year anomaly. UDS-W had the maximum cover in 2019 at 75-100%. This is the same cover that was measured the last time cover was calculated using ArcGIS. The last two times UDS-W was monitored in the field, it was calculated to be 50-75%. This may be a result of the inherent biases related to ocular estimation of vegetative cover in the field.

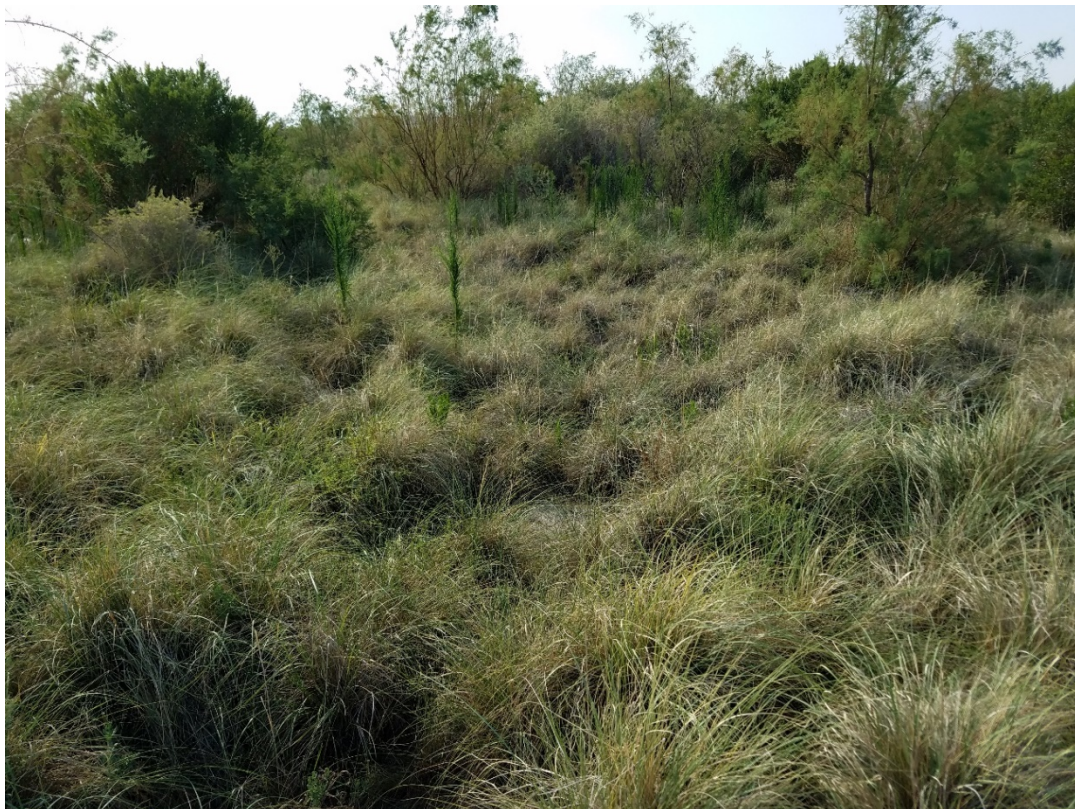
The site for the spring 2015 Green-Up was DCUNS-3. This site is the most upstream site in this area and mainly runs along the Duck Creek Channel, an urban tributary, rather than the Wash. It is located at a slightly lower elevation than most of the other non-wetland sites at the Duck Creek Confluence and Upper Narrow Weirs. While the dominant plant is desert saltbush, just like the other non-wetland sites on the south side of the Wash, three other species also make up substantial portions of the vegetative cover. Desert saltbush had 25-50% cover in 2019 while desert broom, honey mesquite, and alkali sacaton (*Sporobolus airoides*) all had 5-25% cover (Figure 13).

Figure 13. An alkali sacaton stand with a variety of other vegetation at DCUNS-3 in 2019.

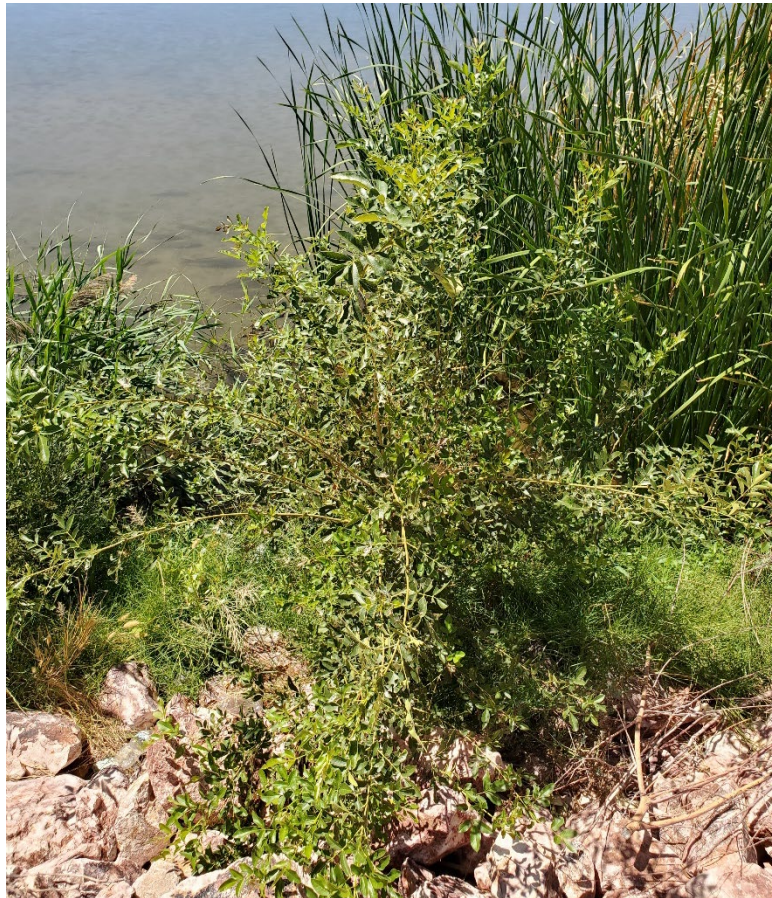
The DU Wetlands No. 1 Weir (DU1W) passive wetland site was the only revegetation site not monitored in the field at the DU Wetlands No. 1 Weir in 2019 (Table 10). The weir was cleared of vegetation earlier in 2019 and reduced to 0 acres but is still included in monitoring due to knowing subsurface vegetation as well as new plant establishment will result in some replacement of the removed vegetation in upcoming years. The lone wetland site at DU Wetlands No.1 Weir, DU1E, has had the highest possible cover value each year since monitoring began in 2013. In 2019, however, it had its lowest species richness recorded at 27. The highest number of species at this site was in 2013 when there were 40 species. This is likely explained by the growth of the two dominant species on the site. Common reed, the dominant species on the site, had 2.5% cover in 2013 and 46.5% cover in 2019. The second most dominant species, Goodding's willow, had 1.2% cover in 2013 and 29.9% in 2019. The expansive growth of these species is likely outcompeting other species for space and resources. One new species on the site is the non-native Siberian Elm (*Ulmus pumila*; Figure 14)

Figure 14. A non-native Siberian Elm at DU1E in 2019.

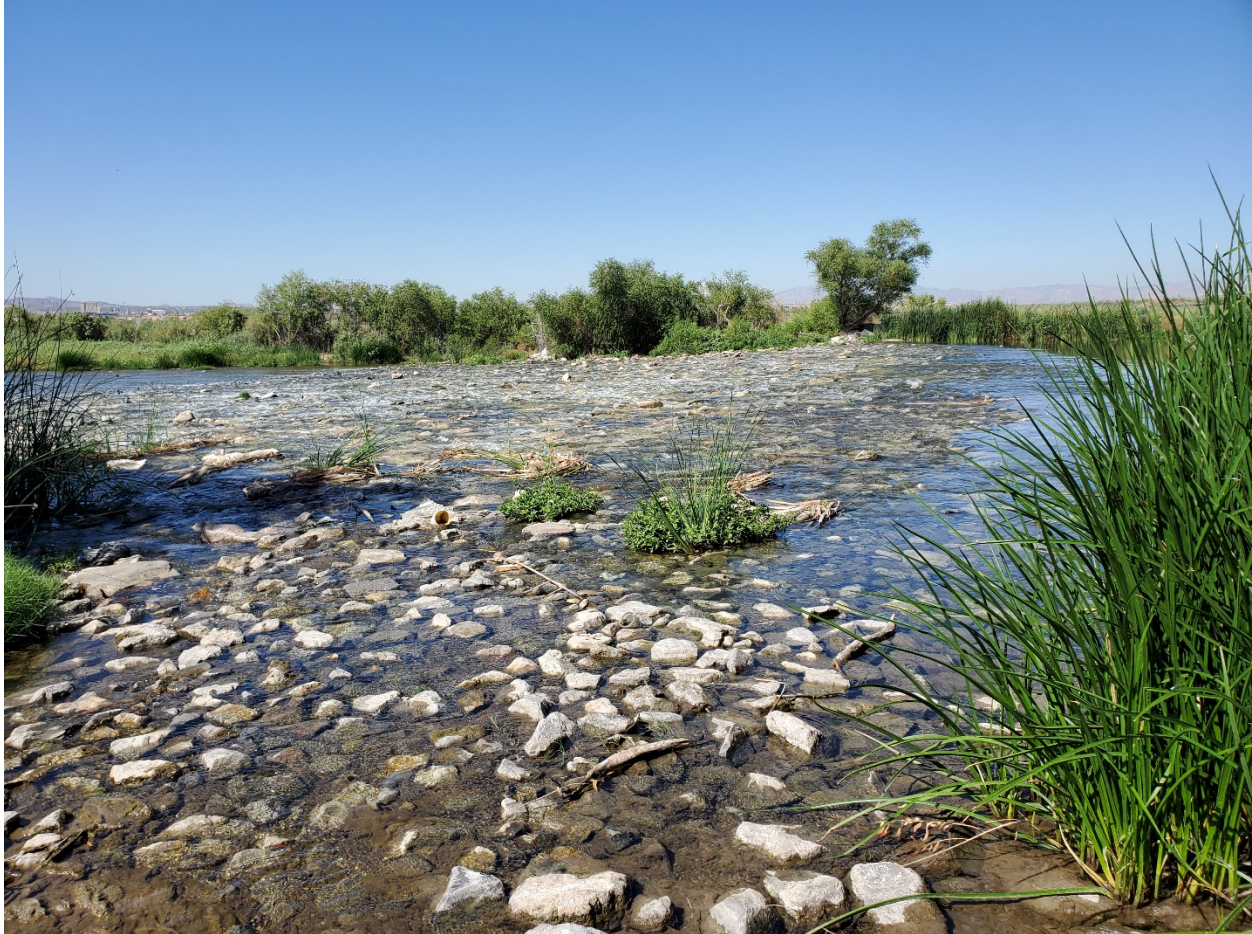
Figure 17. Vegetation was cleared from the DU Wetlands No. 2 Weir in 2019.

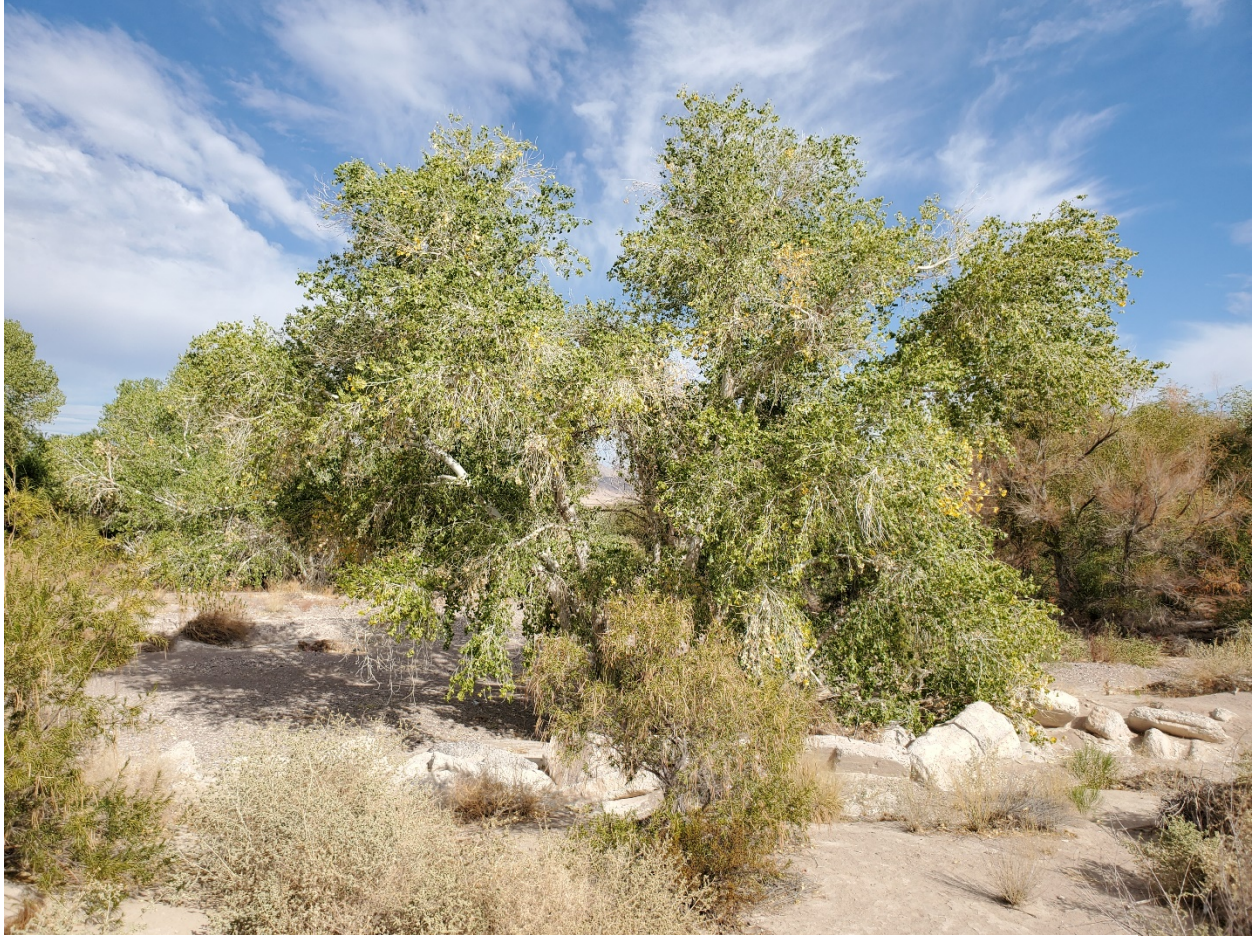
established populations, but many were observed in 2019. Upstream Historic Lateral North South (UHLNS; Figure 19) increased from 11 species to 18. Seven of the 18 species identified in 2019 were never documented on the site before, although the remaining 11 species identified weren't the exact same 11 species identified in 2017. One of these new species was tree tobacco (*Nicotiana glauca*). This exotic plant is becoming very common along the Wash. Although not listed on the Nevada state list of noxious weeds, it is treated as one in many other restoration sites in the southwest as it outcompetes many desirable native species. The third wetland site, Upstream Historic Lateral South Bank – Wetland (UHLSB-W), increased from nine species to 20. Only four of these 11 additional species were not recorded on the site in prior monitoring years. Many of these species have cover values less than 1% which makes them susceptible to being absent in subsequent years but changing conditions either lead to establishment or reestablishment on the site or germination of seeds previously deposited on the site. An exception this year was the identification of false daisy (*Eclipta prostrata*) which had a 1-5% cover in 2019 after never being documented on the site before. So, in approximately two years, this species established over the site and now covers over 1% of the 0.87-acre site.

Figure 19. Species richness increased at UHLNS in 2019.

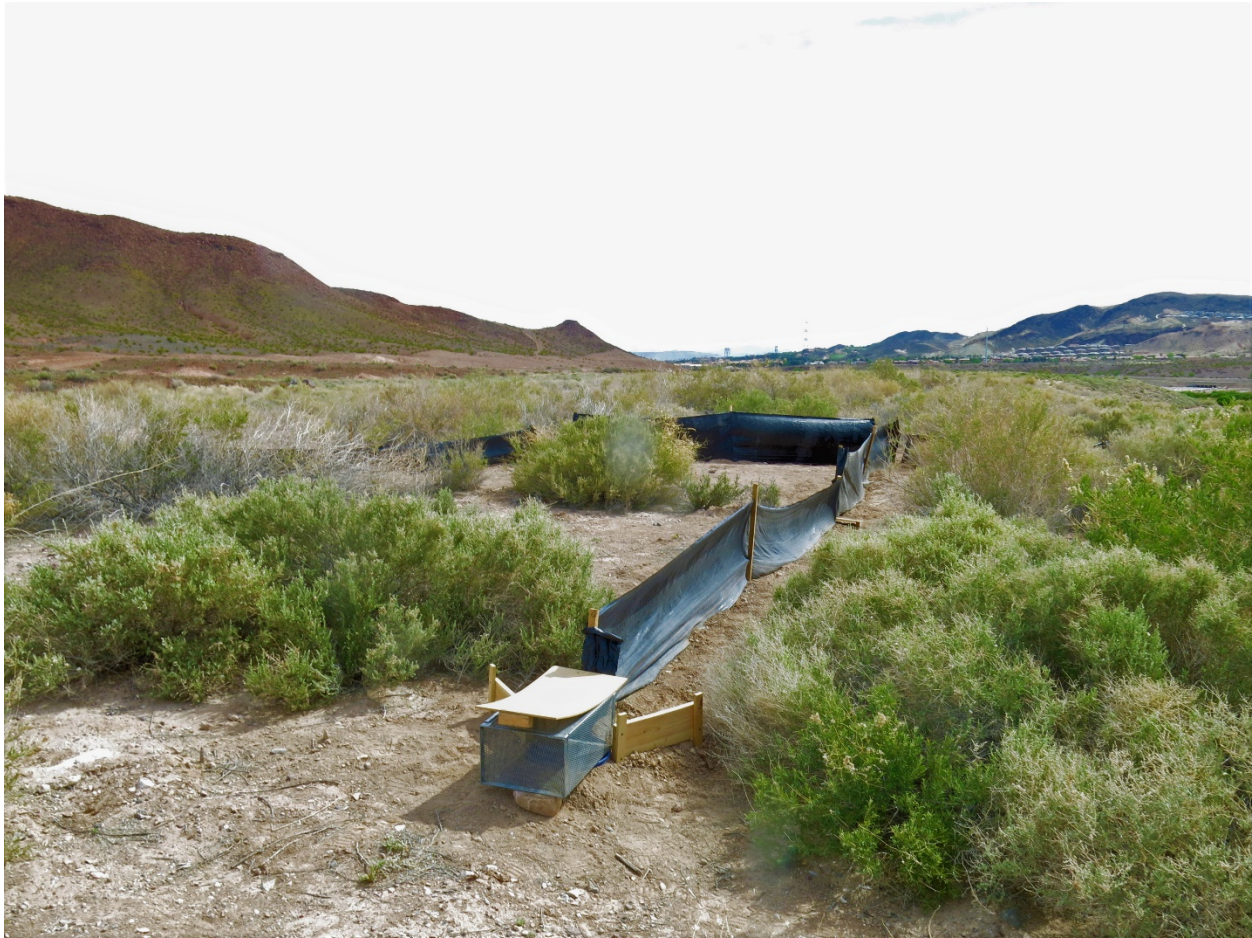
in 2017. The total cover was also the same at 50-75%. In the alternate years where the site is monitored for total cover using ArcGIS the total cover has been lower at 25-50% in both 2016 and 2018. This could be a result of one or many factors. First, it is a very large site and difficult to accurately estimate the cover in the field. Second, because the desert shrubs found here are light in color, they may not show up clearly in aerial imagery and may be undercounted using ArcGIS. Combining both methods, it is likely that the site is near the 50% cover mark for the past few years. A reptile survey conducted in 2019 included LNHN as a representative upland site (Figure 21).

Figure 21. A reptile survey array was erected on the LNHN site in 2019.

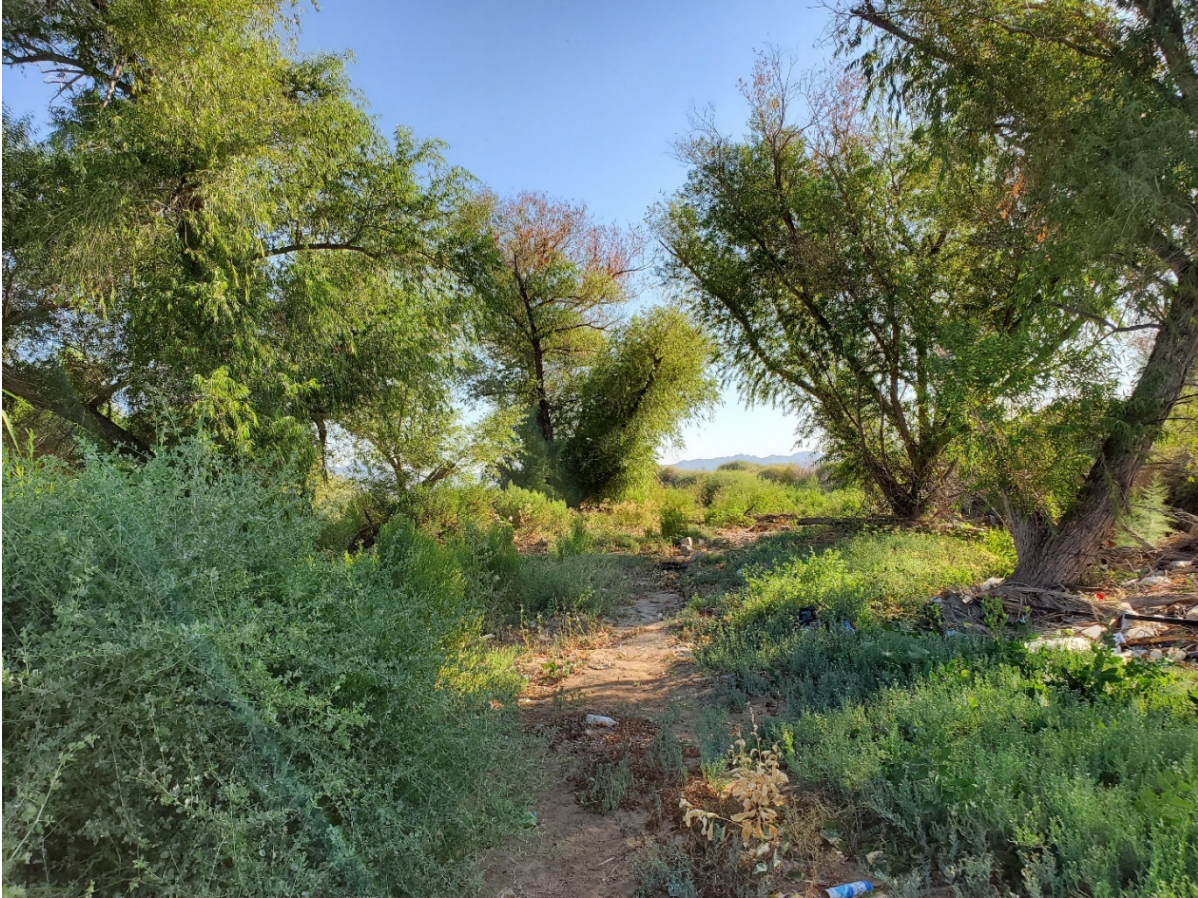
Figure 23. Goodding's willow stand tall across DMN-W in 2019.

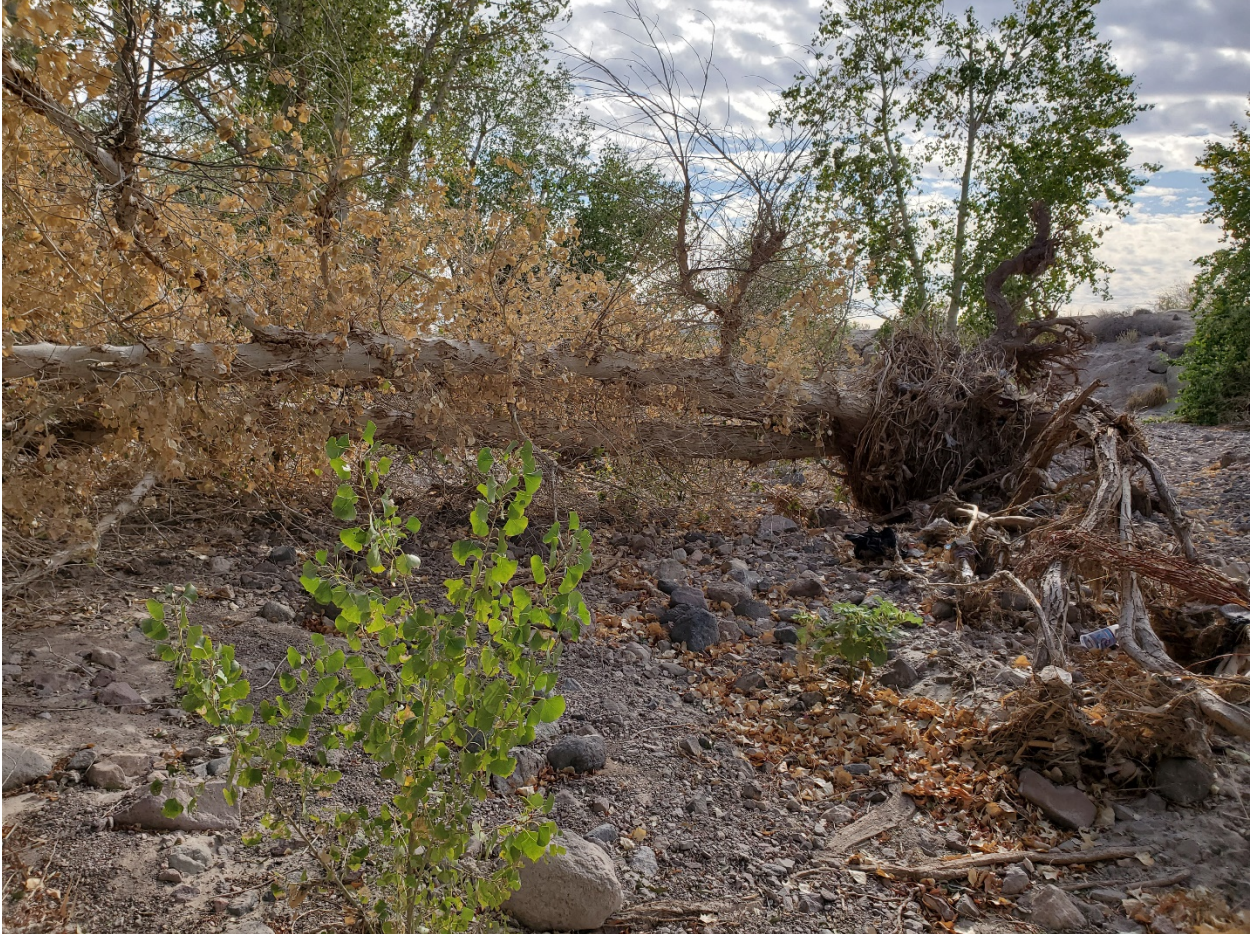
Figure 25. A fallen cottonwood tree and a sapling on DPS in 2019.

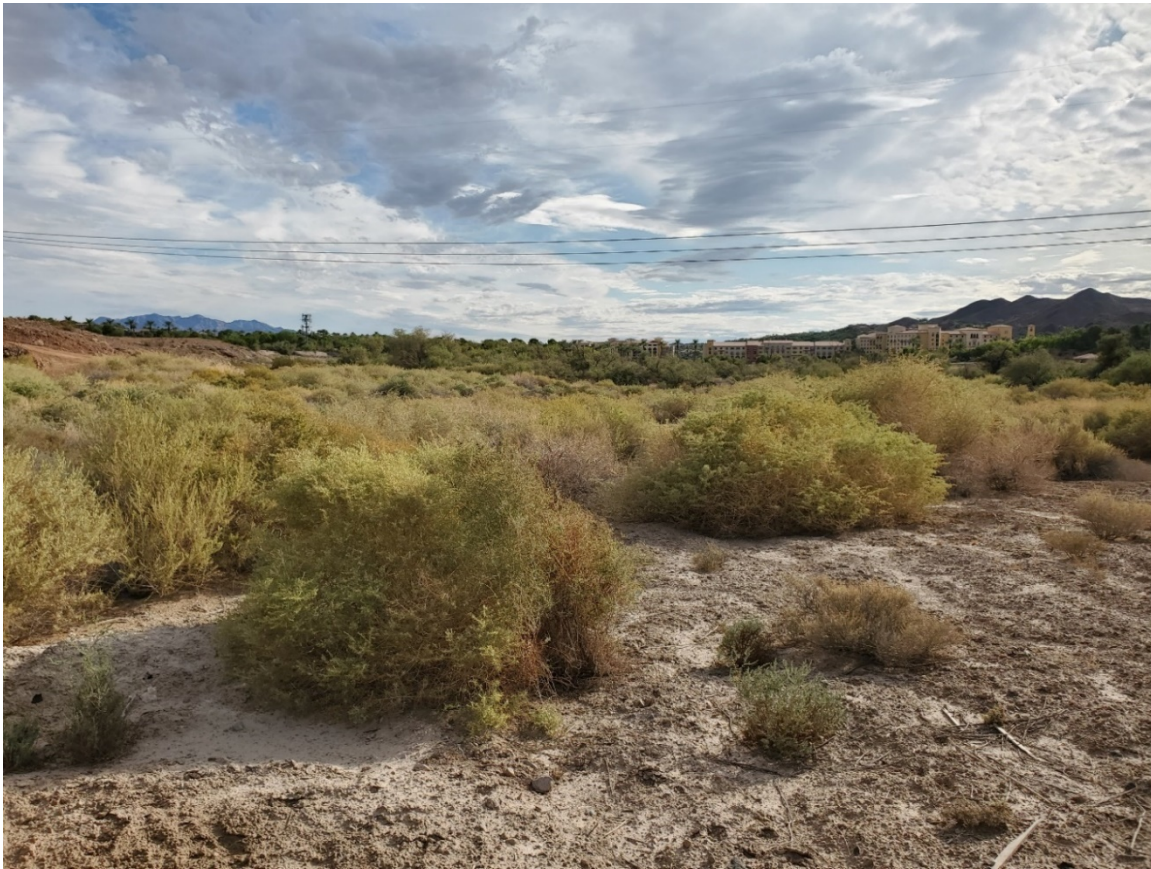
2017 to 5-25% cover in 2019. While increasing in richness and cover slower than most planted sites, this pace may be the best that could be expected given the sites environment.

Figure 27. Saltbush are the dominant species on UPLNP in 2019.

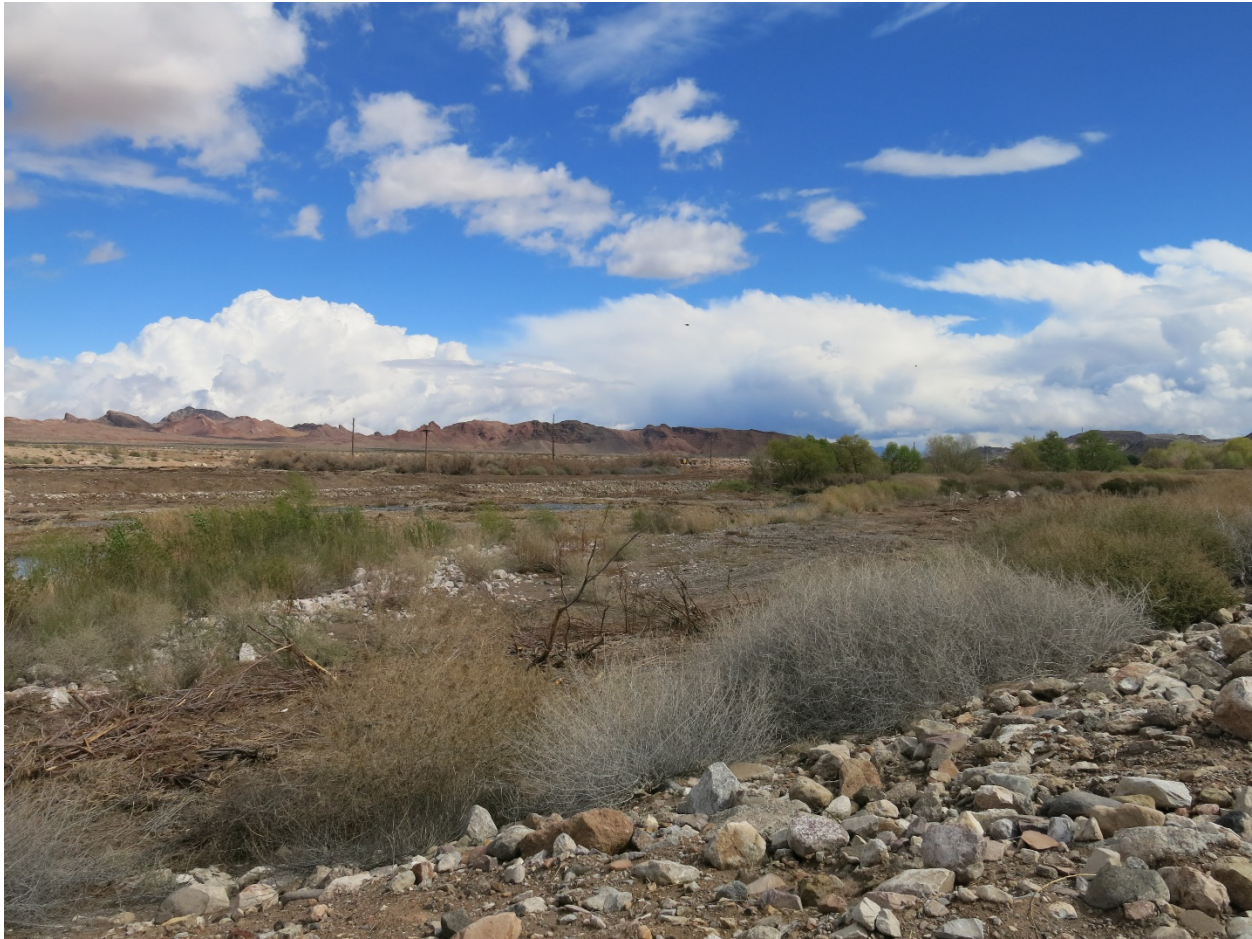
Figure 30. Portions of Site 108 were removed for the Sunrise Mountain Weir.

Site 108 had its lowest total cover in many years. Each of the four areas broken down by funding source also had their lowest total cover in many years. Some of this can be attributed to the removal of areas with denser vegetation as part of the construction of the Sunrise Mountain Weir which was completed at the end of 2018. Current plans call for planting the south side of the Sunrise Mountain Weir in 2021. This may be a good opportunity to do supplemental planting or seeding across Site 108 which is located just to the west.

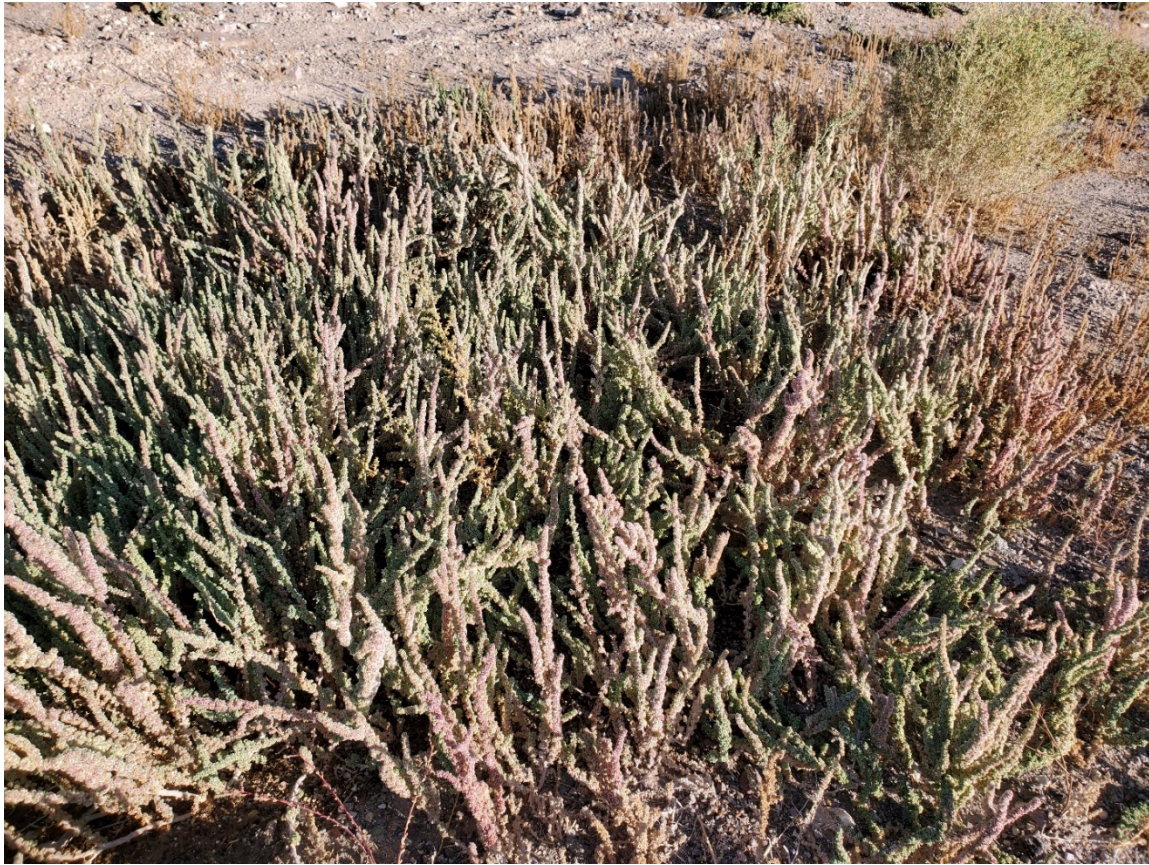
Figure 33. Saltlover at U3KS in 2019
