Las Vegas Wash Vegetation Monitoring Report, 2019

May 2020

**SOUTHERN NEVADA WATER AUTHORITY
Las Vegas Wash Project Coordination Team**

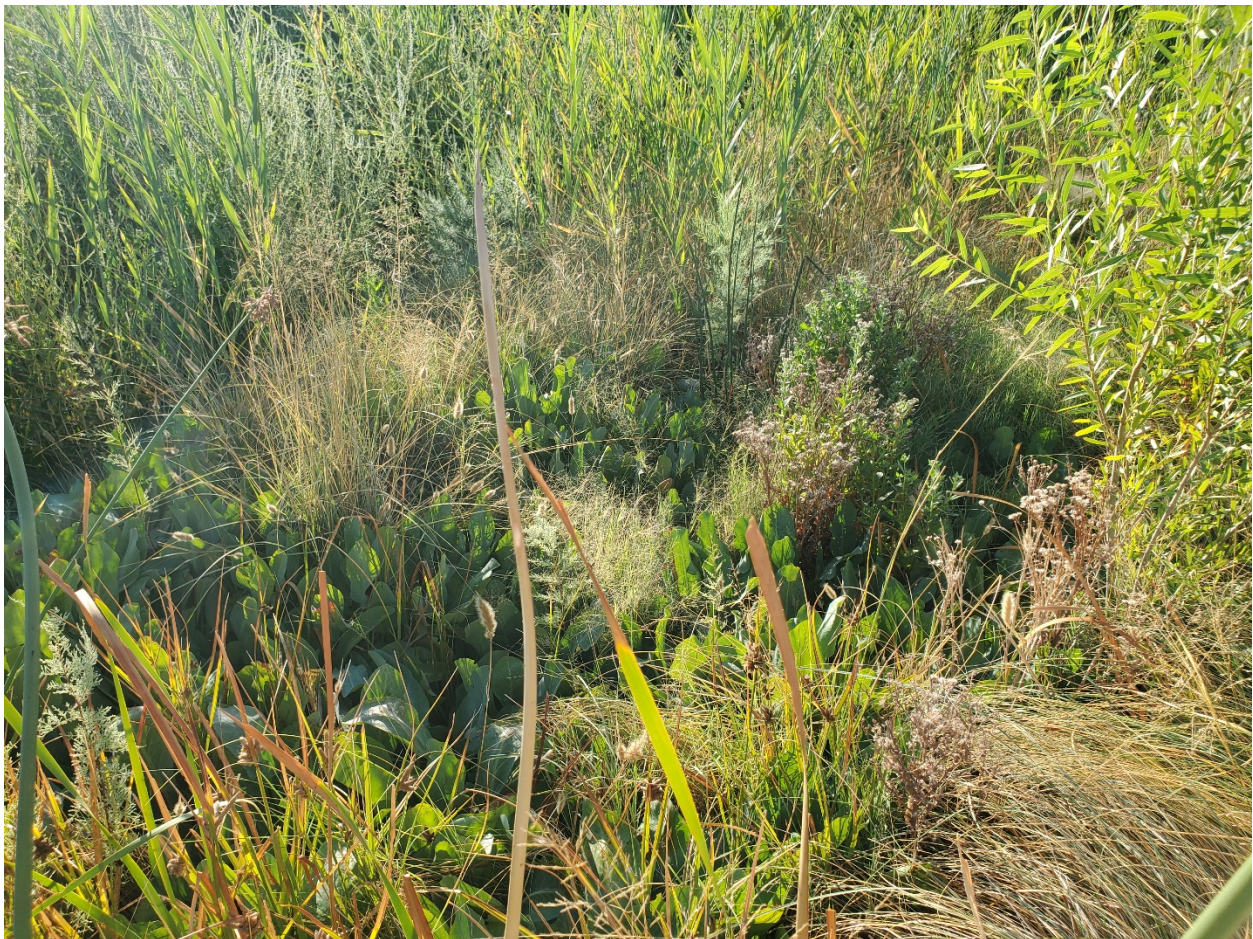
Figure 35. Dense and Diverse vegetation at Tropicana West 1 in 2019.

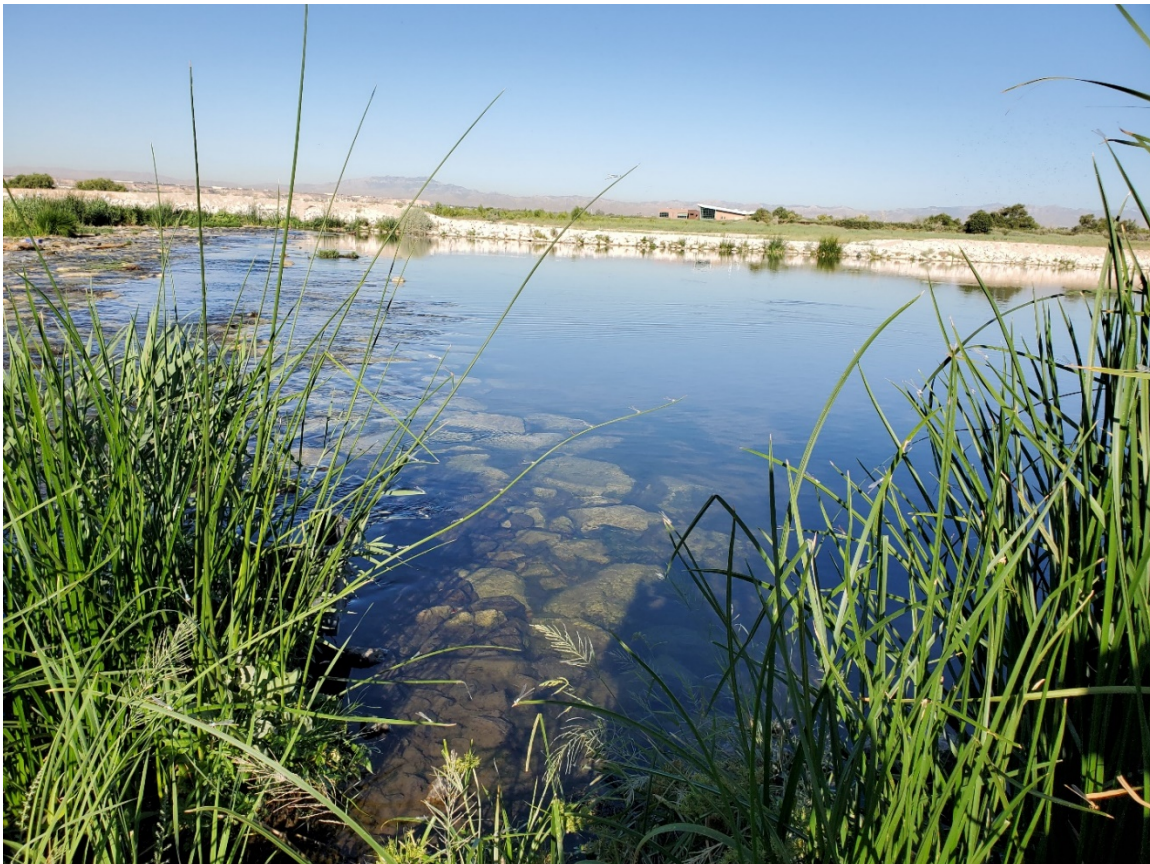
Figure 36. Looking from the east side of the Wash upstream of the Tropicana Weir in 2019.

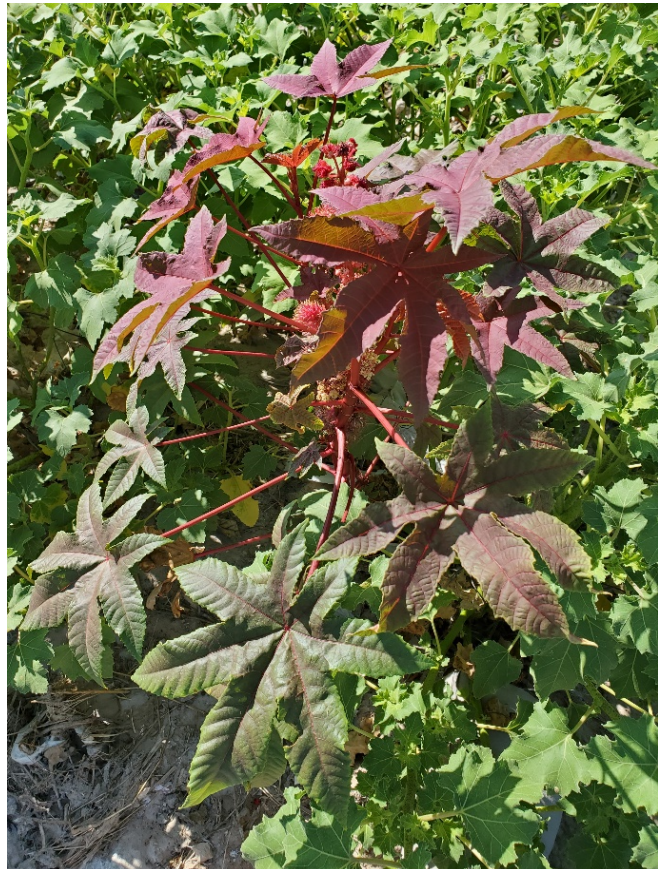
Figure 38. A new species for the Wash, castor bean, was found at Upper Diversion Island in 2019.
