Las Vegas Wash Vegetation Monitoring Report, 2021

December 2023

**SOUTHERN NEVADA WATER AUTHORITY
Las Vegas Wash Project Coordination Team**

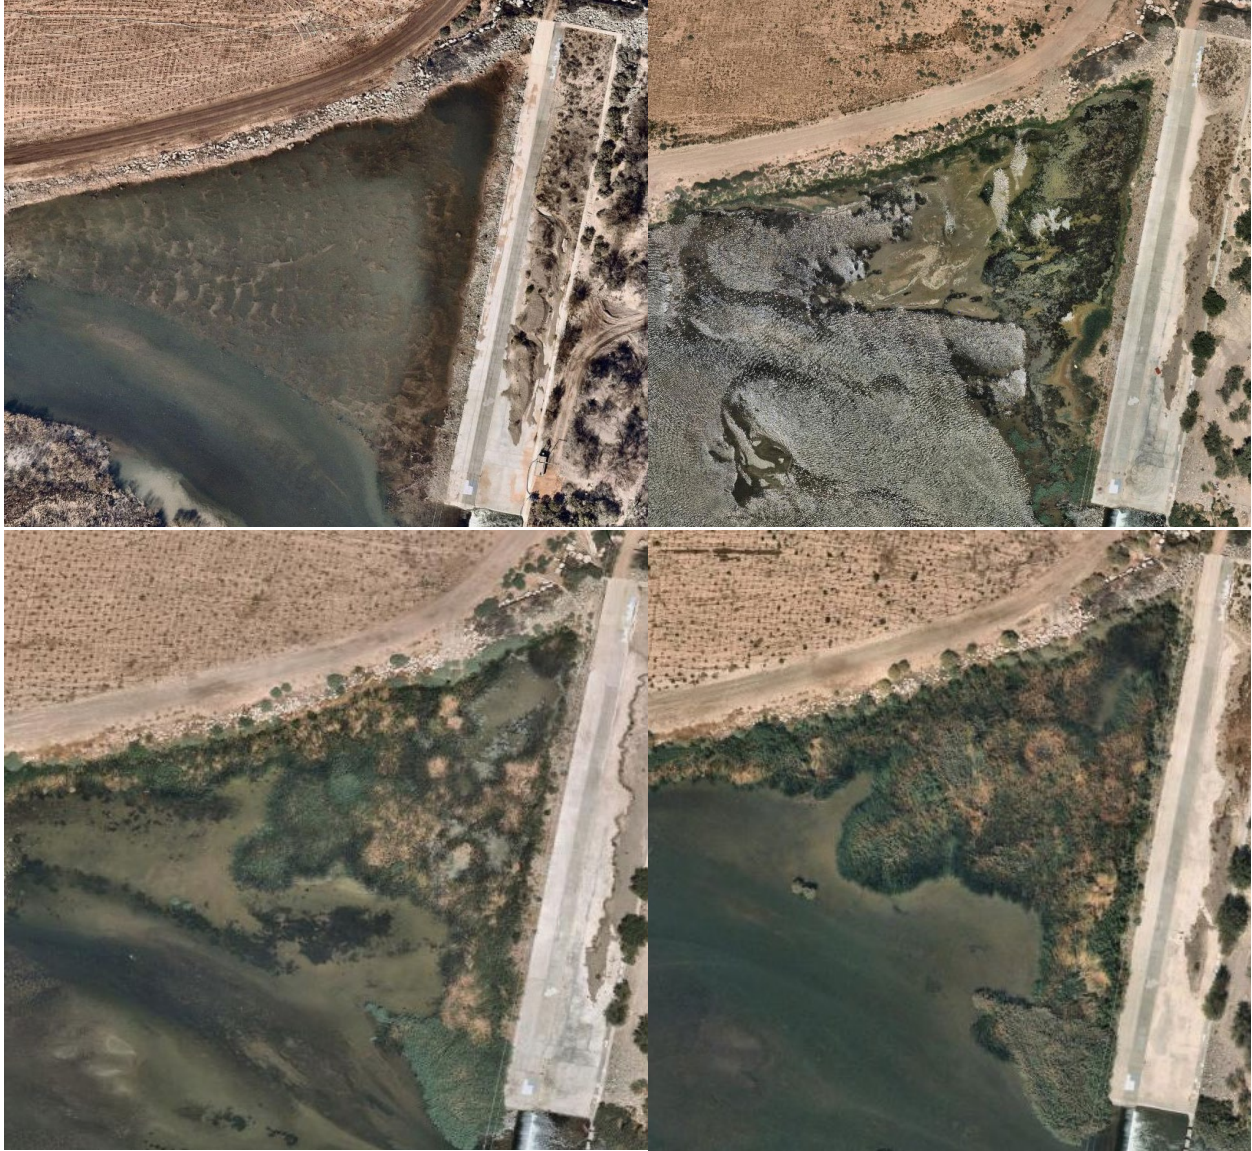
Figure 17. Upstream Pabco North’s transformation from February 2020 (top left), June 2020 (top right), June 2021 (bottom left) October 2021 (bottom right) to February 2022 (bottom right).

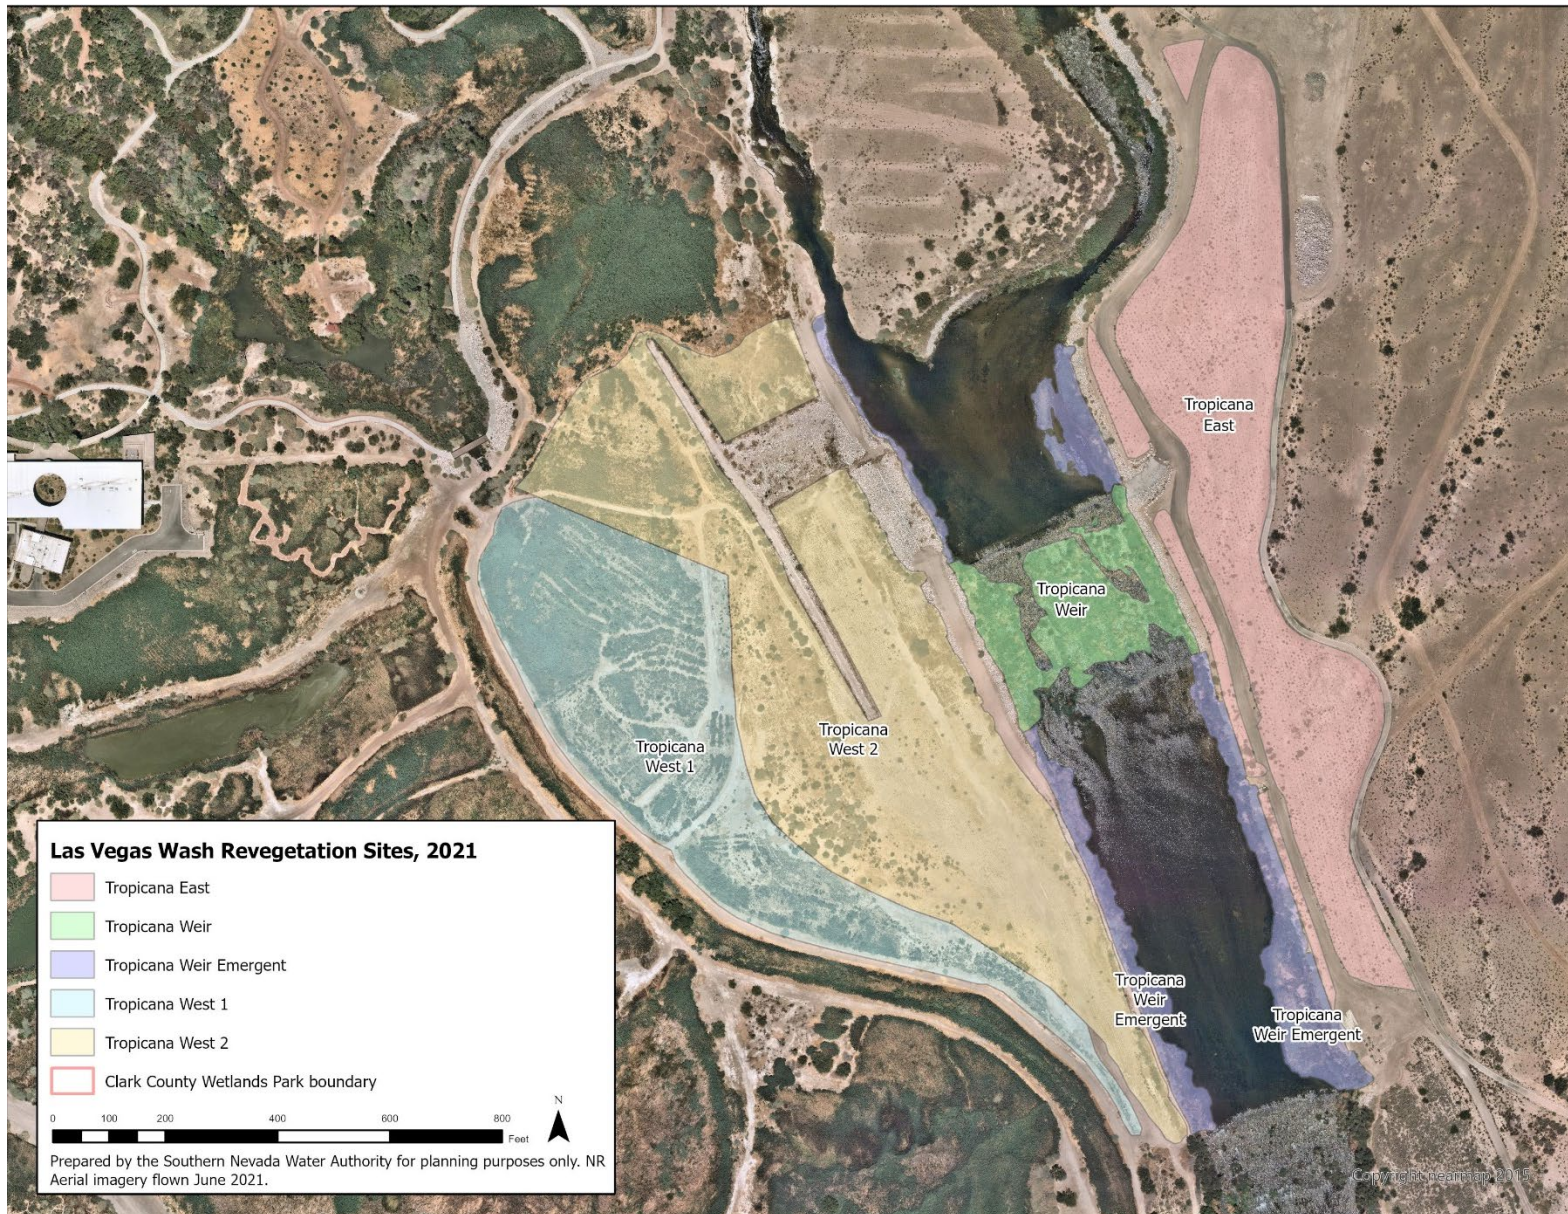
Figure 24. Aerial photograph of 2021 delineated Tropicana Weir revegetation sites.

There are five sites associated with the Tropicana Weir (Table 23, Figure 24). All sites but Tropicana Weir (TW) were monitoring in the field in 2021. Three of the sites were actively planted as Green-Up volunteer events. Tropicana West 1 (TW1) was the spring 2018 event, Tropicana West 2 (TW2) was the fall 2018 event, and Tropicana East (TE) was the spring 2019 event. The remaining two sites were passively created. TW is the vegetation growing on the weir itself and Tropicana Weir Emergent (TWE) is the vegetation growing on the Wash banks upstream and downstream of the weir. TWE is broken up into two monitoring areas, east and west, and then combined using a weighted average based on acreage.
